THE SALVAGING OF THE GREEK SHIP CAPTANTONIS

COMMANDER T. P. IRWIN, R.N., A.M.I.MECH.E., M.I.MAR.E.

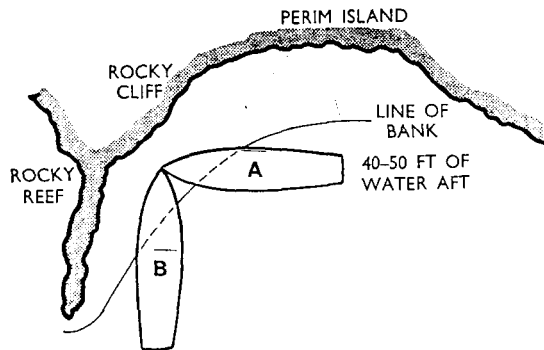
FIG. 7—A—ORIGINAL POSITION OF CAPTANTONIS
B—POSITION AFTER BREAKING OUT.

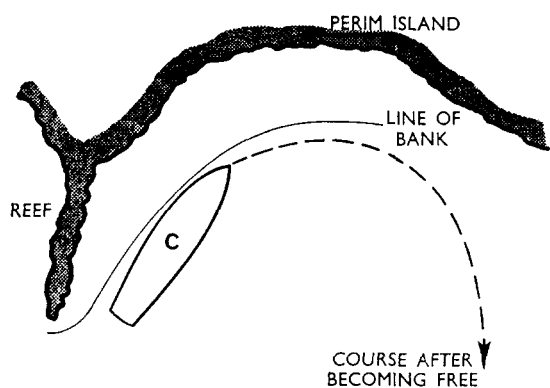
FIG. 2—C—POSITION AFTER UNLOADING AND SWINGING ON GROUND TACKLE

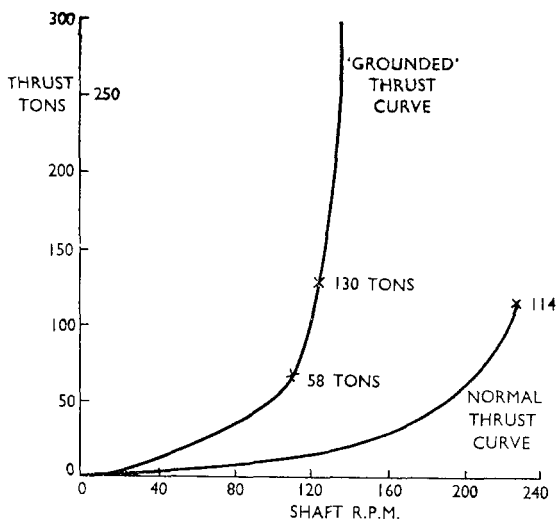
FIG. 3—THRUST (?)—R.P.M. CURVE

It was then possible to plot out thrusts against r.p.m. and s.h.p. using the breaking strain of the 4 and 6-inch wire ropes which parted, (the former 58 tons and the latter 129.6 tons). Once more considerable dangers appear to be present again if the extension to the curve is correct. It was also possible to make an estimated thrust curve for normal running, using the thrust block figures of 57 tons per block.

Other information began to come to light. Firstly the 'rule of thumb' for finding thrust by dividing s.h.p. by 100 does not apply when towing a grounded vessel at high powers. Secondly, when towing a 'free' vessel, the curves should fall between the 'grounded' tow curve and the 'normal' curve; it may be possible to estimate the thrusts under free towing by the 'rule of thumb' figure

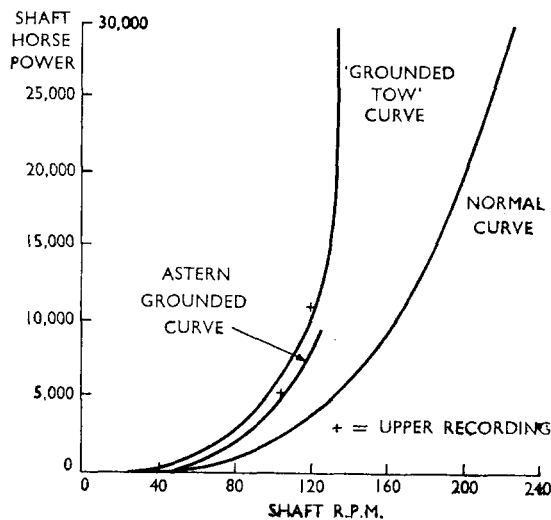
FIG. 4—S.H.P.—SHAFT R.P.M. CURVES

When daylight came it was felt that at last some facts might be available with regards to thrusts. The s.h.p.s obtained were plotted against the r.p.m. The slope of the curve is alarming. If the extension of the curve to maximum horse power is correct, then an increase of 10—12 revolutions increases the power developed from 10,000—30,000!
