CORRUGATED-MONEL EVAPORATOR BASKETS

MANUFACTURE, INSPECTION AND REPAIR

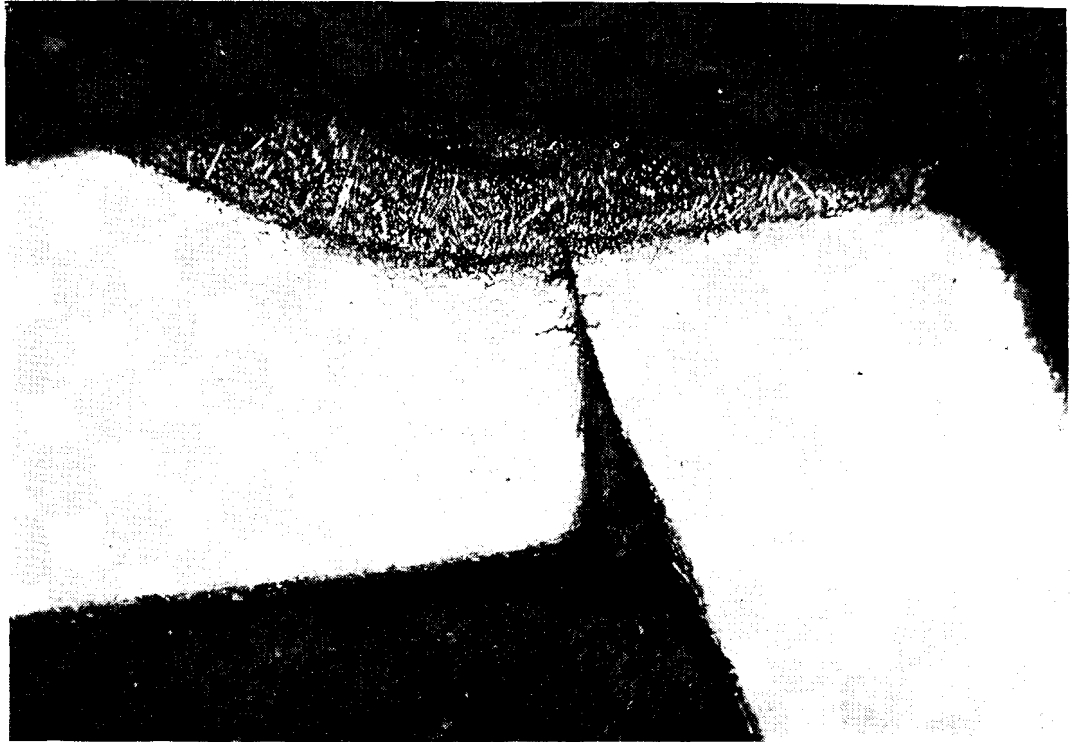
The welding technique used on these seams necessitates welding from one side only: the outside. Failure to obtain full weld penetration results in a manufactured crack at the weld root, thus it is essential to eliminate this defect before satisfactory units can be obtained.

Investigation into the fabrication of these baskets showed that the main reason for the defect was the reluctance of the welder to apply sufficient heat to penetrate the parent plate during the welding of the seams. This was because of the danger, which was quite high, of burning through the thin material (0.050 monel) to the atmosphere, with resultant large holes, difficult to repair.

FIG. 3—UNACCEPTABLE WELD

The original welding techniques appear to be satisfactory and are still being used. FIG. 3 shows an unacceptable weld before repair. FIG. 4 shows an example of a welded repair, using the modified backing bar.

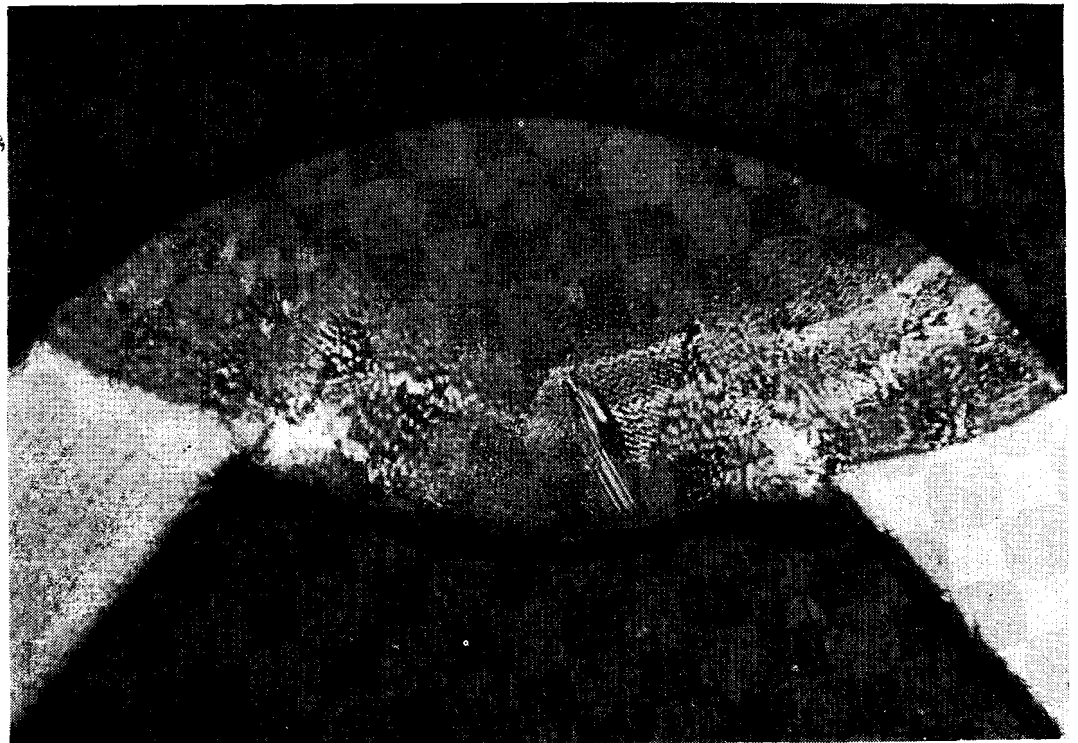
FIG. 4—A REPAIRED WELD USING MODIFIED BACKING BAR

Experiments showed that when old metal was used to form the inner bead no backing gas was required. But in any areas where new material was fitted, argon gas was necessary, as already explained, to shield the weld root. As the work proceeded, a modified backing bar, a perforated length of copper tubing $\frac{3}{16}$ in. diameter was developed. This gadget was easy to use and inexpensive to produce.

It was found that by using this type of backing bar it was possible to obtain an even distribution of the weld metal, without the danger of sharp edges forming on the inner bead. The finger seams were all welded with a Canadian liquid air model H10A manual heliweld torch, with a $\frac{3}{32}$ in. tungsten electrode and Inco 60 monel filler wire $\frac{1}{16}$ in. diameter; the optimum setting for this type of work on our machine was 45-50 amps, 15 volts.
