'MACHINING TYPE' TURBINE BEARING FAILURES

This article is an Admiralty appreciation of various factors associated with the phenomena of 'machining' or 'wire wool' bearing failures in turbine machinery. Although H.M. ships have not suffered such failures, it has appeared desirable to investigate reports and research in this field due to various opinions which were being freely expressed by certain authorities. In recent months opinion has hardened to some extent, and it appears that there may be good reasons why naval machinery is adequately protected from such failures.

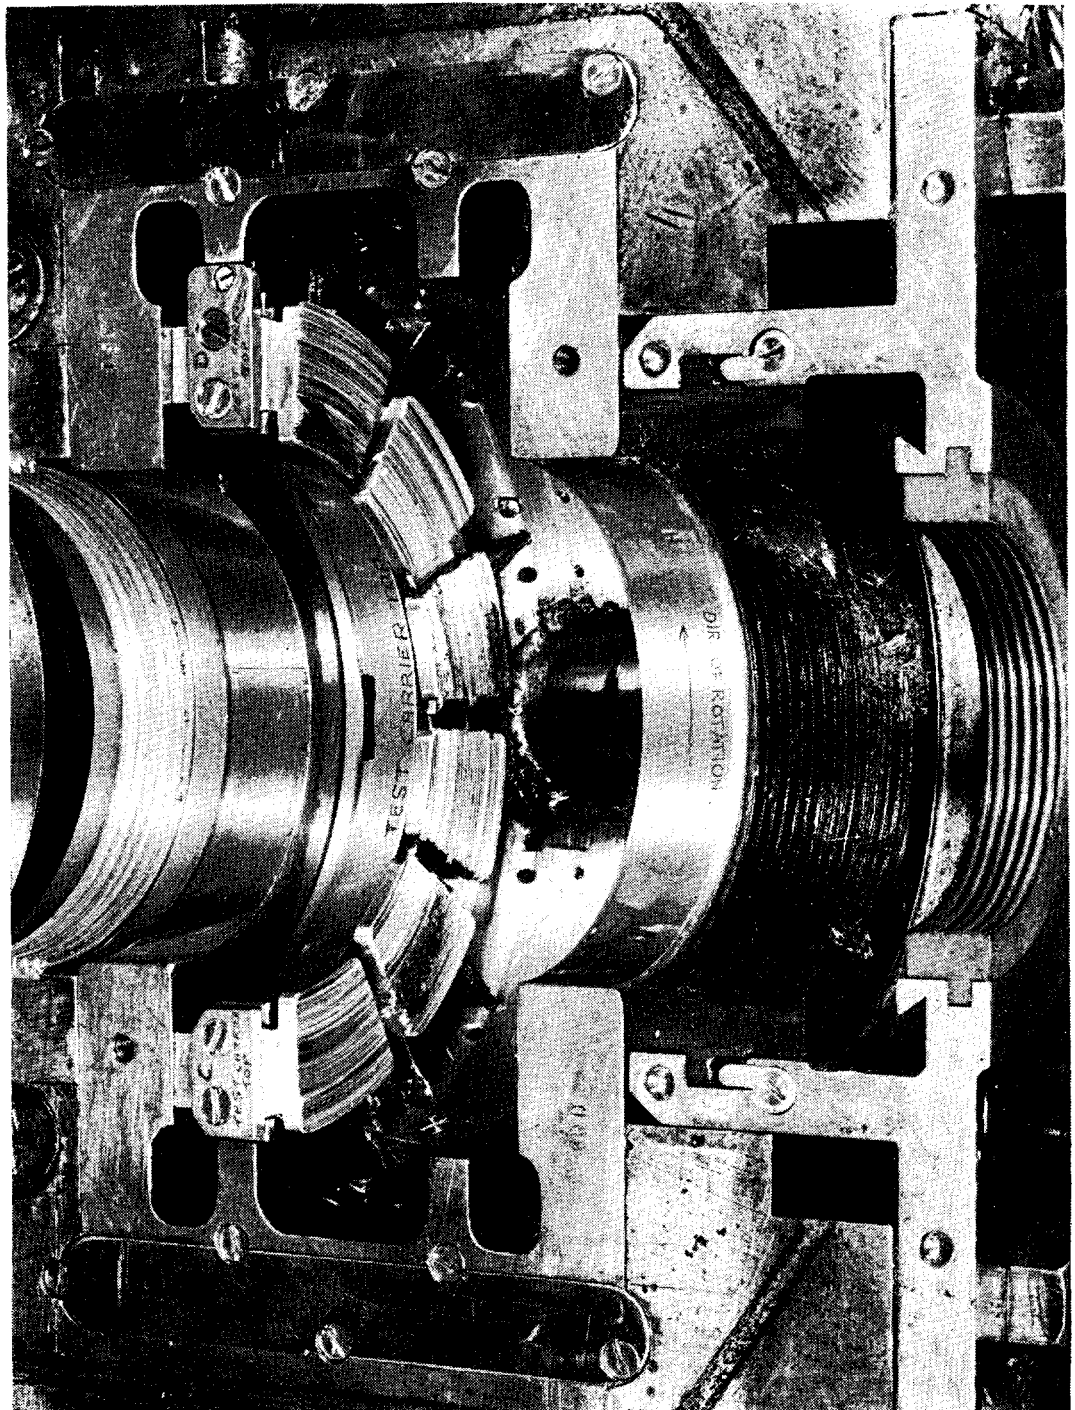
FIG. 1—AN EXAMPLE OF A MACHINING TYPE FAILURE ON A THRUST BEARING TEST RIG SHOWING THE SCABS ON THE WHITEMETAL PADS AND WIRE-WOOL DEBRIS

The heat generated in the black scab through machining the collar or journal is known frequently to melt the surrounding whitemetal. This generation of heat, combined with the quenching effect of the oil, may also crack and break up the scab, so that it is washed away with the oil. Both these factors may contribute to some 'complete' failures of bearings, where most of the 'evidence' is lost.
