A MAJOR SALVAGE OPERATION

LIEUTENANT-COMMANDER A. N. S. BURNETT. R.N., A.M.I.MECH.E.,
M.I.MAR.E.

The following is an account of the salvage of S.S. Melika and S.S. Fernand Gilabert which took place at the entrance of the Persian Gulf in September, 1958, during the Middle East crisis. The Author was, at the time, the Engineer Officer of H.M.S. Puma.

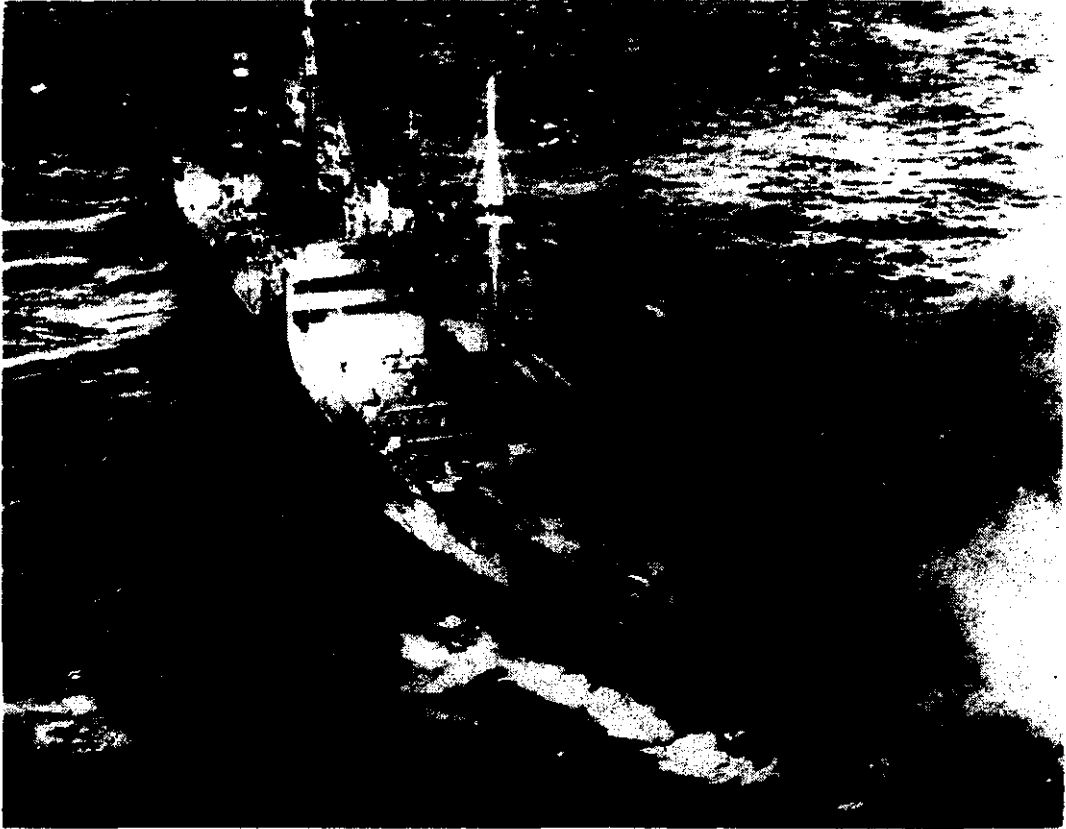
FIG. 1—FIRST SIGHT OF S.S. FERNAND GILABERT

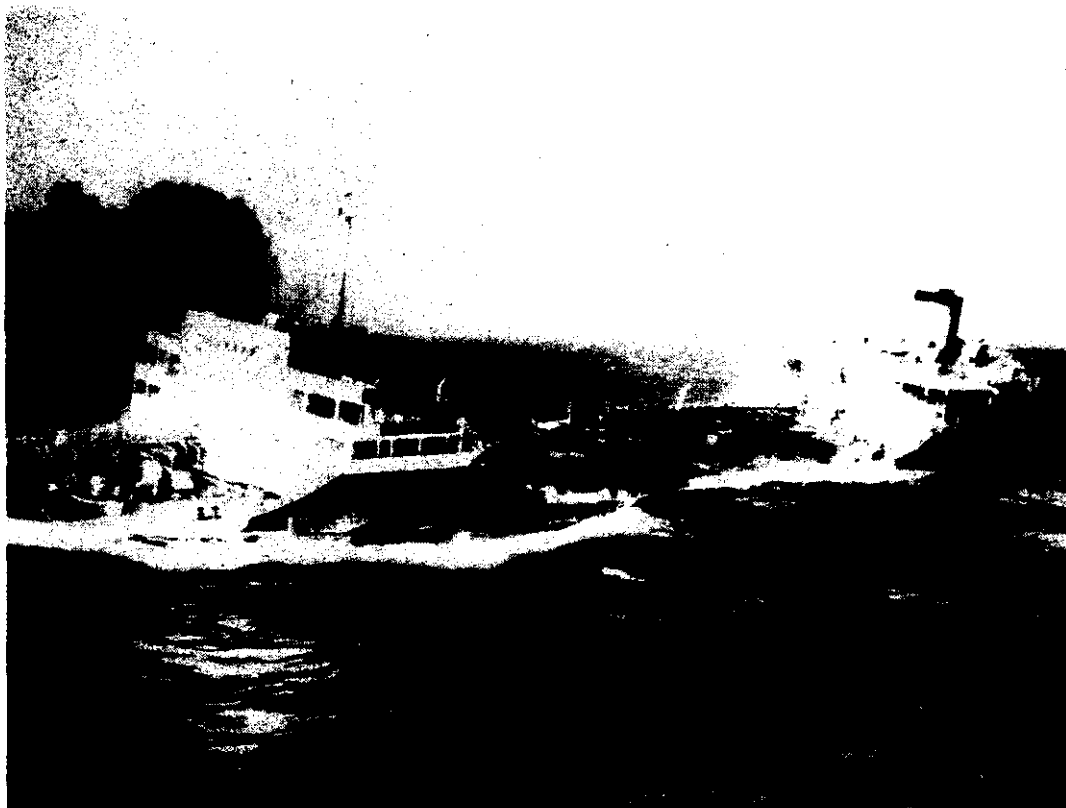
S.S. *Melika* had meanwhile disappeared but was found several hours later by the Skyraider, 25 miles to the south of her estimated position, stopped, listing 10 degrees to port, abandoned and on fire amidships and aft. She had been abandoned with her machinery automatic controls still in use.

FIG. 2—FIRST SIGHT OF S.S. MELIKA

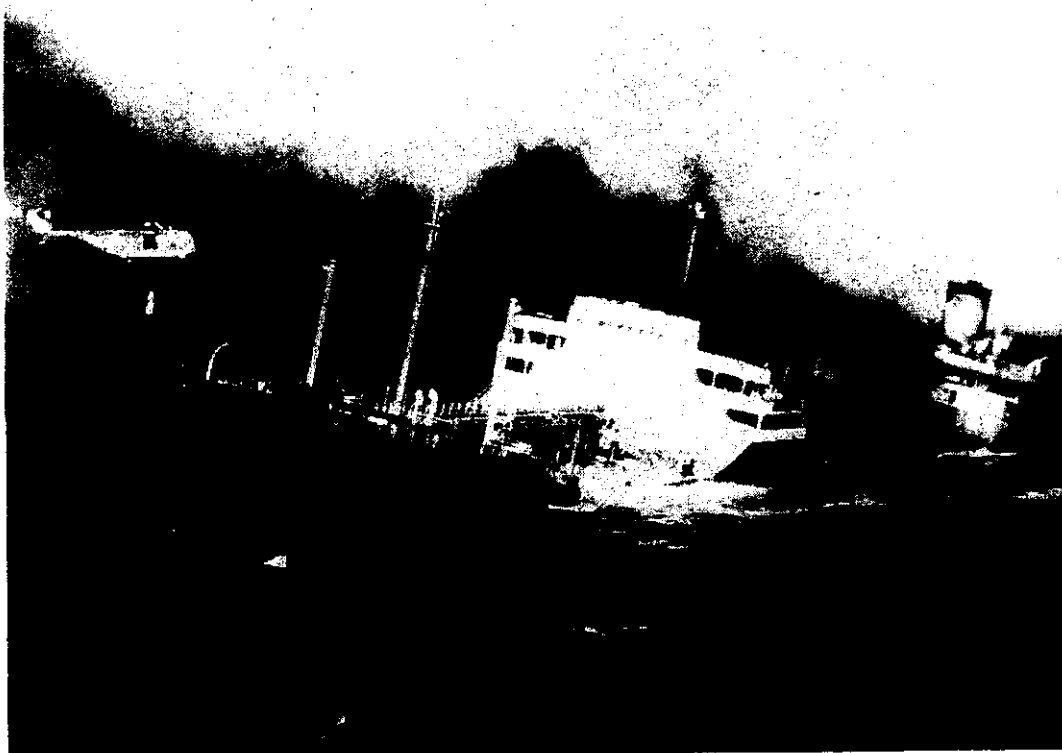
FIG. 4—HELICOPTER FROM H.M.S. BULWARK OVER S.S. MELIKA

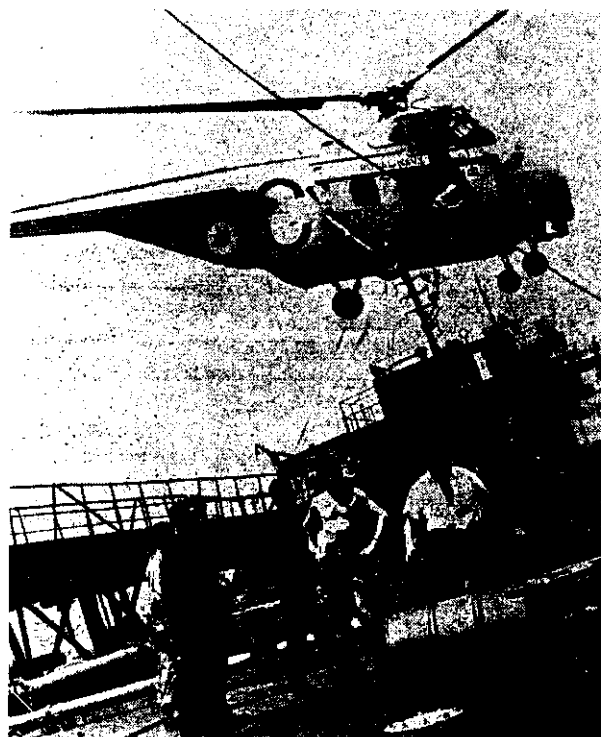
FIG. 5—DELIVERING DIESEL FUEL TO S.S. MELIKA

Diesel fuel was flown in by helicopter from H.M.S. *Bulwark*, to keep both the 100 kW Diesel alternator running and to provide fuel for flashing the boilers from cold.

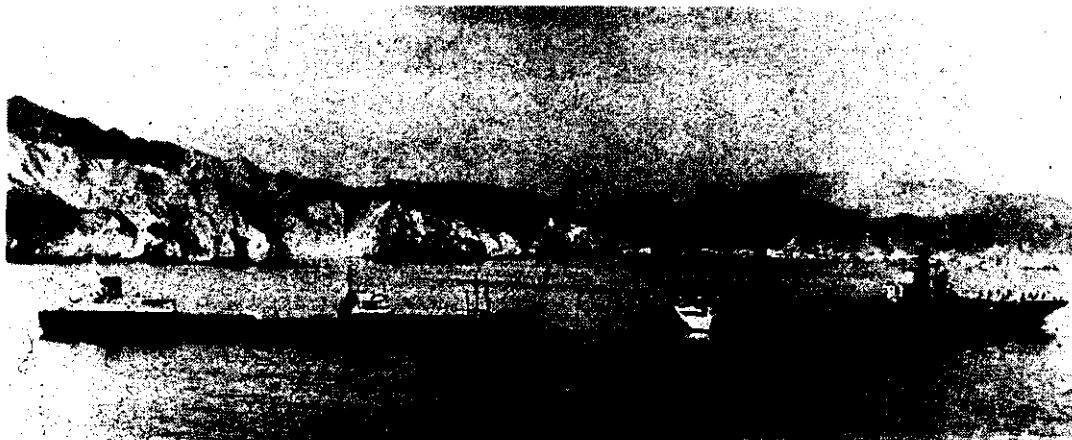
FIG. 6—BULWARK WITH MELIKA IN TOW

The tow was taken up by H.M.S. *Bulwark* during the afternoon, while H.M.S. *Puma* tried to control the movements of *Melika's* stern. A lot of trouble was experienced in controlling the tow on a course for Karachi. Every influence was casting her to starboard. At this juncture the torn upper deck plates amidships in *Melika* started to work. Consequently it was decided to bring *Melika* back on to course for Muscat and not to risk a passage to Karachi in the monsoon season.

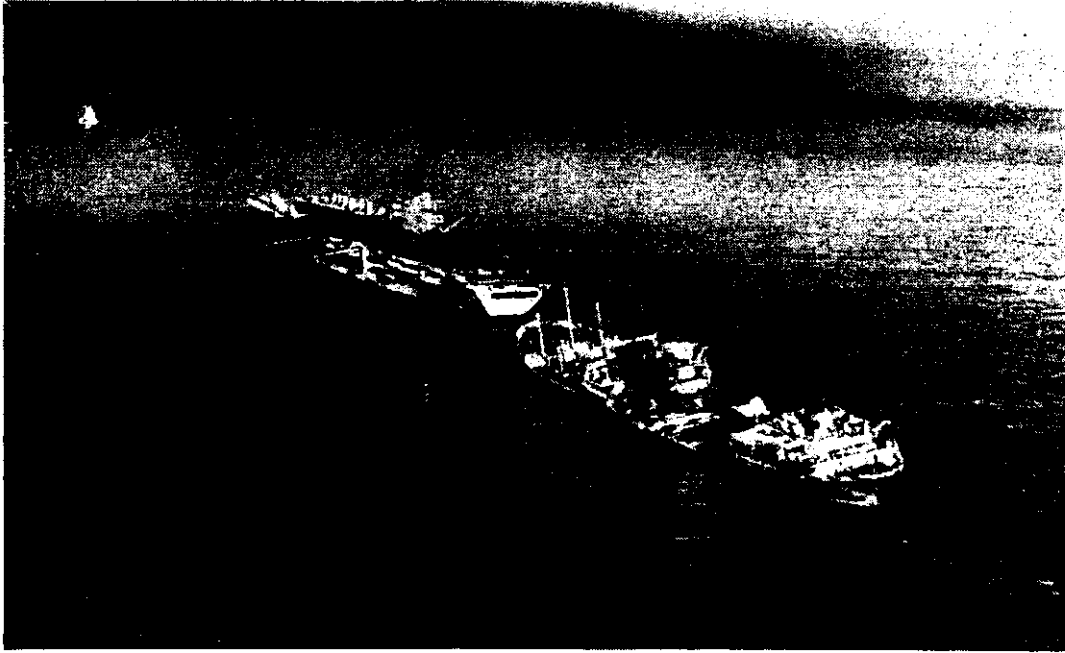
FIG. 7—BULWARK WITH MELIKA IN TOW
