# ARALDITE CASTING

## THE REJUVENATION OF AN ELDERLY DOCK PUMP

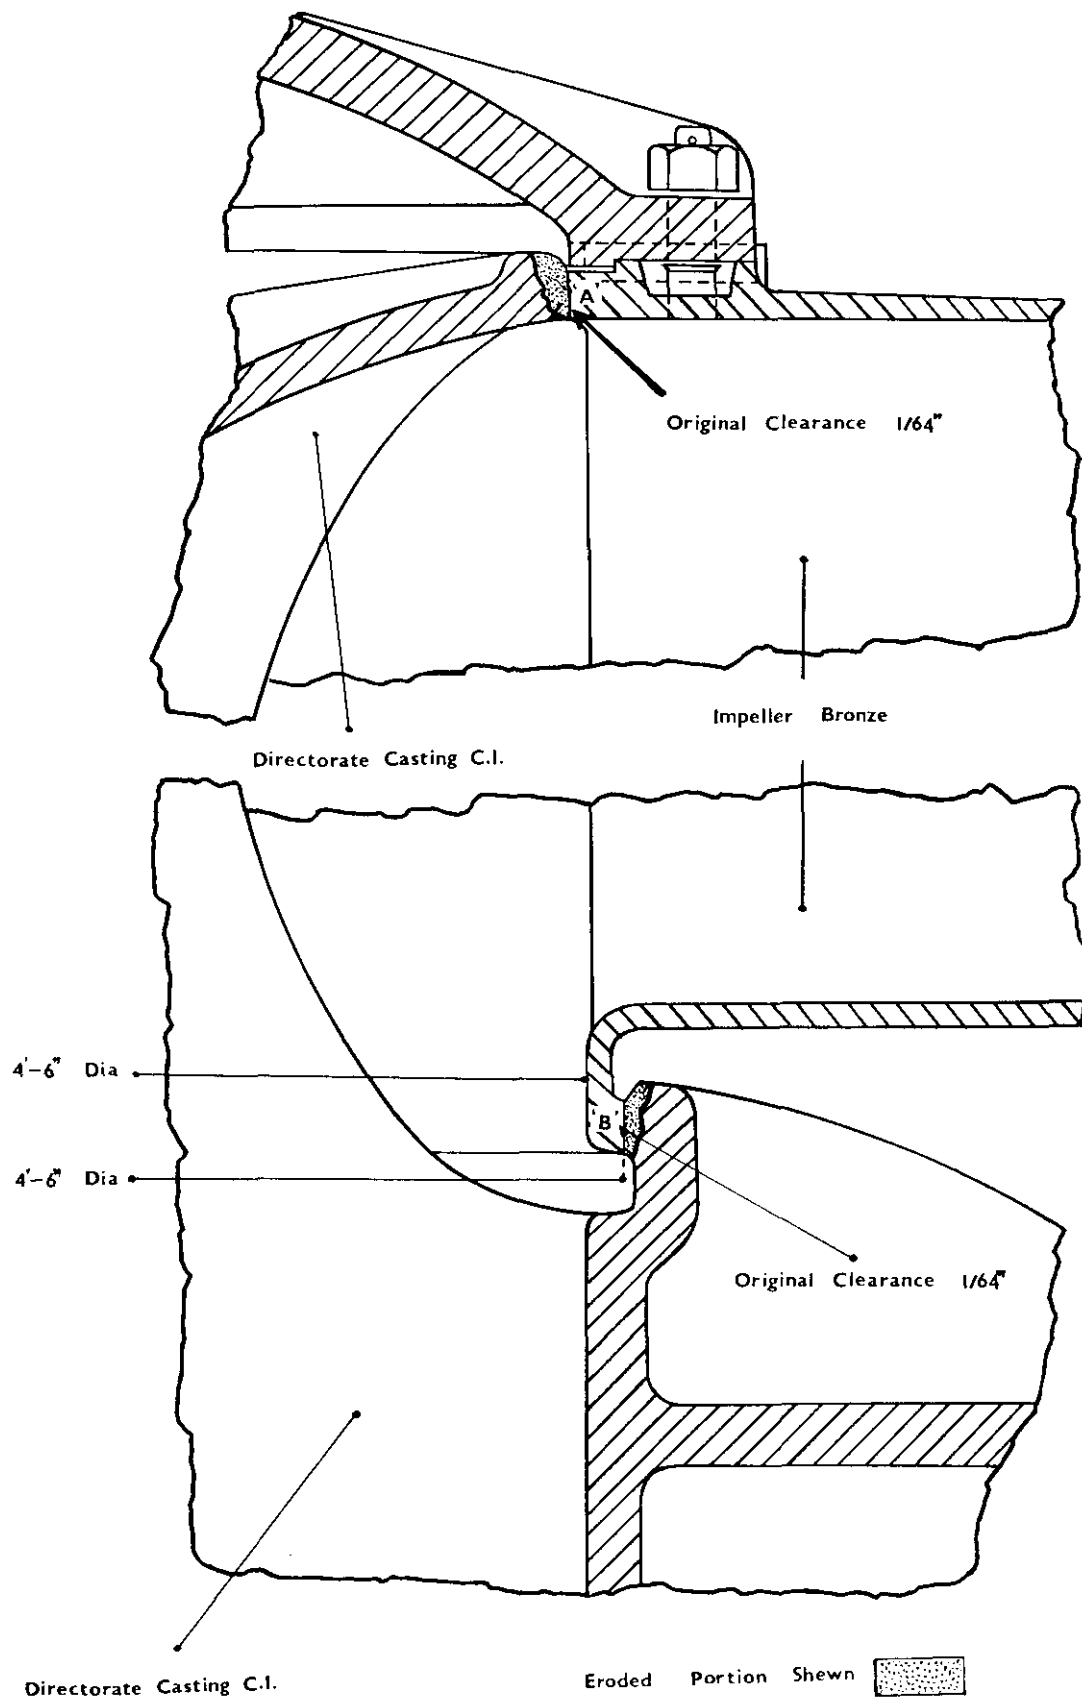
FIG. 1

The investigation revealed that, due to erosion, the design clearances of 1/64-inch for both upper and lower sealing rings now measured from between 1/2-inch to 1 inch at various points on the periphery (See FIG. 1). Fortunately however, measurement of the impeller rings showed that these were both circular and concentric. The impeller is nine feet in diameter which prevented it, or the directorate casting, being removed from the well without previous removal of the complete engine, pump shaft and support brackets. For reasons of time and expense this removal could not be undertaken and a means of repairing *in situ* had to be found.

It was decided to try to build up the directorate casting in way of the erosion with Araldite to restore the correct clearances. One disadvantage of this method was that the cast material could not be machined *in situ* and any finishing of the casting would have to be done by hand. After much discussion it was decided to bind the periphery of the impeller with waterproof tape to a thickness of 1/64-inch and to place it in its running position to act as the core of the casting. FIGS. 2 and 3 show the arrangements used for casting the Araldite.
