NOTES FROM SEA

MARINE ENGINEERING

Boilers—H.M.S. 'Torquay'

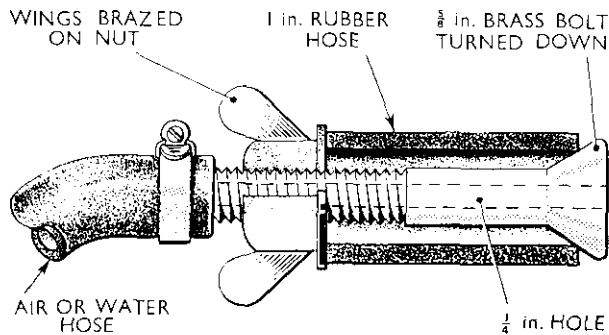
On opening the starboard boiler for water washing, water was seen fountaining from the superheater near the top of the tube end bends, between the support and the monolithic wall.

FIG. 1—TWO IN NO. ARE REQUIRED : 1 IN NO. WITH ¼ IN. HOLE AND AIR OR WATER HOSE ; 1 IN NO. BLANK

Identification of the burst tube proved impossible until a small fitting was devised for testing each tube individually. The device, which is self explanatory, is shown in FIG. 1.

In *Blackwood, Whitby* and similar classes with very compact superheaters it may indeed be difficult to locate a leaking tube and this device would appear to be an excellently simple and effective means of doing so. It is recommended to other ships of the same or similar classes.
