BOILERS

WEAR AND WASTE TESTS

W. F. QUINNELL

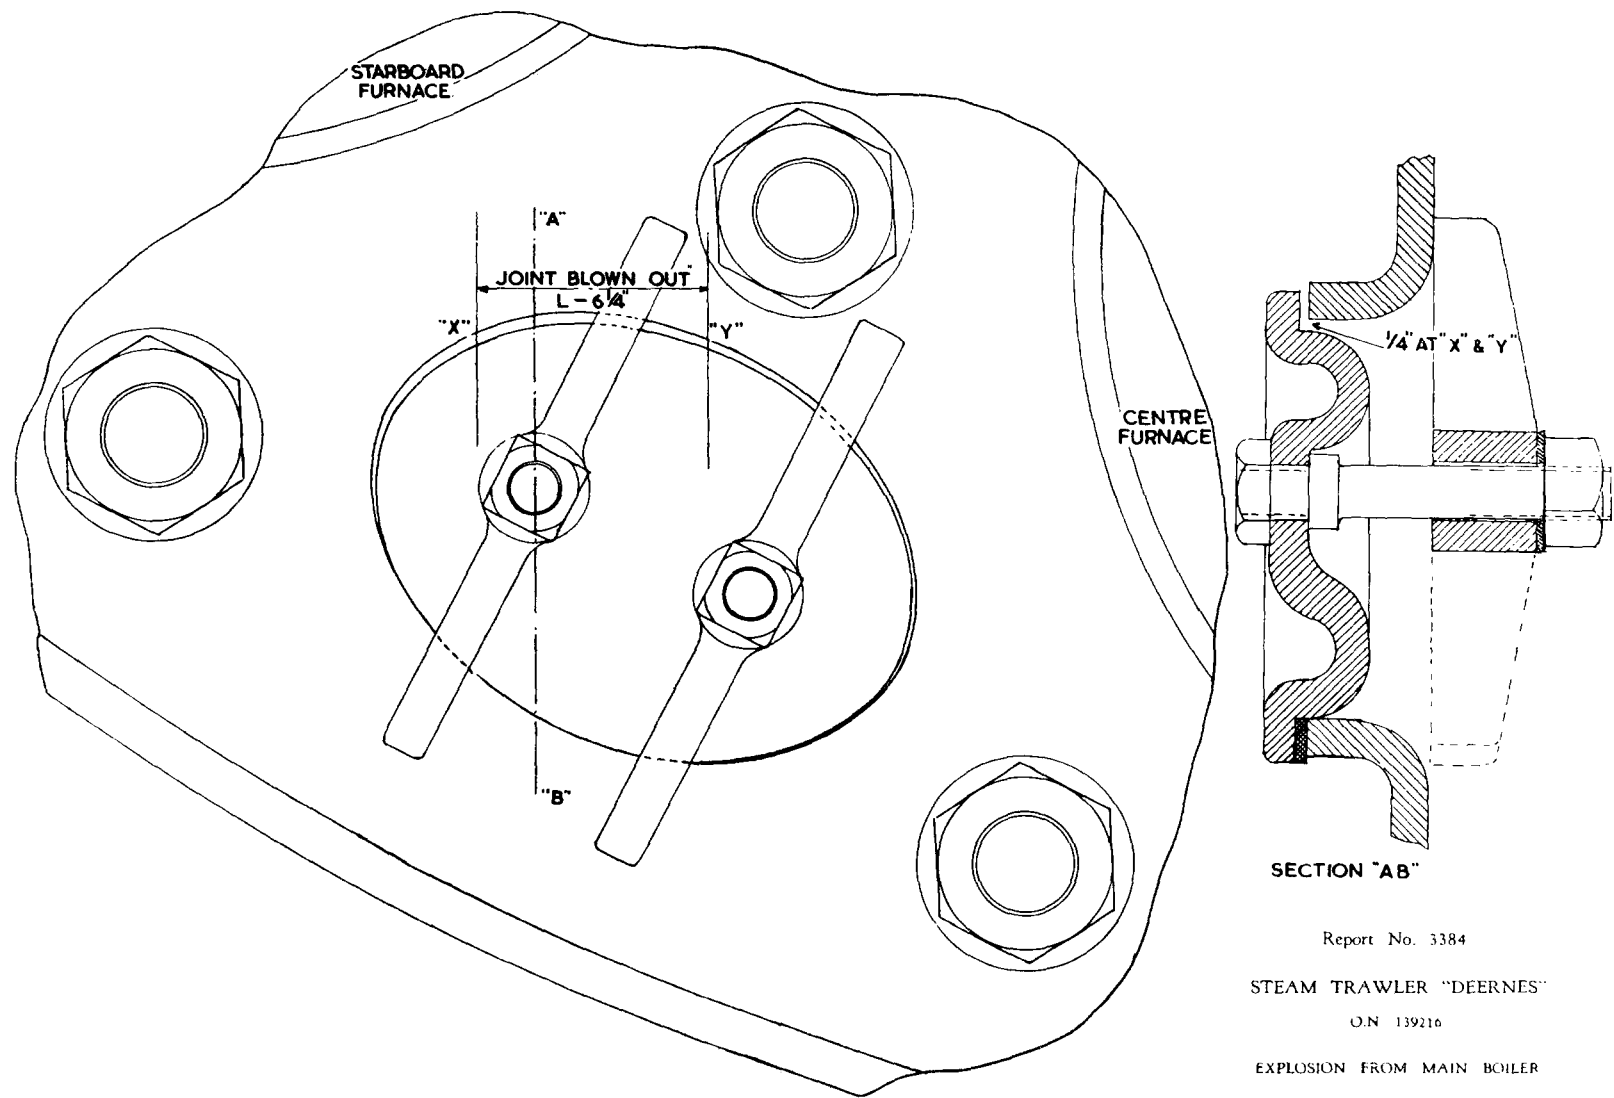
FIG. 1—DETAILS OF MANHOLE DOOR

Manhole doors were reported to have clearance between the door spigot and manhole orifice, in excess of the maximum stipulated in B.R.16, Art. 199, and it was recommended that the doors be refitted at the earliest opportunity.

No doubt the fit of the doors was verified only when they were fitted immediately before the boilers were closed for filling, and too late to effect repairs within the refit period. Delay in checking the fit of manhole doors is usually due to the presence of electric and pneumatic leads passing through the manholes during the boiler examination and repair. Manhole and handhole doors should be checked for fit early in a refit, so that there is time to effect necessary repairs or renewals.

The detail of the fit of a manhole door fitted in a commercially operated trawler is shown in FIG. 4. The excessive clearance between the spigot of the manhole door and the manhole flange resulted in a portion of the jointing material being blown out, and the explosion caused the death of the boiler attendant.

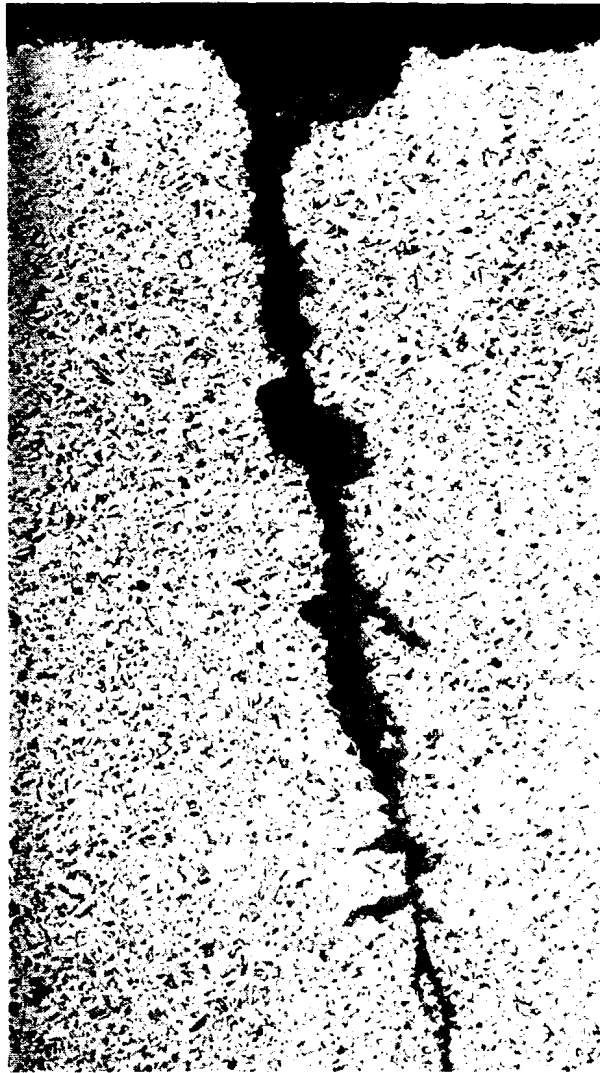
FIG. 4—MICROGRAPH SHOWING CHARACTERISTIC CORROSION FATIGUE CRACK AND GENERAL MICROSTRUCTURE OF STEEL

FIGS. 2, 3 and 4 show grooving and cracking in the radius of boiler end-plate flanges. It will be seen that visual examination only, would be insufficient to evaluate the defect. Grooving in the bend of plate flanges may be examined radiographically, and cores should be removed along the line of grooving in order that the depth of the combined grooving and cracking, also the remaining sound plate thickness, may be determined.
