## REPAIR OF A CAST IRON GEARCASE

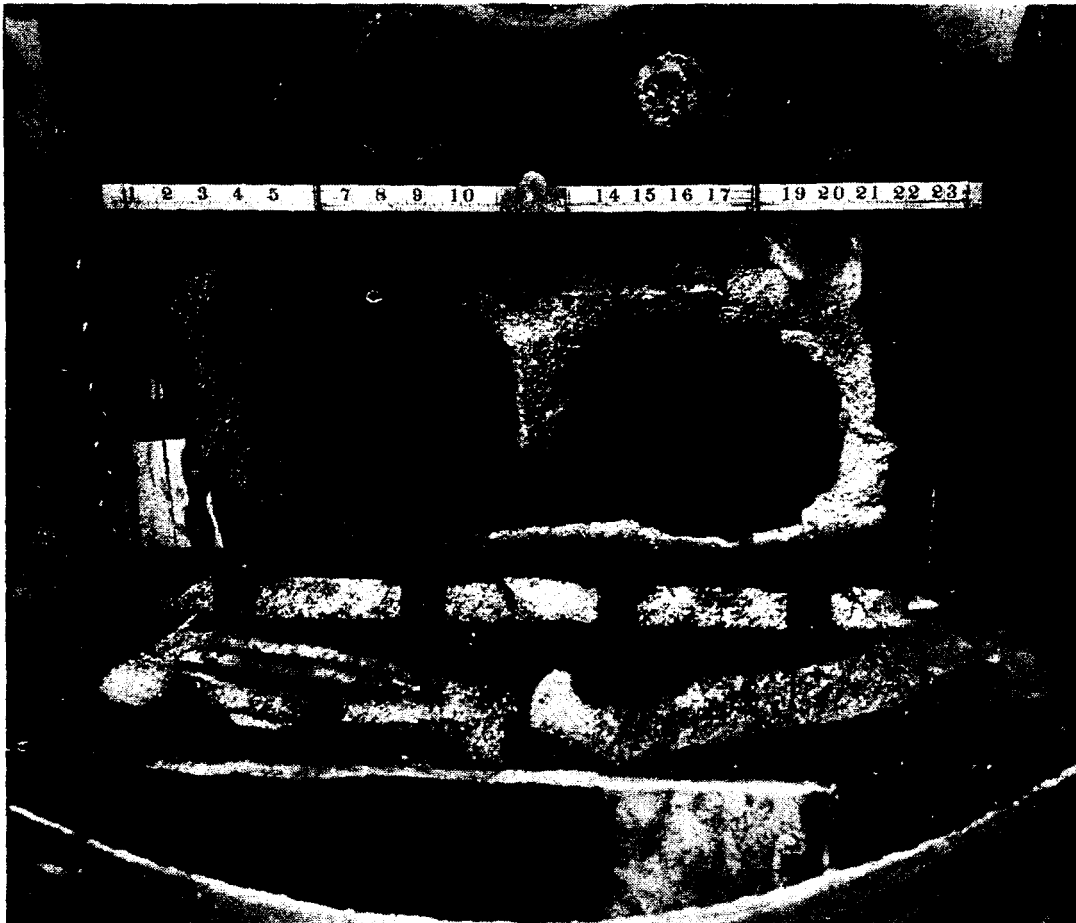
FIG. 1

During preparations for the removal of a complete H.P. turbine from a ship for repair, a horizontal row of four bolts securing the turbine to the gearcase was overlooked. These bolts are visible only through small handholes and no detailed drawings of the bolting arrangement of the turbine and gearcase were available in the ship.

When the turbine was lifted the cast iron gearcase fractured as shown in FIG. 1. It will be seen from this illustration that the fracture extended into the oil gallery below the H.P. pinion forward bearing.

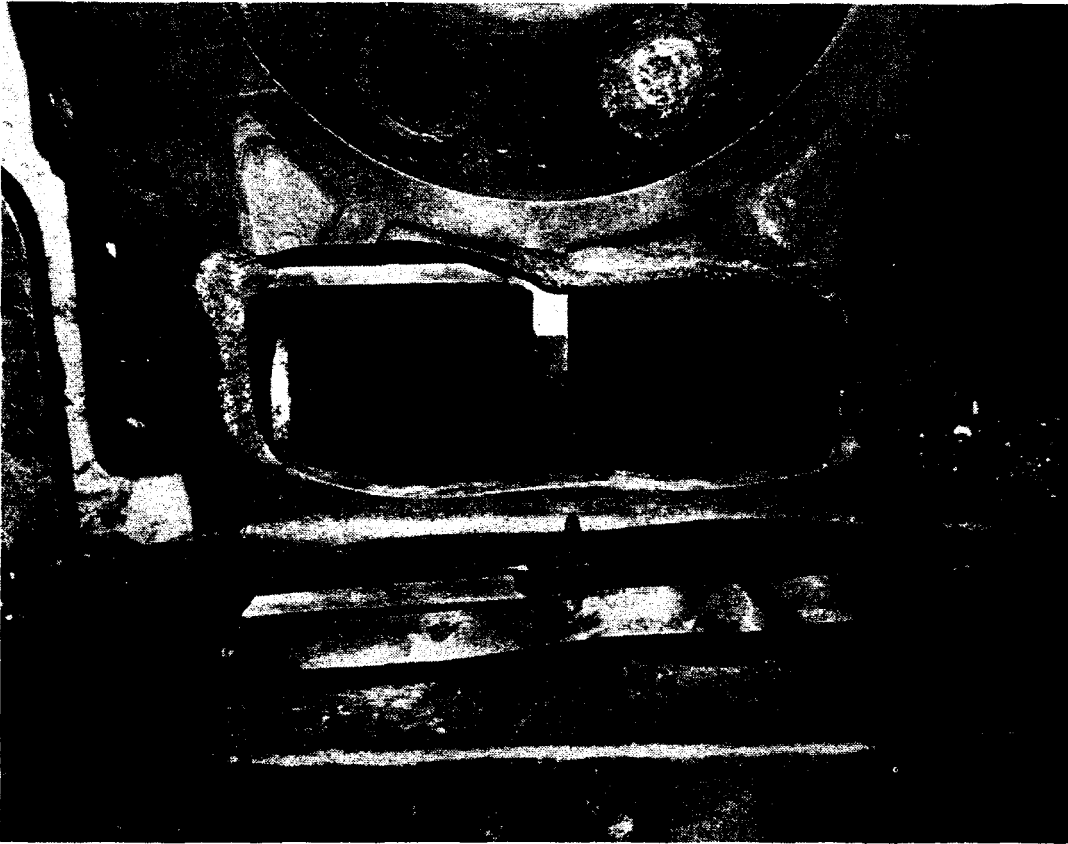
FIG. 2

patch was cast. The patch, which is shown lying in the foreground in FIG. 2, was provided with an integral web carefully mated with the horizontal 'floor' of the oil gallery.

The rough edges of the fracture were trimmed and faced and a wooden template was made to fit the aperture. With this template as a pattern, an iron

The central vertical web of the damaged casting was drilled and tapped to take three set-screws which were used to hold the patch firmly in place during subsequent work. The patch was then placed in position and secured by the set-screws. Slots were cut transversely to the fracture to a depth of about two-thirds that of the parent metal, and keys of 50-ton alloy steel were driven into the slots, one after the other, in layers. The joint face remaining between the sets of keys was chain drilled and tapped and alloy steel studs were inserted across the face tangentially to each other.
