PAPER OF TRANSACTIONS NO. CLXV.

The Care of Ships' Electric Installations.

BY MR. T. R. STUART (MEMBER).

Monday, January 31, 1910.

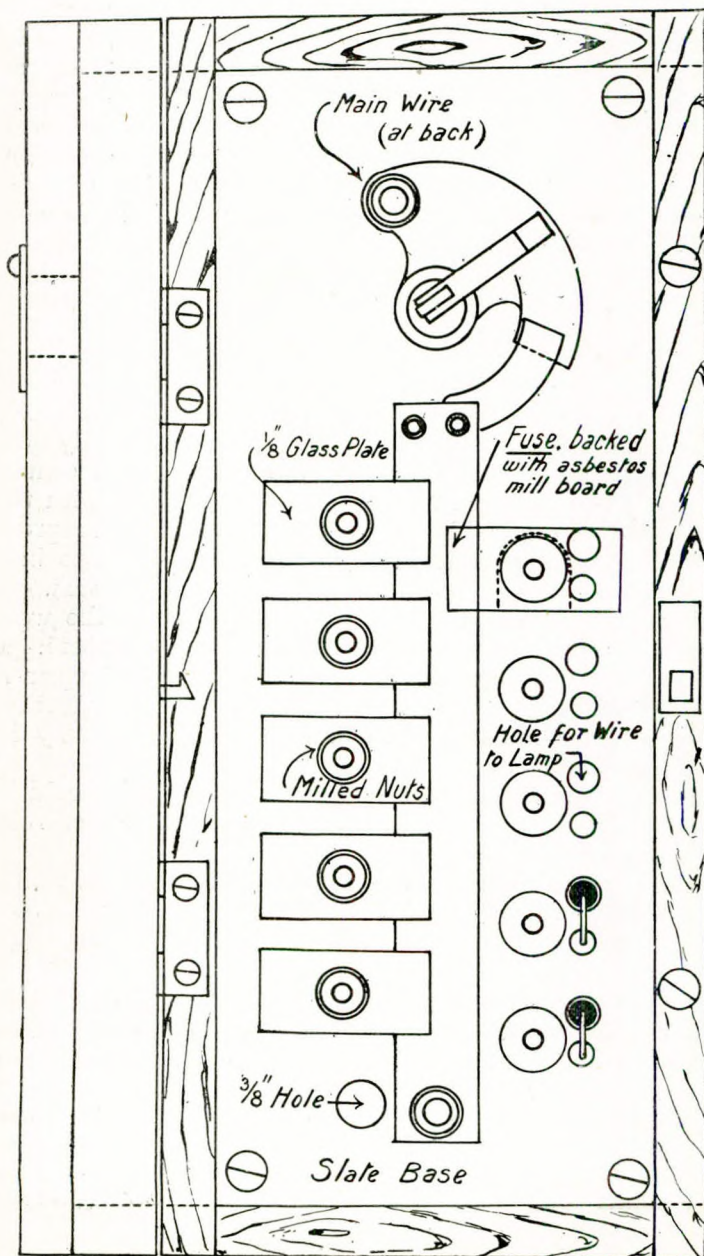
The sketch shows a fuse box frequently fitted; it contains many points open to criticism. It is of no use having a slate

base pierced by large holes allowing fire, water and dirt to have a free passage. These boxes are usually full of ants or cockroaches, they are easily opened by people who should not have access to them—any knife blade will do it. There is no limit to the strength of fuse that may be put in. I have seen one fuse carrying three lights and two fans, others with seven 16 c.p. lamps. The fuses are of a very poor design, the distance across the narrow bridge is very small, the central screw is just where it should not be, as an arc once started is readily carried on by it. When a fuse melts, the wire end

is often burnt where it leaves the box through the slate base. The frames would be better if metallic and watertight; these boxes are fitted in alleyways where the paint is washed down with abundance of water, and are certainly "damp places." They should exclude vermin and be accessible to the electrician only. The size of fuse should be strictly limited to suit the circuit. Before renewing a fuse, the lamp and wire leading to it should be examined for intermittent breaks,

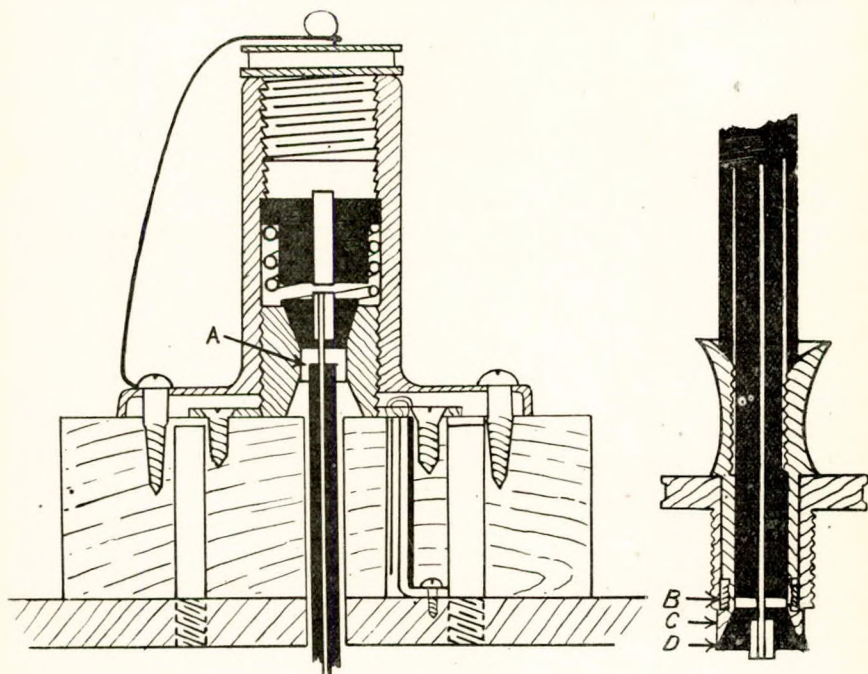
partial earths, etc. If the lamp glows for a few minutes and then the fuse melts again, it should not be renewed till the cause has been ascertained. The most frequent breakdowns occur in that part of the installation used for portable cargo clusters. When new, everything appears to be good and well insulated, but troubles soon develop, the wood speedily shrinks or warps and lets in water back and front.

The wire is bared at (*A*) and you will see that there is only about $\frac{1}{8}$ -inch gap between the positive and the nipple acting as negative, and this is often filled with water during a shower. The brass caps are nearly always lost. I do not see what useful part the wood base takes as the brass base can be screwed to the iron plate as easily as the wooden one, neither do I see any use for the spring or distance piece; they do not give a quick break or serve any useful purpose whatever. The wire terminal makes no pretence at being watertight, and certainly never is. Another small but important point is, that the fine thread (*B*) is unscrewed when the terminal is screwed in place owing to the friction at collar (*D*); this often pulls off the nipple (*C*). On a ship having ten of these cargo lights it is quite common for six or eight to fail during a heavy shower. The cables, too, are not strong enough for the rough treatment they receive. I have seen them sparking and spitting fire; this only wants to occur in a hold full of cotton to start a big blaze. The chief trouble with these portable wires after dampness is that they get kinked and that cuts the inner insulation and allows the wires to come together.

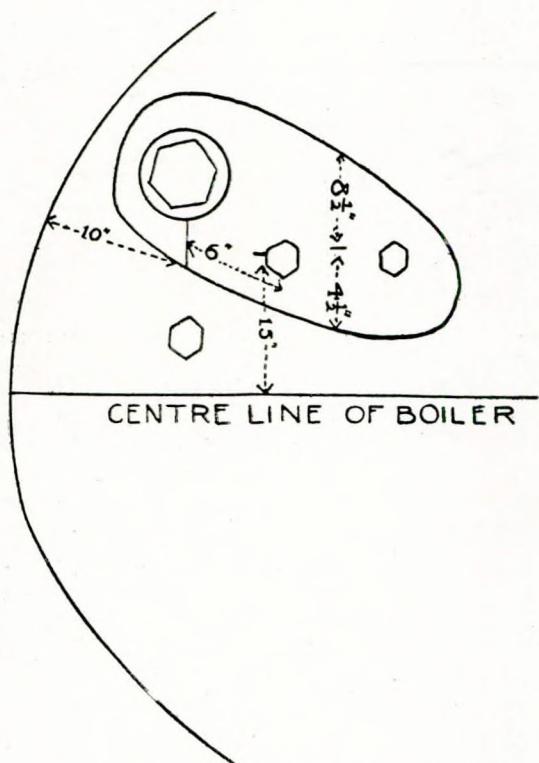
BOILER END PLATE.

After leaving Huelva, and on our way to Liverpool, we had another experience of the end plate of the same boiler; this I noticed leaking badly, running freely through the lagging. On examining it found that the plate and the nut were badly corroded. This was located on the combustion chamber of the same furnace which had the riveted patch put on. It was leaking so badly that I decided to work the steam off, and blow the boiler down; this was rather a hard trial to the new patch. When the pressure was off, and water all out, I cleaned it well, and on sounding it with a hammer, a hole was made as per sketch—

The lines running from the stay and hole indicate further cracks.

the patch, the oatmeal taking the water in, and drying quickly helped it to salt up. We went home at reduced pressure (130 lbs). Expansion full out, doing our ordinary speed, and all engineers resting their ordinary hours. While at the home port, it was repaired as per sketch, and proved a very good job.

Two new combustion chamber stays were added owing to the thickness of the patch. The patch was riveted around

the longitudinal stay, as it showed signs of corrosion around the stay, with the nut well screwed on made a very good job of it.
