# MAIN STEAM PIPE FAILURES

R. V. DAVIS

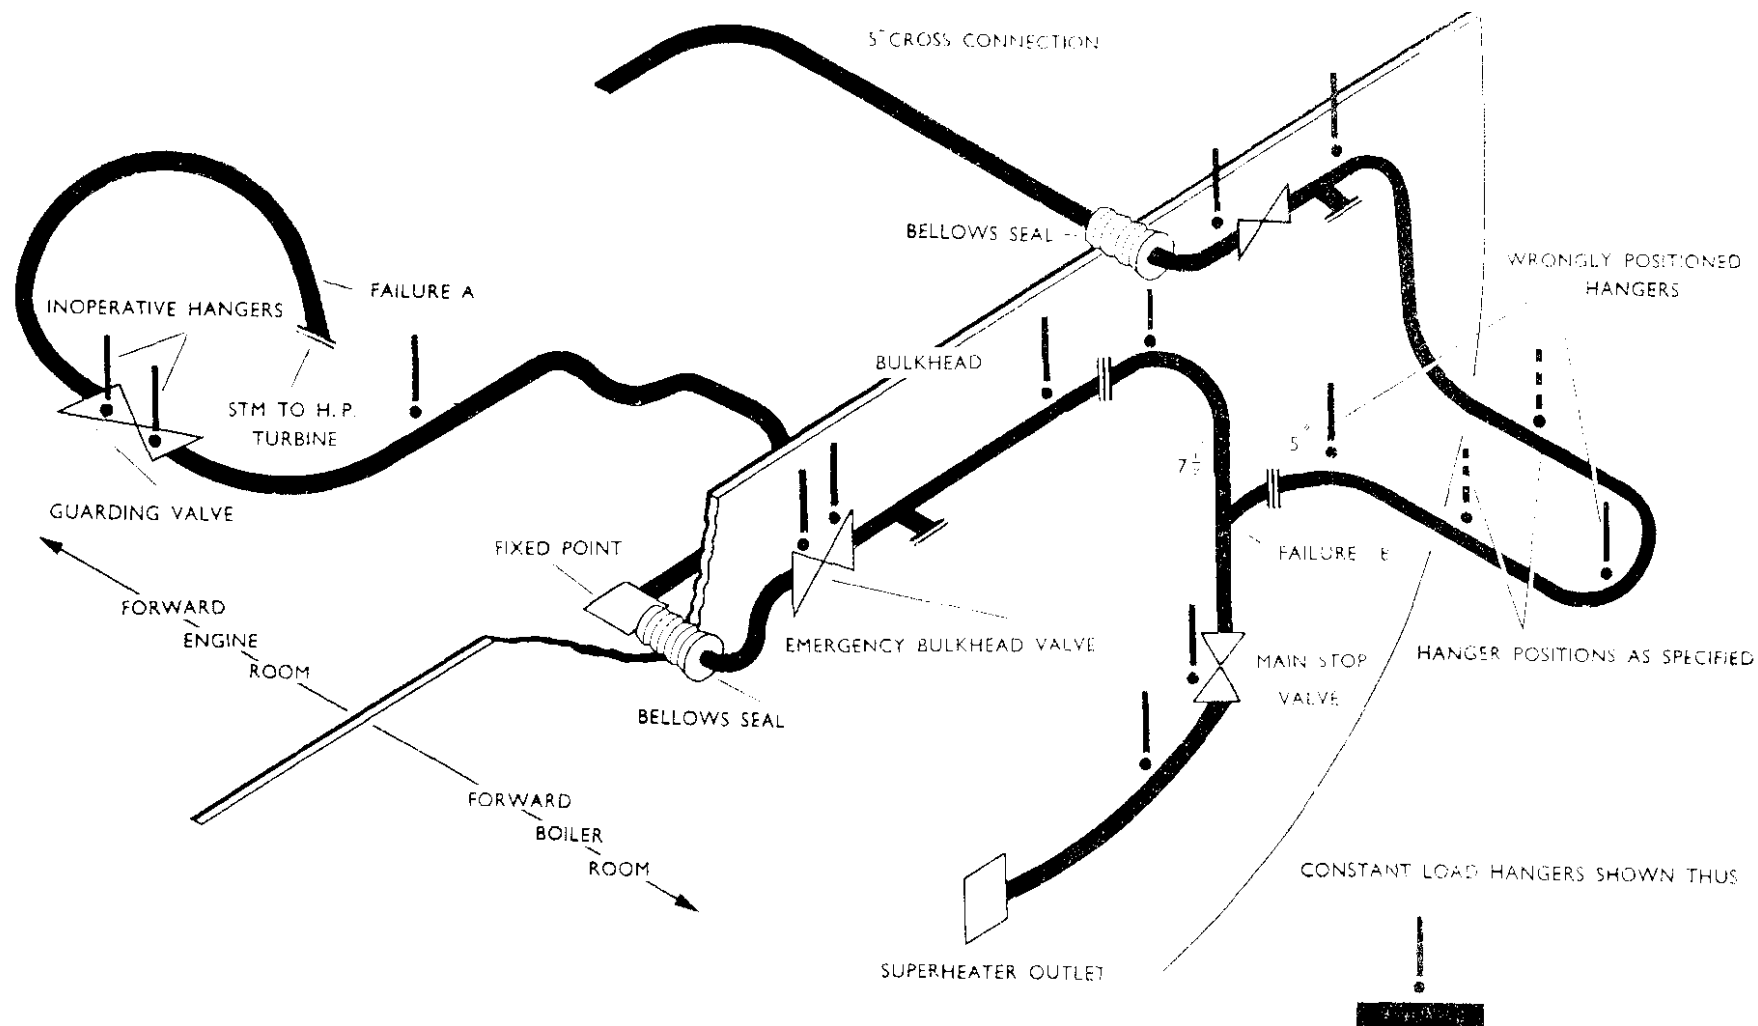
FIG. 1—DIAGRAMMATIC LAYOUT OF SHAM SYSTEM

The two ship failures are surveyed separately, and treated as 'Failure A' in the for'd engine room and 'Failure B' in the for'd boiler room. The system layout is shown diagrammatically in Fig. 1.

The siting and adjustment of the hanger quoted at (iii) above in this ship was not as in the Guidance Instructions issued at the time of building. The 'as fitted' and 'as specified' positions of the hangers for the cross-connection are illustrated in FIG. 1.

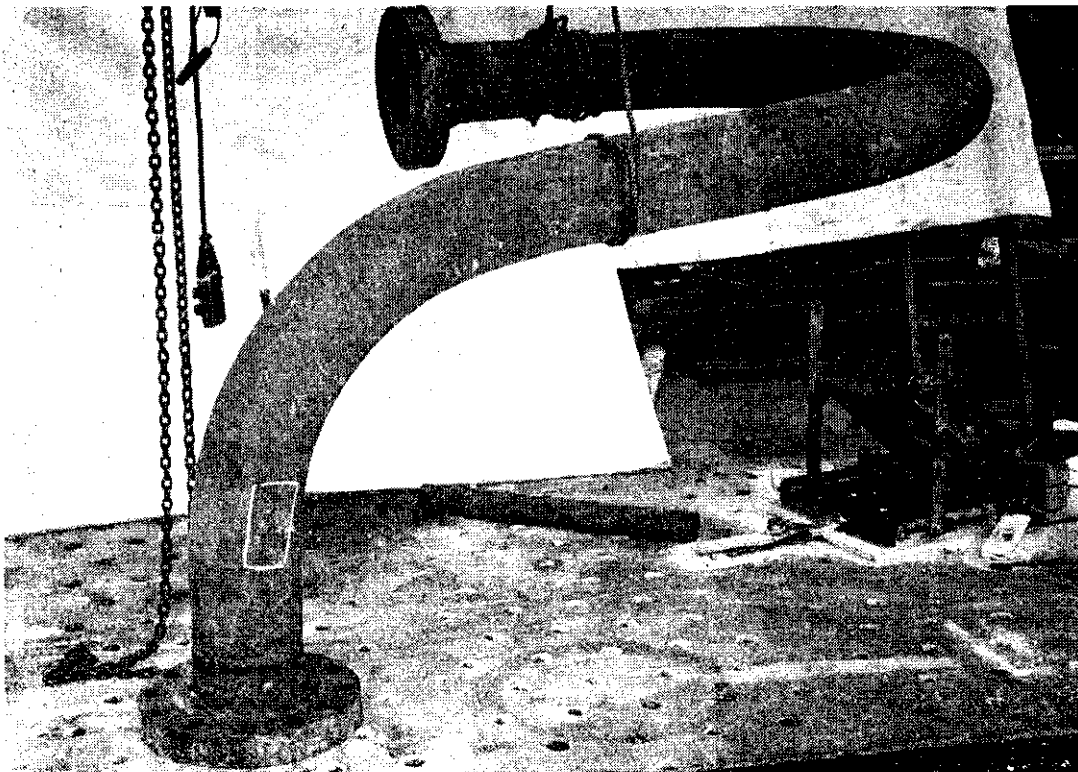
FIG. 2—DEFECTIVE STEAM PIPE SHOWING LOCATION OF CRACKING

Failure occurred on the neutral axis at the commencement of a bend of 24 in. radius on the main steam pipe immediately above the flange adjoining the H.P. turbine nozzle control valve chest. (See Figs. 2 and 3).

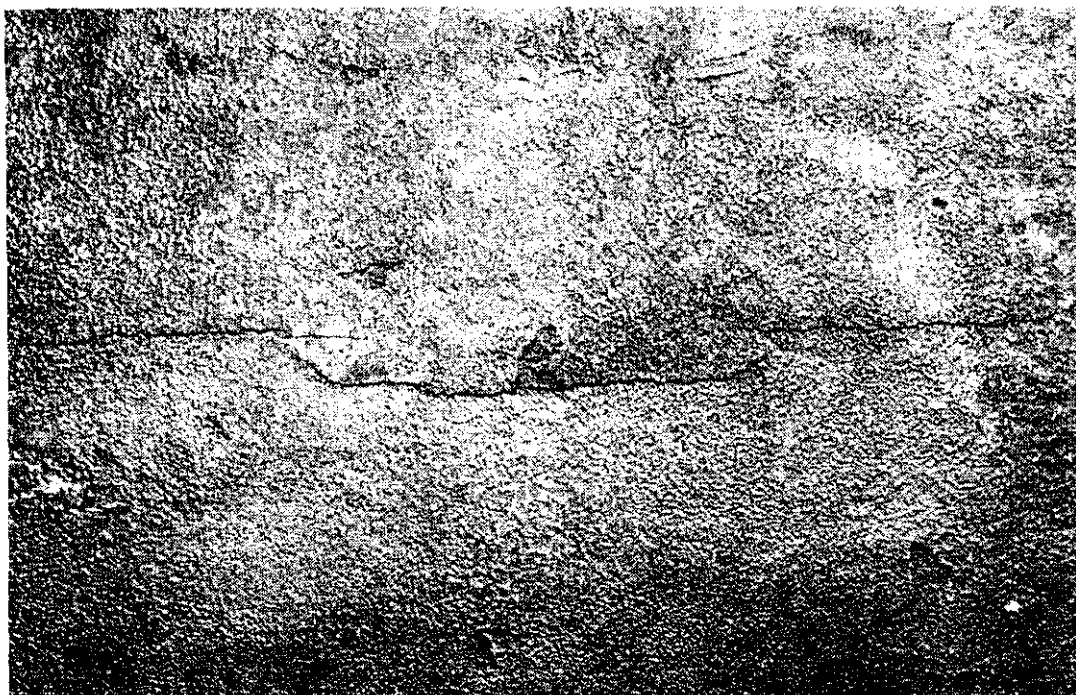
FIG. 3—APPEARANCE OF THE CRACKING ON THE OUTSIDE OF THE PIPE

- (i) Failure was due to a creep crack originating from the outside of the pipe wall
- (ii) There were no indications of surface damage to the pipe
- (iii) Chemical analysis of the alloy steel conformed to that specified
- (iv) There was a variation in the tensile strength of the pipe near the area of failure, i.e. 42 tons/sq in. with Diamond hardness V.P.N./30 of 165–171 compared with an average figure of 35 tons/sq in. and hardness 132–165 for other portions of the pipe.

In view of (ii) above, creep failure can be attributed to overstressing. The condition at (iv) is indicative of irregular heat treatment. It should also be noted there were indications of slight surface decarburization, suggesting that local torch heating may have been applied during the fitting of the pipe. (See FIG. 5).

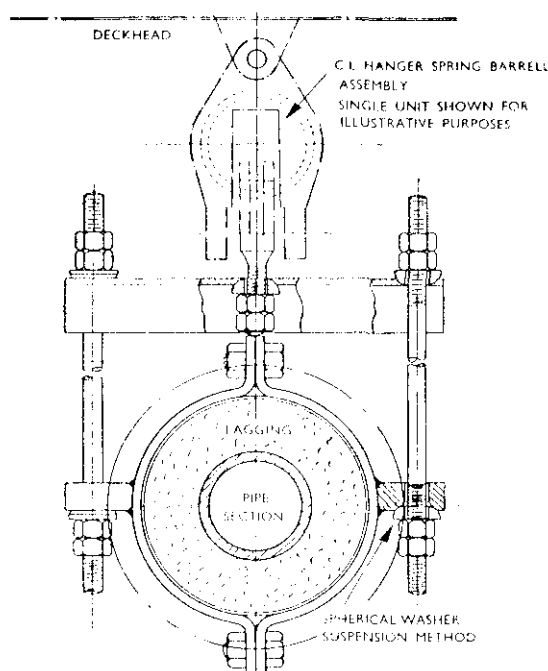
Inspection revealed that the hangers were inoperative because the spring barrels at the rear of the spring retaining caps were internally coated with paint and deposits of cork chippings : this condition indicated that the hangers had been in this state since the ship was built. The hanger rods are connected

FIG. 4—CONSTANT-LOAD HANGER

by a yoke pivoting on spherical washers shown in FIG. 4. The inoperative state of the hangers resulted in the weight of the turbine guarding valve (11 cwt.) being imposed on the pipe system in the hot condition.

pipe systems is of the utmost importance. A most essential point in maintenance is to ensure that pipe hangers are fully operative.

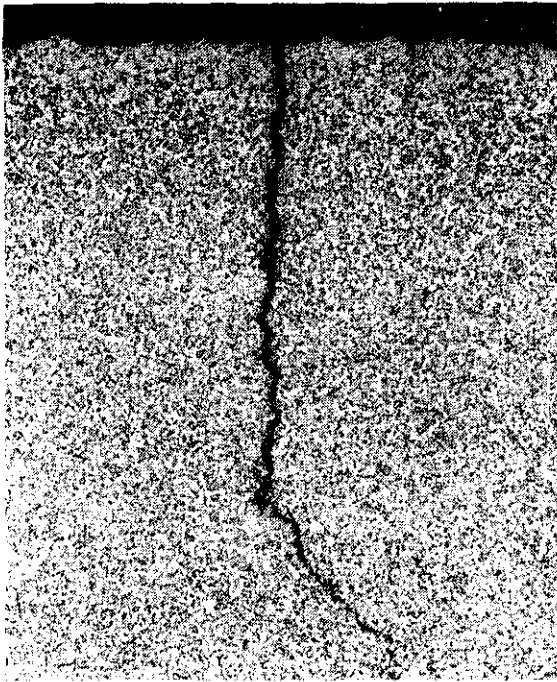
FIG. 5 — MICROGRAPH SHOWING ONE OF THE MAIN CRACKS AND THE SURFACE DECARBURATION OF THE PIPE

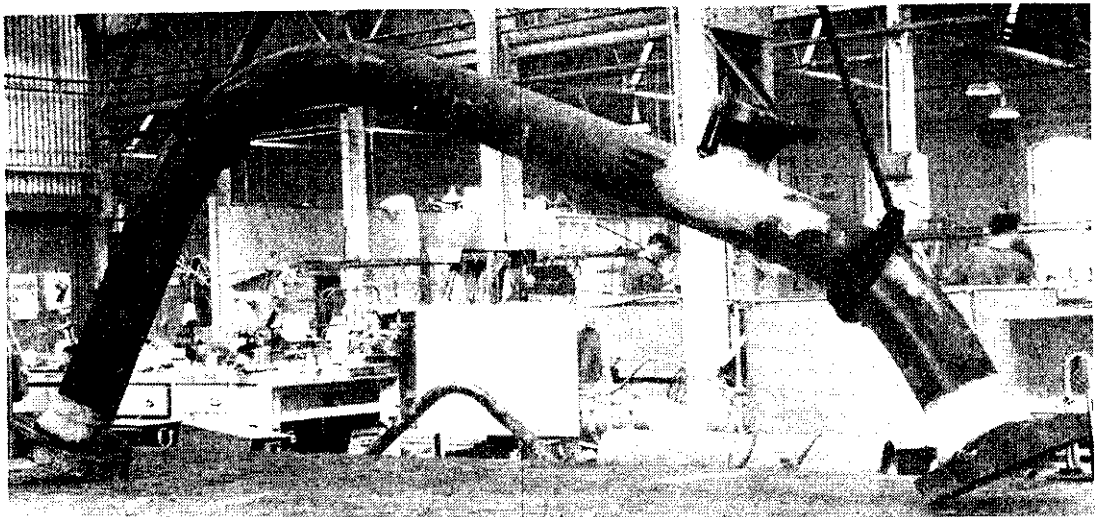
Failure occurred on the underside of the branch, in a circumferential direction, at the toe of the fillet weld securing the reinforcing strap where the branch enters the main pipe. FIG. 1 (boiler room) shows the system layout and FIGS. 6 and 7 show the detail.

- (i) Failure was due to a creep crack originating from a corrosion fatigue fissure on the outside of the pipe at the toe of the fillet weld
- (ii) Corrosion fatigue fissures existed on the external surface in the neighbourhood of the main crack
- (iii) Chemical analysis of the alloy steel conformed to that specified.

Incorrect hanger restraint is considered to have induced a high stress in the branch. This, coupled with the presence of corrosive conditions referred to at (i), is considered to have initiated corrosion fatigue cracking, leading ultimately to failure by creep cracking.

FIG. 6—APPEARANCE OF DEFECTIVE PIPE. CRACK IS ON THE BRANCH PIPE

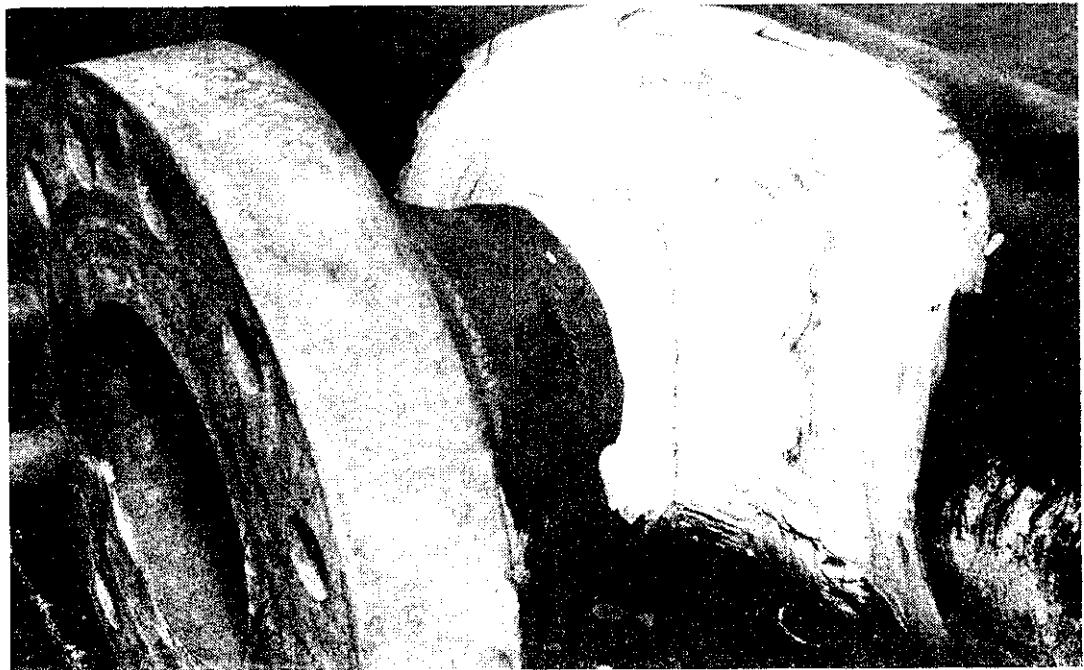
The corrosion fatigue phenomena could have been produced by a leak from the joint, or saturation of lagging caused by a leak from an overhead system.

FIG. 7—CLOSE-UP OF BRANCH PIPE SHOWING CRACK AT THE TOE OF THE REINFORCING STRAP FILLET WELD
