NAPIER DELTIC SEA TRIALS

LIEUTENANT-COMMANDER A. O. F. VENTON, R.N.

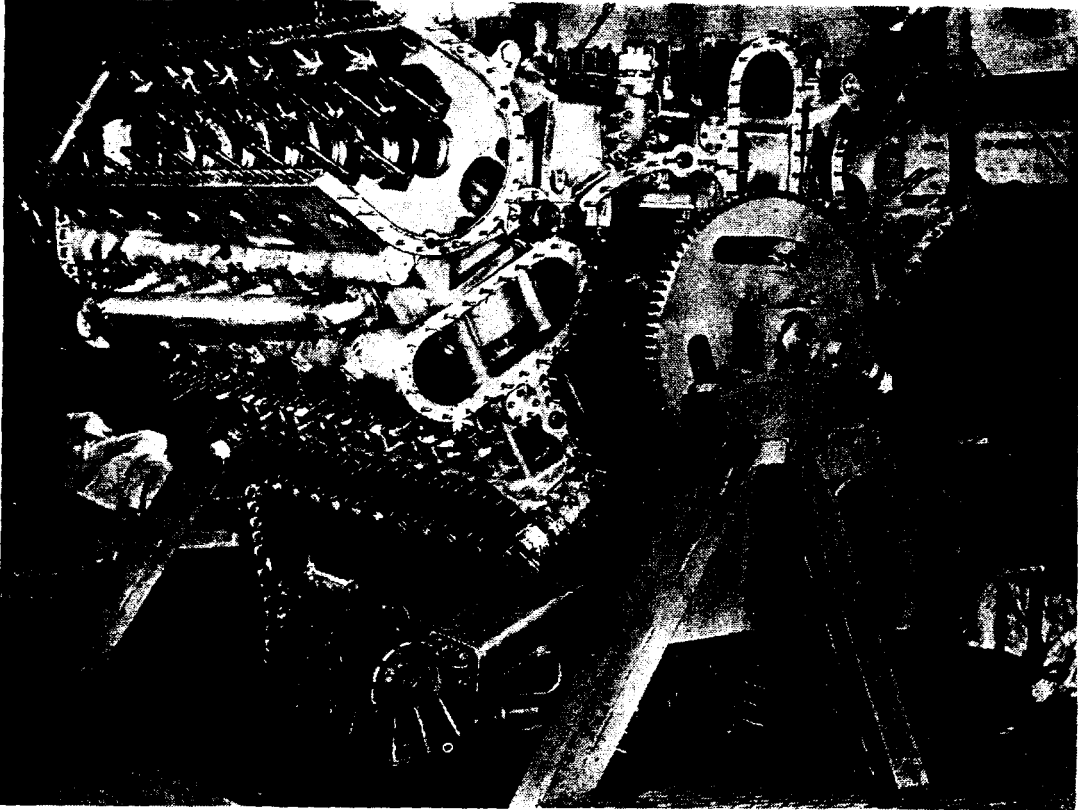
FIG. 5—PORT ENGINE TRIANGLE ON ASSEMBLY STAND

in the sump, led to the discovery that three liners were leaking through cracks in the soldering which secured the exhaust end ring carrier. A repetition of the stripping of the port engine was therefore undertaken in addition to the gearbox strip.

Following the appearance of the water leak in the port engine, a combined team from H.M.S. *Hornet* and Napiers removed the engine from the boat and stripped it as far as was necessary to return the cylinder blocks to the firm for the withdrawal of the liners and re-sweating the ring carriers. The work entailed was the removal of the engine from the boat, the removal of the reverse/reduction gearbox, phasing gearbox and blower, the removal of crankshafts, connecting rods, pistons, crankcase-mounted auxiliaries and camboxes, and breaking down the triangle to allow the separation of the blocks.

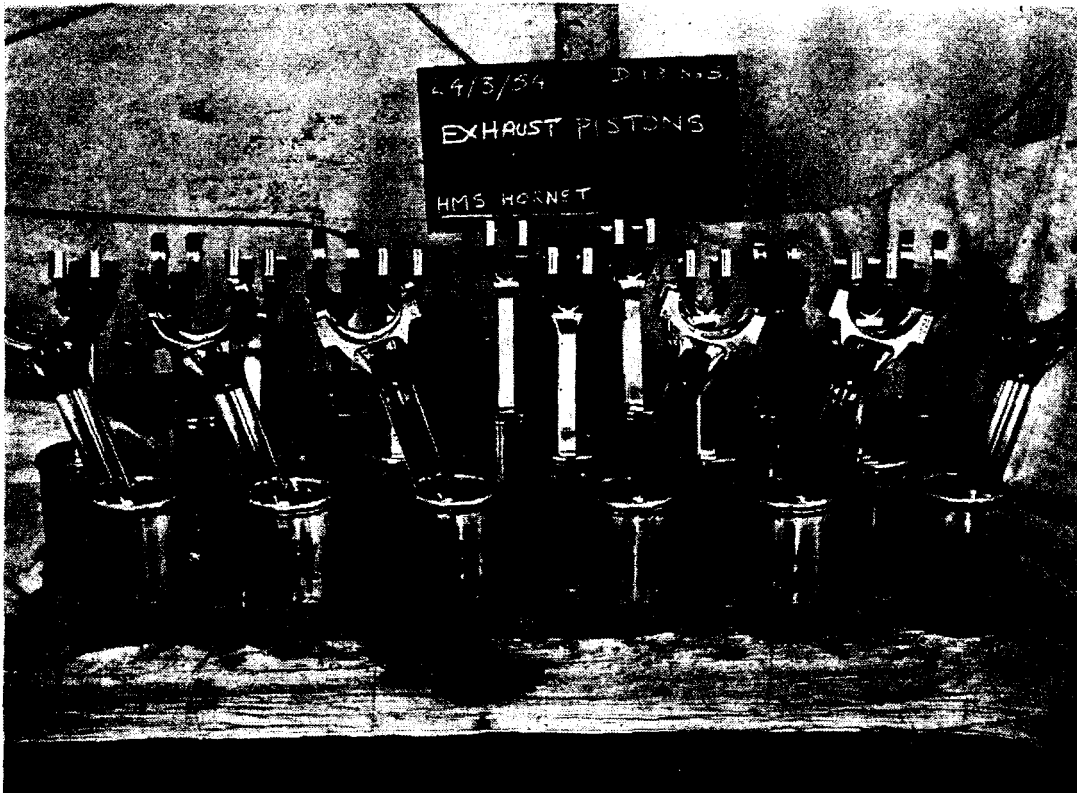
FIG. 6—PORT ENGINE EXHAUST PISTONS

The pistons were generally in good condition though three showed signs of slight blow-by, one inlet top gas ring was broken, one piston had cracked and lost a piece from the crown land and two had suffered partial failures of the ring insert bond. No carbon had built up in the crown cooling grooves of the gudgeon pin housing and, in this respect, this piston showed a great improvement over the earlier type. Subsequent metallurgical examination of the bond failures and cracks, attributed them to a sharp corner on the ring groove insert. The remainder of the engine was in very good condition, the bearings, crankshaft and liners showing no sensible wear. The pistons and the large-end bearings as removed from the engine are shown in FIGS. 6, 7 and 8.

The engine was rebuilt with three new pistons in place of those damaged, one new inlet piston ring in place of the broken ring, and new compression rings in the third ring groove of the exhaust pistons, the old third ring being transferred to the top groove and the old top rings discarded. These items, together with the tab washers, joint washers and split pins disturbed on stripping, were the only spares fitted. The rebuild was carried out with the same labour force as the strip and was completed in 339 man-hours. It included phasing crankshafts, timing injection pumps and priming the injection system. The engine was reinstalled by the ship's staff with the aid of a mobile crane, in the tidal waters at H.M.S. *Hornet*. The installation amounted to 56 man-hours. The alignment of the engine on reinstallation was set up to that obtaining before removal, which meant that the engine output shaft was approximately 0.140 in out of line with the propeller shafting. No attempt was made to improve on this alignment, as the flexible coupling had run under this condition
