NOTES FROM SEA

MARINE ENGINEERING

An Interesting Phenomenon—H.M.S. 'Diamond'

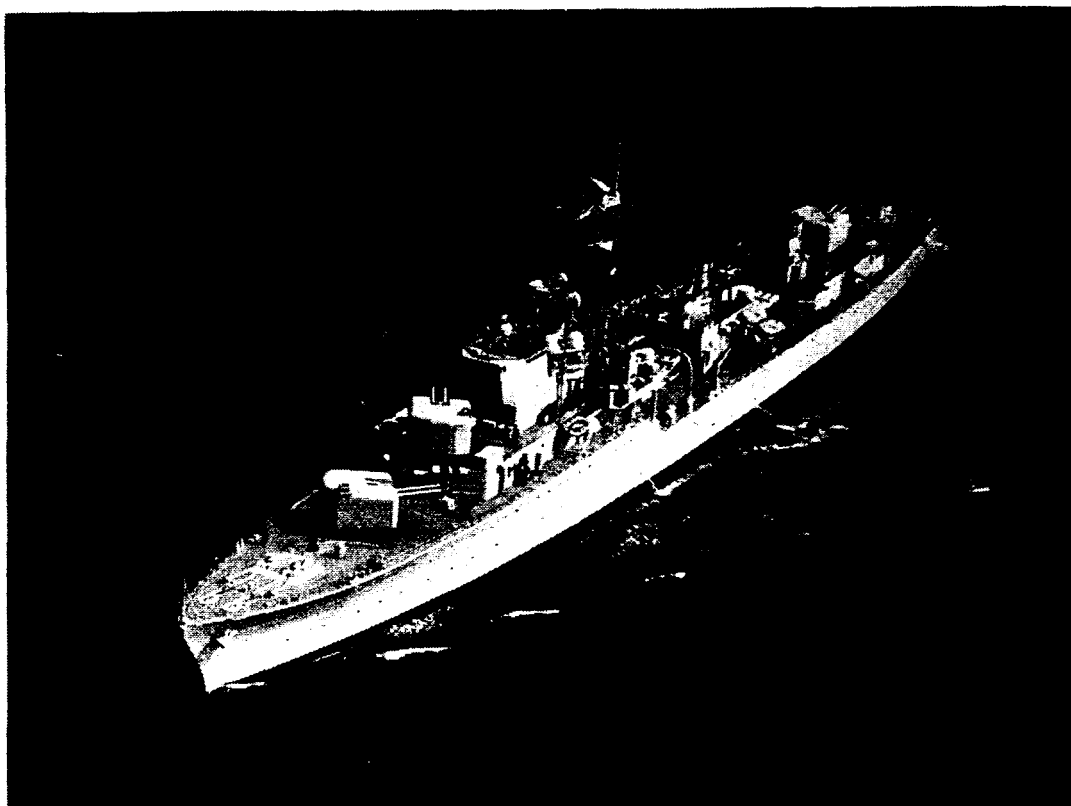
H.M.S. 'DIAMOND'

On passage from Naples to Toulon, a small leak was noticed in the joint between the superheater outlet pipe and the safety valve on 'A' boiler. On lighting up again, four days later, the leak became very bad. When the boiler was at 650 lb/sq in and the steam temperature at 500 degrees F., it was connected to the auxiliary range and the leak was again examined. A most peculiar phenomenon was noticed. Where the steam issued from the flange there was a

bluish-violet light, about 1/10th inch in diameter, which extended round the flange for about $\frac{1}{4}$ inch. It remained in exactly the same position unless physically disturbed. When touched with the tang of a file the light could be moved round the flange from one to two inches, when it became so attenuated that it disappeared. Immediately the file was withdrawn, the light reappeared in its accustomed place.

The light was very similar to a small intense blue flame, but a pencil held against it did not char.

It was necessary, for other reasons, to shut down the boiler and the light disappeared when the steam pressure had fallen to between 550 and 450 lb/sq in after an interval of between fifteen minutes and one hour. The boiler was flashed up again after three hours and was connected to the auxiliary range at 650 lb/sq in and 520 degrees F., when the light reappeared. It continued to be noticeable until the steam temperature was increased to 650–700 degrees F., while warming through main engines, when it became smaller and intermittent. It finally disappeared when main engines were turned under steam and the steam temperature was about 800 degrees F.

It is thought possible that this phenomenon may have been caused by hot dry steam, issuing from the leak at high velocity, striking a cool wet atmosphere, from an adjacent steam leak, and setting up an electro-static field of sufficient intensity to cause a glow of this nature.

It is known that water vapour, escaping in the manner witnessed in the leaking main steam joint, can become frictionally ionized. The re-combination of the ions after escape from the gland would give the blue 'flame' or glow provided the concentration of ions was great enough. In this case, it would appear that this was so when starting up and for some time afterwards, but with increasing temperature (and presumably pressure) the ions became sufficiently scattered for the blue glow not to be seen, although the re-combination would be taking place continuously. The period of intermittent light would be consistent with this explanation, as this would naturally occur as the critical velocity was approached. The blue 'flame' associated with ionic combination would be associated with low temperature so that it would not be expected to char wood.

Nevertheless, the probable explanation of the phenomenon is an electro-static discharge caused by a combination of steam pressure, temperature and nature of crack.
