## H.M.S. ORION AT CRETE, MAY, 1941

COMMANDER (E) H. FARQUHAR ATKINS, D.S.O., D.S.C., R.N.

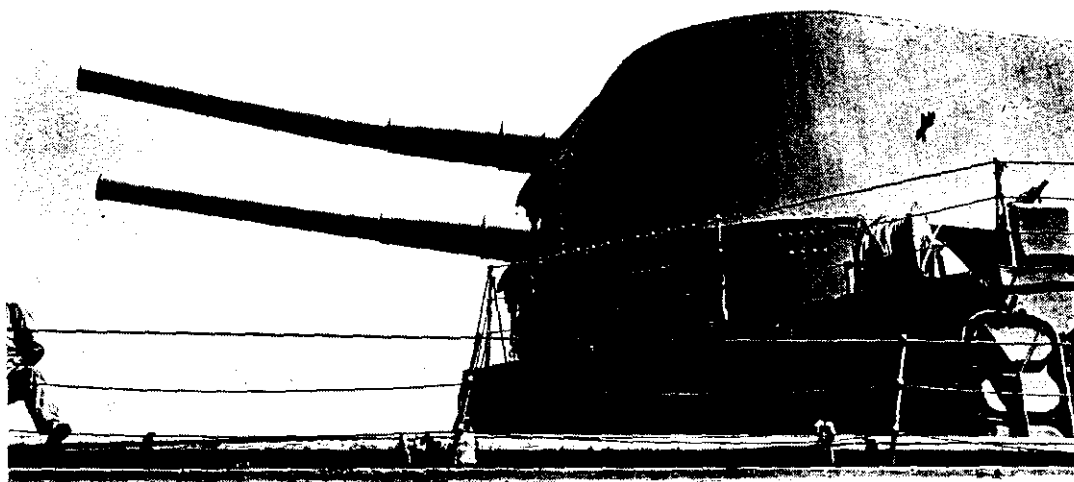
FIG. 2.—BENT GUN BARRELS OF "B" TURRET AFTER FIRST BOMB HIT.

*Dido* was hit on a forward turret and then a Junker put in a suicidal attack on *Orion* and at 0905 scored a hit on 'A' turret with a 1,000 pound bomb, the aircraft crashing on the ship's bow before falling into the sea. The bomb exploded on the after side of the roller path. The gunhouse was blown over the side, and in passing hit the muzzles of the guns of B turret, knocked the barrels up to maximum elevation and bent them through about 15°. The breech carrier arms snapped off under the shock, both breeches being open at the time.

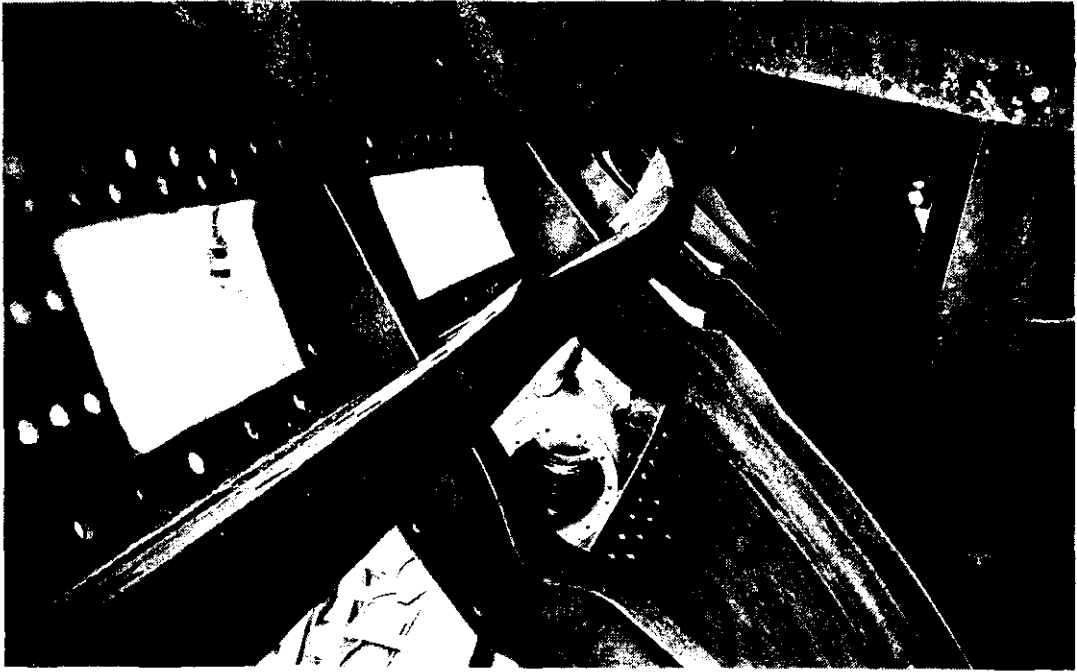
FIG. 4.—RESULT OF NEAR MISS CLOSE TO S.O. PROPELLER
