NOTES FROM SEA

Turbo Generator Maintenance

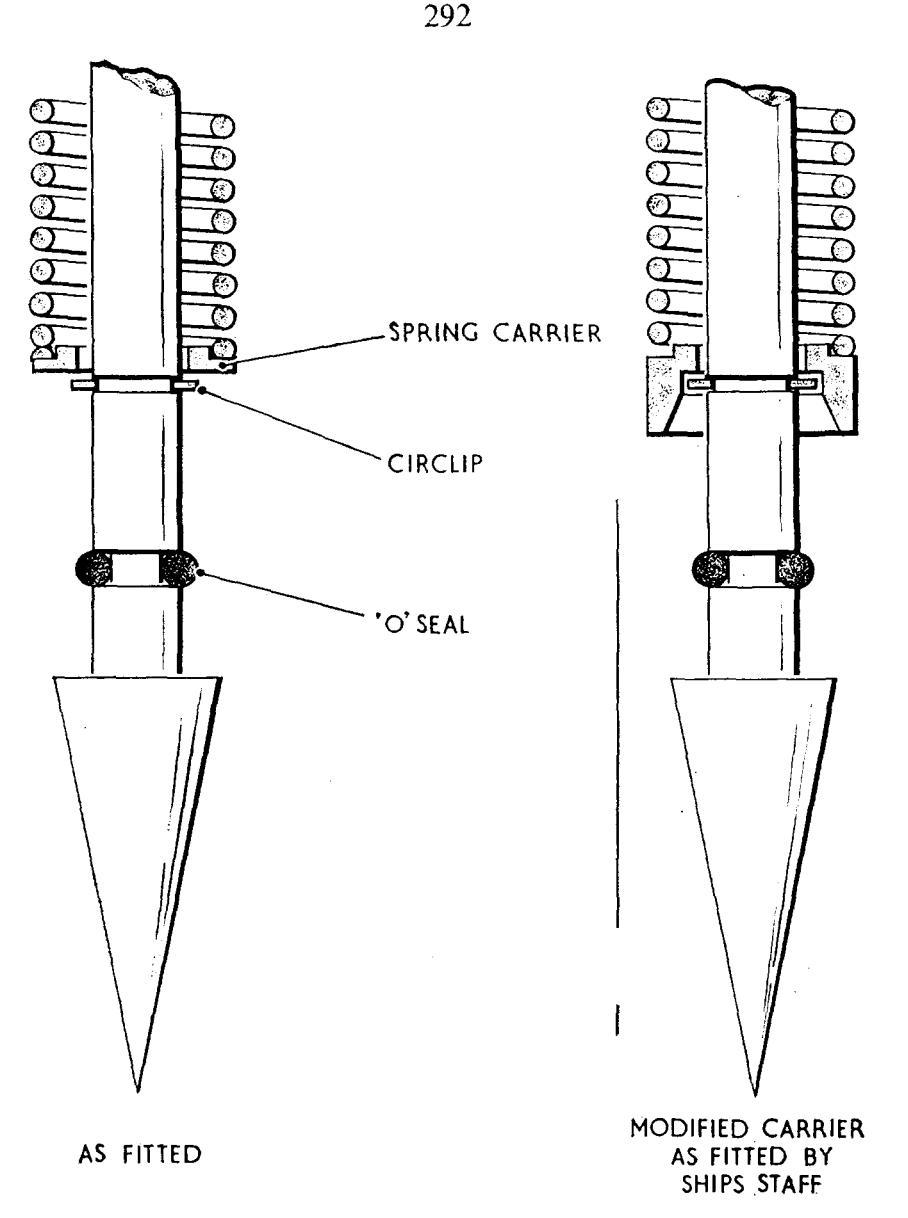
FIG. 1—ALLEN 500KW G.T.A. ISOLATING VALVE FOR STARTING FUEL RELIEF—VALVE 'D'

On the isolating values for the starting fuel relief value (value 'D') fitted to Allens 500kW G.T.A.s, the spring carrier is positioned by means of a small circlip recessed into the spindle; the recess being in the order of 0.01 in. deep. On three occasions this circlip was strained from the recess, resulting in the carrier plate sliding down the spindle and cutting the 'O' ring seal. This was eventually overcome by the manufacture of a modified spring carrier to act also as a circlip retainer, the circlip lugs being ground off to fit the annulus (see FIG. 1). This arrangement has now been running satisfactorily for 1,500 hours and it is suggested that it could well be incorporated as a standard modification.

A standard modification based on this principle is now being incorporated for these valves. The similarity between FIG. 1 and the official drawings of the modification (Nos. GZ638812-3) can be seen and it will be noted that the circlip has also been modified to make it more effective.

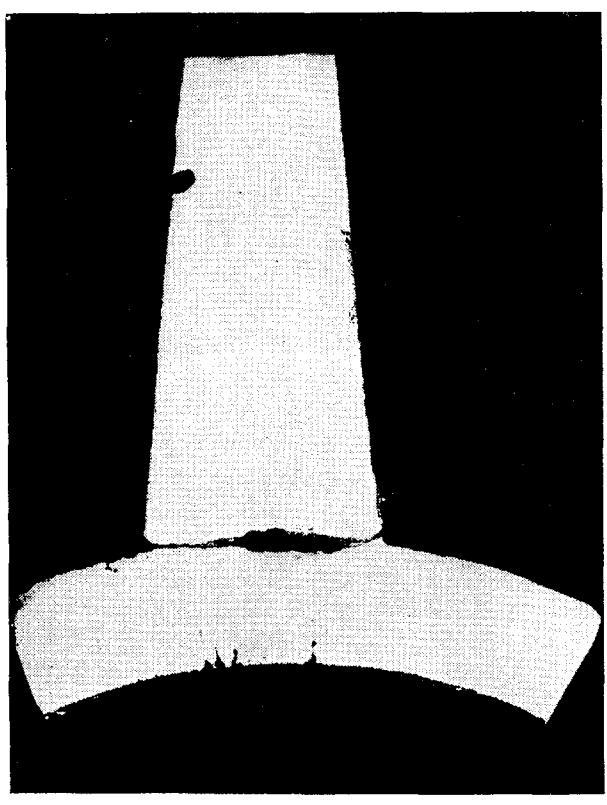
Fig. 2

A recent failure of one economizer element was investigated by the Dockyard Laboratory, Devonport, who found the failure and widespread cracking in the other elements due to corrosion fatigue.

The interesting part of their findings was that in each tube affected by corrosion fatigue the spacer fin was inadequately welded to the tube wall, and, conversely, where the fins were securely attached the deterioration was absent.

FIG. 2 shows the cracking and the incomplete welding.

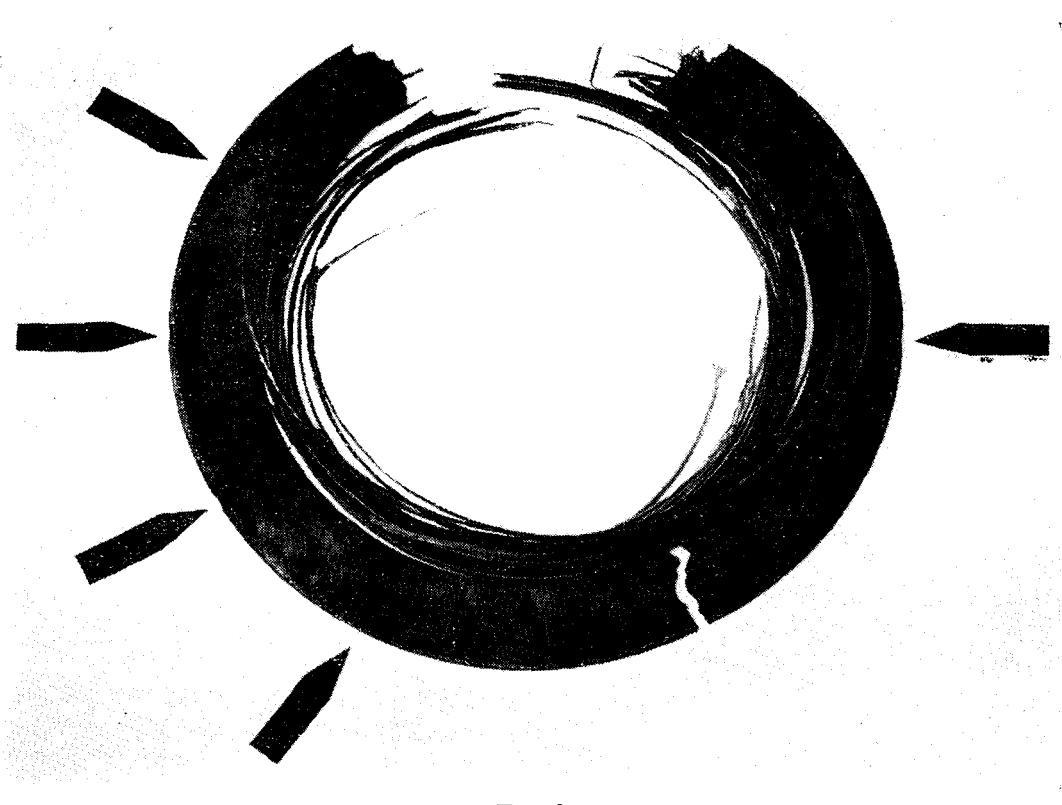
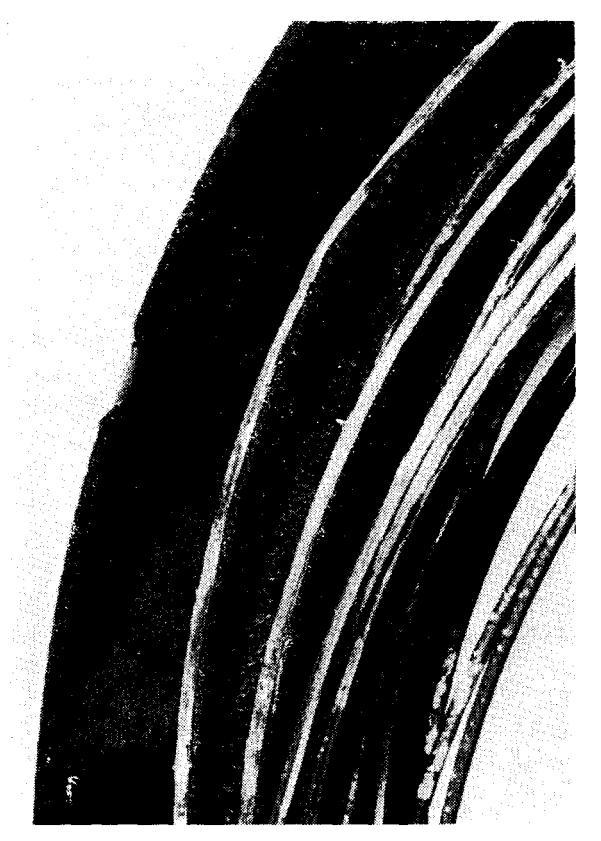
A dangerous failure of a main steam joint recently occurred in a *Daring* Class destroyer. The ship was shutting down at the time with one boiler only connected. The leak developed suddenly on the boiler side of the main bulkhead valve and in about 20 minutes reached such proportions that it became necessary to shut the main stop valve, resulting in a complete blackout.

FIGS. 3 and 4 show the condition of the spiral wound gasket removed from the joint. Complete disintegration had occurred and the backing ring was found to be fractured. It was noted that the backing ring had been incorrectly fitted, apparently being forced into position within the circle of securing studs causing the outer surface to the dented. It is assumed that the backing ring either fractured when fitted or subsequently. Main engines were being prepared for sea when the boiler-room turbo alternator slowed considerably in speed but then returned to normal. Two or three minutes later the turbine exhaust and labyrinth was found to be glowing red. The machine was tripped immediately. Failure of the turbine thrust bearing was suspected and this was confirmed on investigation.

The second boiler was being connected at the time. Water levels in both boilers were steady at $\frac{1}{3}-\frac{1}{2}$ glass throughout this period and the boiler was connected slowly, auxiliary first and then, some fifteen minutes later, to main. It is assumed therefore that the pressure in the first boiler was slightly greater than that in the second and that this caused water which had accumulated in the main steam range, on the range side of the second boiler main stop valve, to flow back into the auxiliary superheated steam range and pass over to the turbo alternator turbine. When this occurred the drains adjacent to the main and auxiliary stops were open to trap.

Had the trap on the drain from the range side of the main stop been bypassed, it seems likely that the accumulation of water and the consequent damage would not have occurred.
