Some marine machinery failures And their causes

R. F. Munro and P. E. Haynes

Lloyd's Register of Shipping

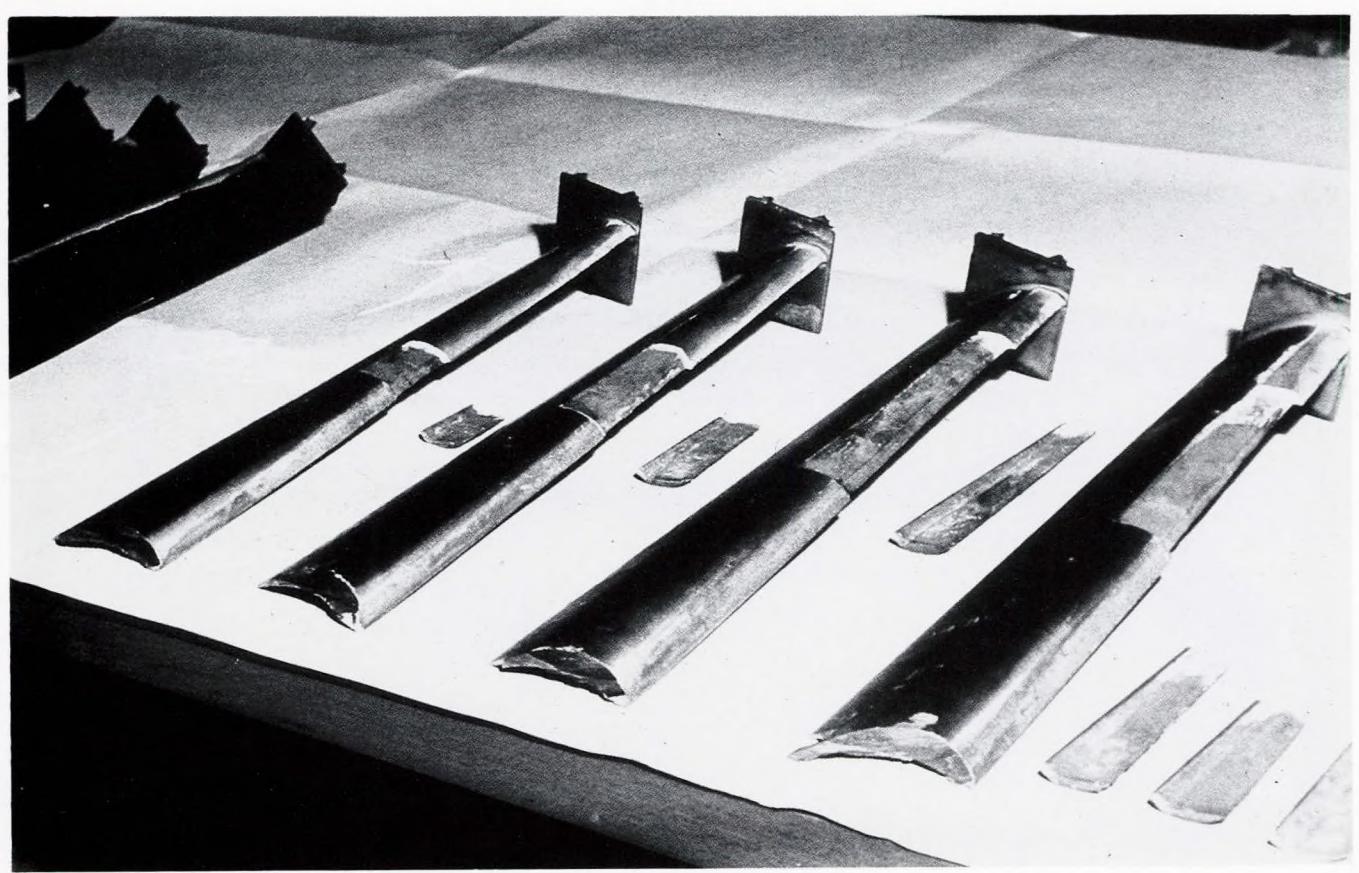
FIG. 2

Figure 2 shows low pressure turbine blades from which the stellite protection has become detached. One case was a consequence of severe overspeeding. In the further three cases which are known to the designers, the cause was considered to

be overheating during prolonged running astern. This resulted in the inner (radially) ends of the stellite pieces becoming loose, and separation taking place in the interface between the brazing filler metal and the blades, due to thermal expansion differences between the two materials.

In normal manoeuvring the temperature at the exit end of the LP turbine does not reach a level at which this damage can be suffered, but cases can arise where a shipmaster may require the highest possible astern power over a long period and high temperatures can be reached.

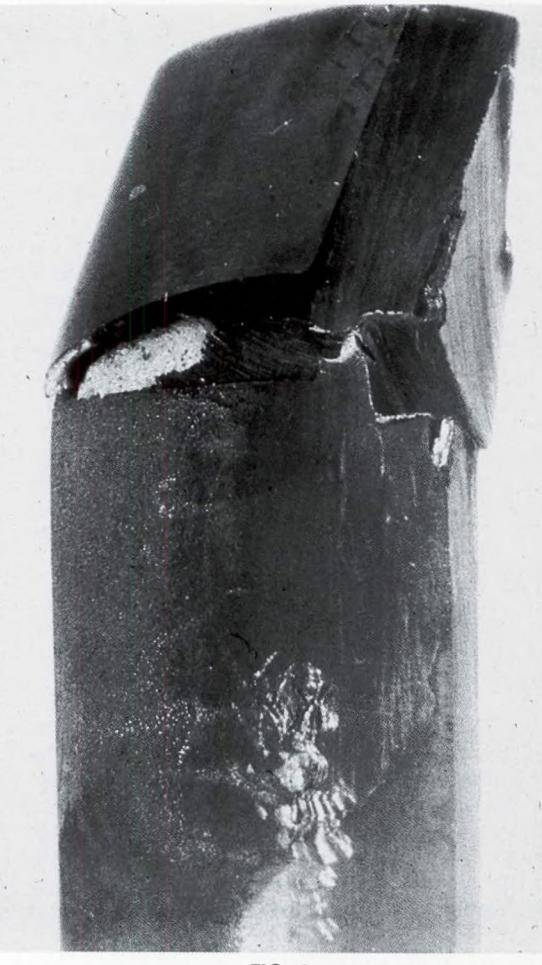
FIG. 4

The origin of the cracks was the braze metal-stellite shield junction near to the leading edges. The ground edge of the shield was clearly visible on the braze metal junction (see Fig. 3) and liquid penetrant and microscopic examination of an unaffected blade from the same stage showed lack of wetting by the braze metal between both the shield edges and blade faces (see Fig. 4).

vibration was close to the builders' value. It is likely that induced vibratory stresses, probably increased by stress concentration effects of the lack of bonding between the stellite shield and the blade, produced stresses in excess of the fatigue limit of the blade material.

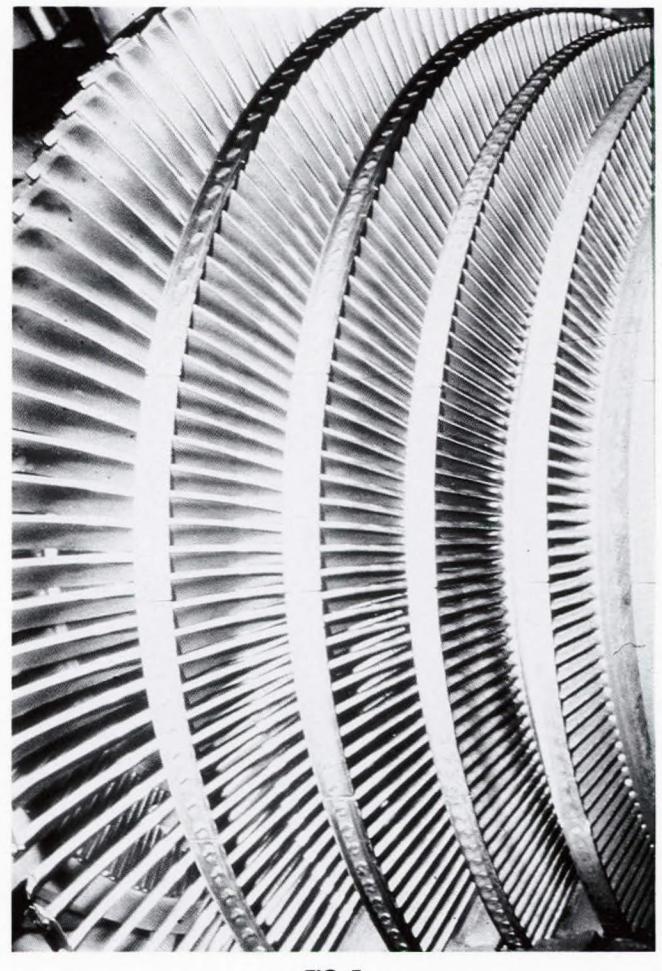
FIG. 5

On two occasions within 3 months, the Chief Engineer opened up and examined the LP rotor of this turbine because of vibration and found shrouding missing from the last stage blading (see Fig. 5).

After the first incident, the affected blade segments were replaced from stock. In the course of a thorough investigation following the second failure it was discovered that, during manufacture of the shrouding, the holes to accommodate the blade tenons had been left with sharp edges on the underside, thus introducing stress concentrating notches in the tenon roots during the peening process (see Fig. 6).

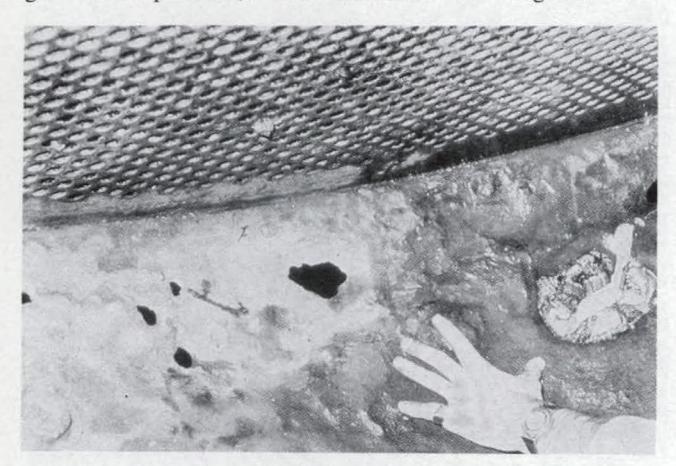
FIG. 7

On investigating the source of unusually high bilge water it was found that the main condenser water box was perforated (see Fig. 7).

The damage to the water box was due to repeated impact of the steel carrier for the sacrificial anode, which had become detached from the inspection door and carried round violently in the great turbulence in the cast iron water box (see Fig. 8). The anode support bracket failure was due to corrosion fatigue. Where possible, anodes and indeed all fittings should be

located away from the main water flow and also in a position offering the least resistance to water circulation.

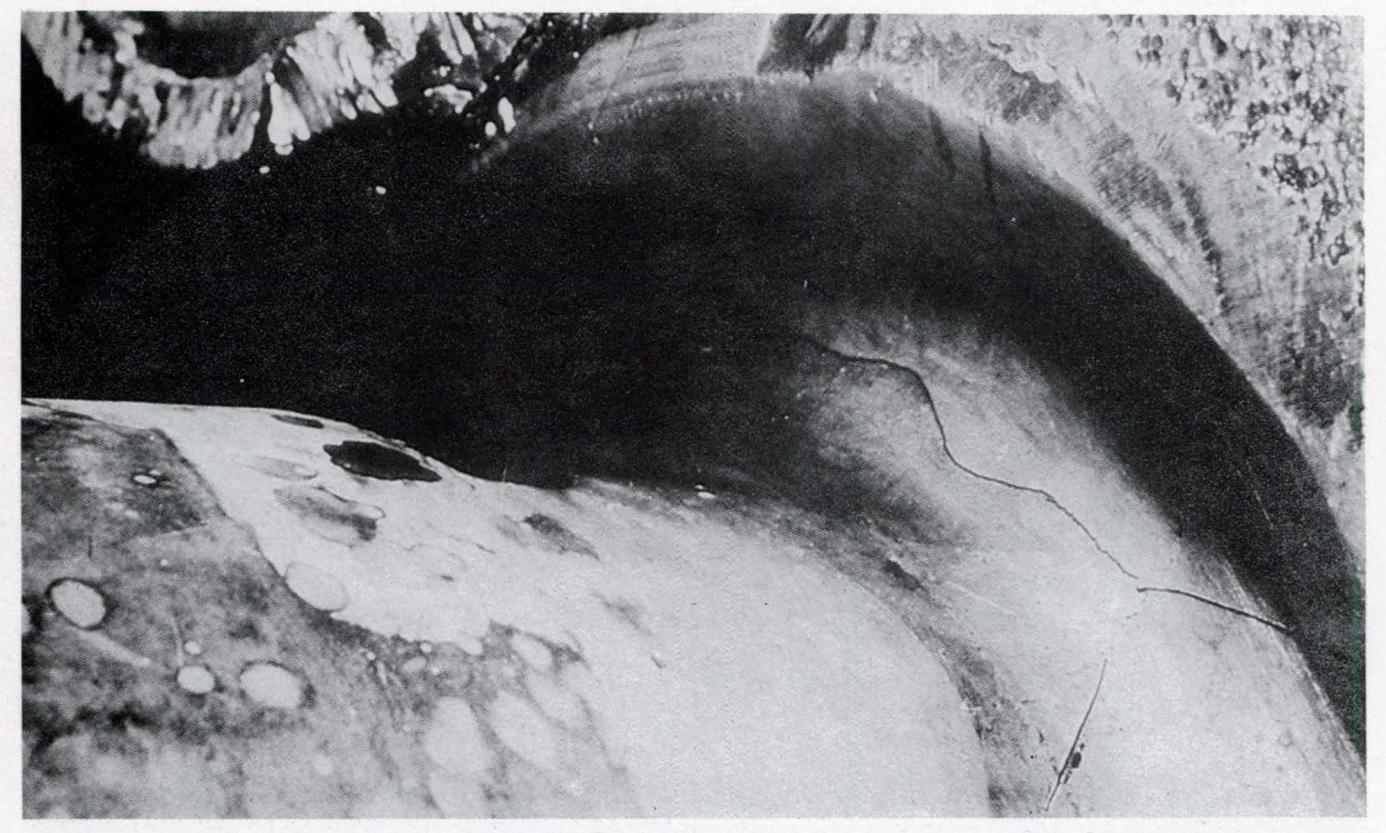
FIG. 11

The engine was made in 1959. On a routine inspection after 2 years in service, a severe crack was found in the undercut fillet between crankpin and web (see Fig. 11).

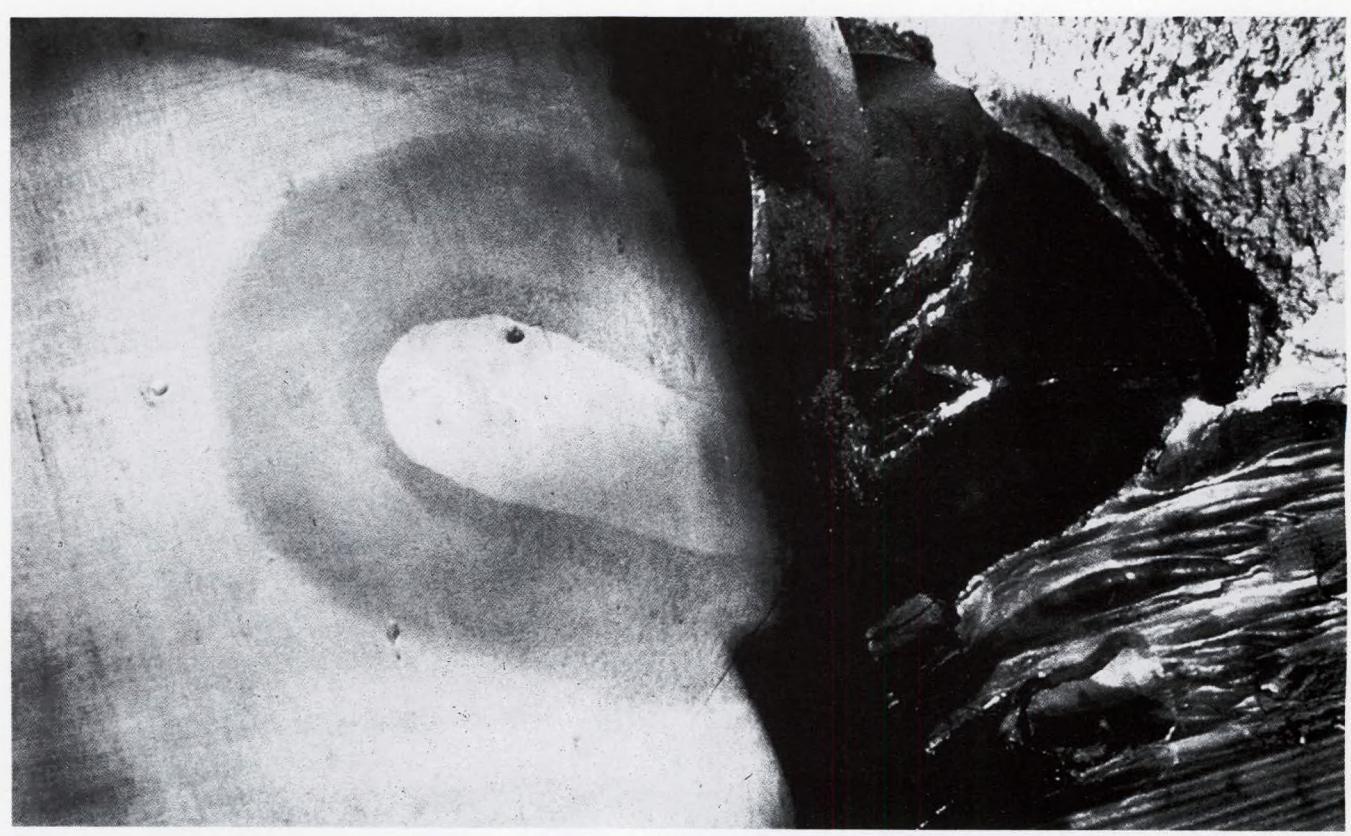
FIG. 12

Investigation revealed that a local repair by welding had been carried out during manufacture in the steel foundry. Figure 12 clearly shows the heat-affected zone after etching.

An engineering investigation may have shown increasing cyclic stresses over a period of time due to, for example, uneven firing of the engine, poor maintenance, changes in duty, misalignment etc. The crankpin could therefore have been subjected to a sufficient number of stress cycles to cause failure in any case, if the fatigue limit of the shaft material had been exceeded.

Even when weld repairs were carried out on steel castings under strict control and with adequate heat treatments, variations in grain morphology and composition, together with probable hardness variation, are likely to give unreliable and

For many years the Rules have been explicit on the subject of permitted and prohibited zones for repair welding on castings for crankshafts, because of the cyclic stresses involved.

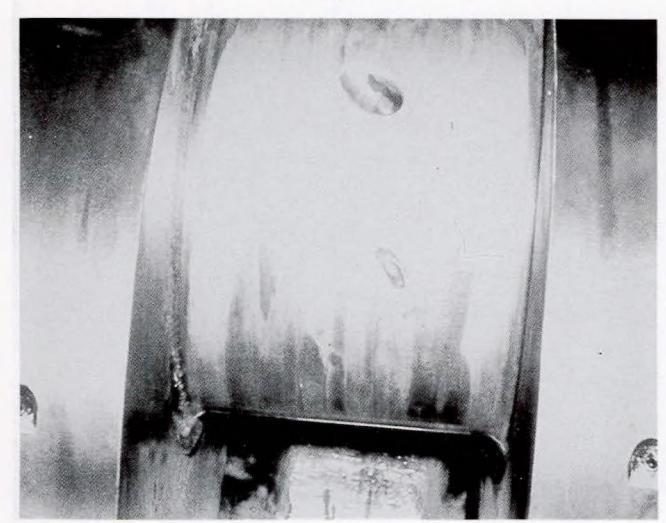
FIG. 14

Figure 14 shows the crankpin of a medium speed engine in which the Chief Engineer had ground a crack he had found near the oil hole.

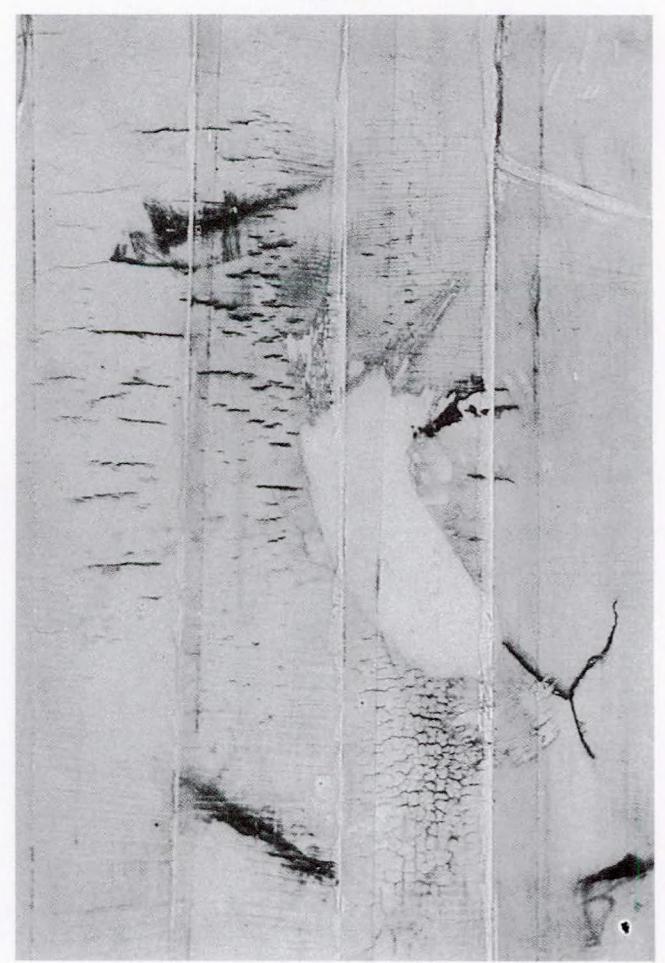
FIG. 16

At '1' can be seen a serious branching crack having torsional connotations and large areas of crazed and longitudinal cracking which are the result of excessive heat. Figure 16 also shows a useful technique whereby a permanent record of a magnetic powder 'picture' can be made by the careful laying on of transparent adhesive tape and then transferring it to a sheet of white paper. The process can, of course, be repeated as often as required.

Craze cracking is usually shallow and may frequently be ground out. However, thermal shock cracking, often longitudinal, and fatigue cracks are relatively deep and may extend

throughout the hardened layer if present. In the latter case, renewal of the crankshaft is the only reliable course of action. Even when cracking is completely removed by grinding, the affected parts should be checked minutely for significant variations in hardness.

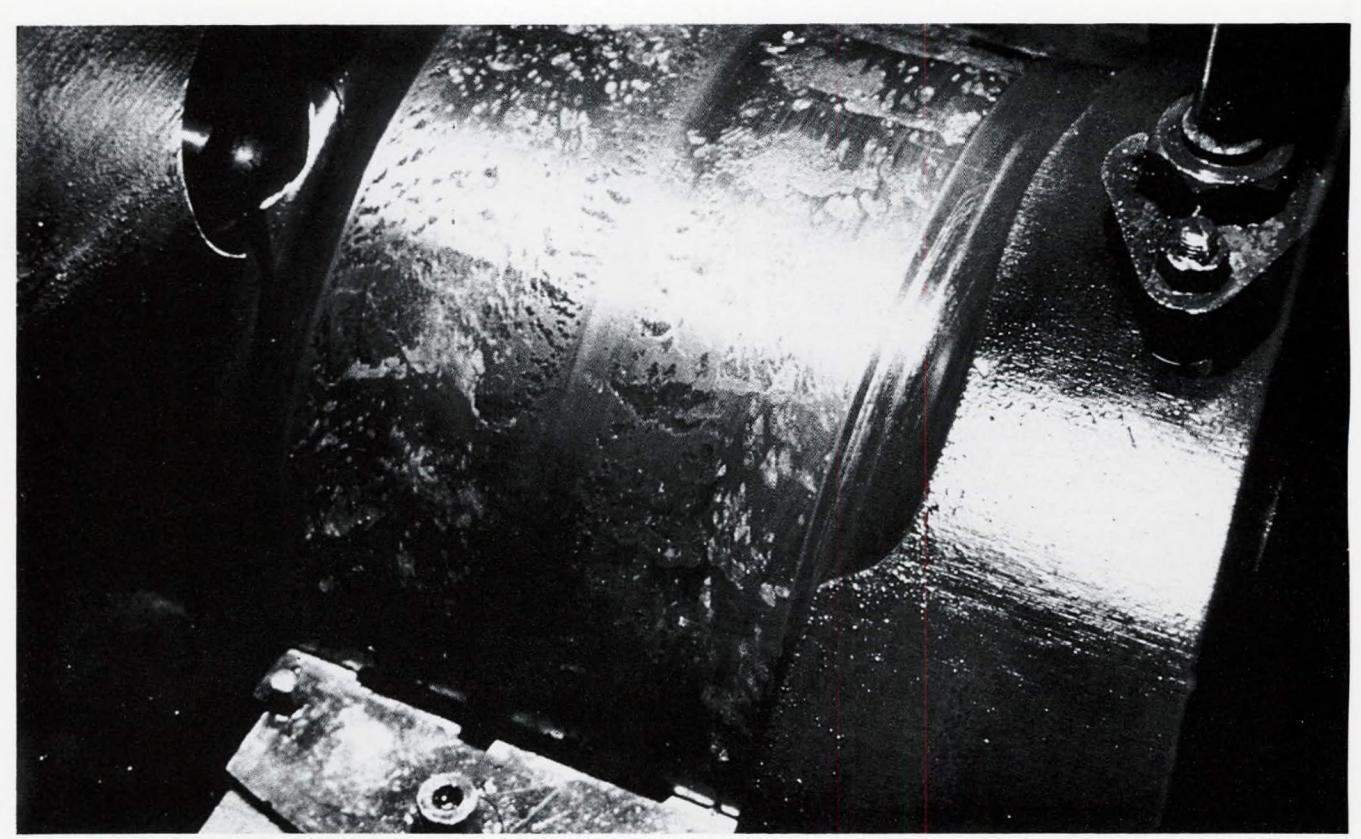
FIG. 17

Some years ago, when there were many engines at sea which did not have the benefit of a diaphragm dividing the scavenge space from the crankcase, the type of damage shown in Fig. 17 was common; and because these engines had water-cooled pistons it was accepted that the corrosion was due to sulphurous contamination of the lubricating oil in the presence of water leaking from the cooling system into the crankcase to form sulphuric acid.

Today, very similar severe damage is being seen but it is known that it is due to microbial infection of the lubricant. Similar damage can result if hydraulic systems and piston coolants become infected.

A number of shipowners have placed 'dip slides' on board their ships for regular use by the Chief Engineers in order to detect the presence of infection before serious damage can occur. When the dip slides prove positive, it is essential to consult a specialist microbiologist to identify the precise nature of the problem and recommend the appropriate biocide.^{1,2}

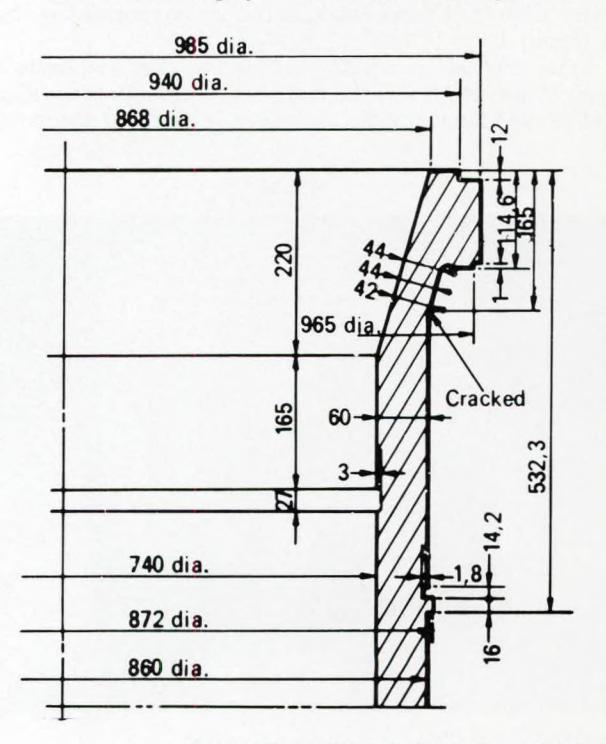
FIG. 19 Existing cylinder liner for main engine

Figure 19 is a section through the cracked liners and the

Cylinder liners are usually manufactured from grey cast iron, a material which, apart from very isolated occasions, has the same fracture surface appearance whether broken under impact, tensile or fatigue loading conditions. Further, this material exhibits relatively low ductility and the danger of failure by reducing section thickness in order to save weight is obvious.

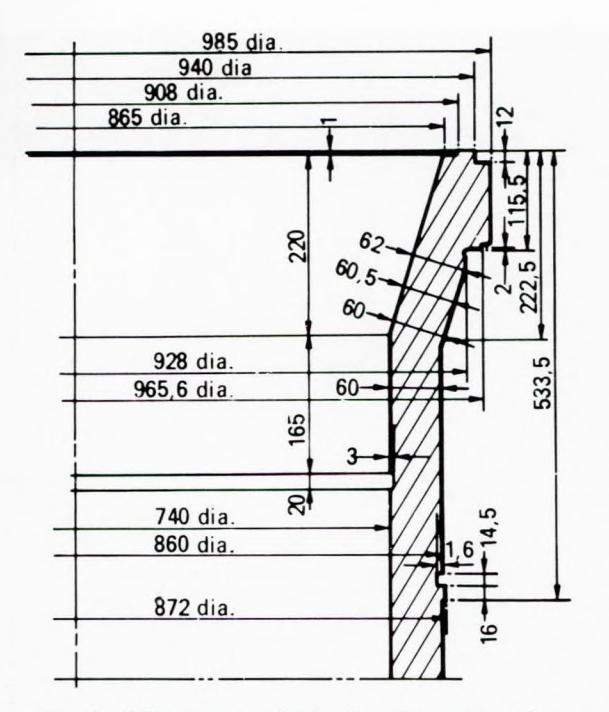
Fig. 20 Ship's spare cylinder liner for main engine

dimensions should be compared with those in Fig. 20, which were measured in the original spare liner secured to the engine room casing side.

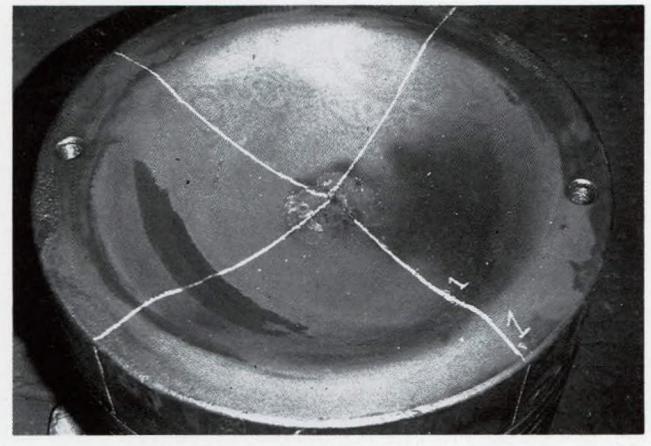
FIG. 23

Figure 23 shows an oil-cooled piston crown which cracked, allowing quantities of cooling oil into the combustion space resulting in a violent and fatal explosion.

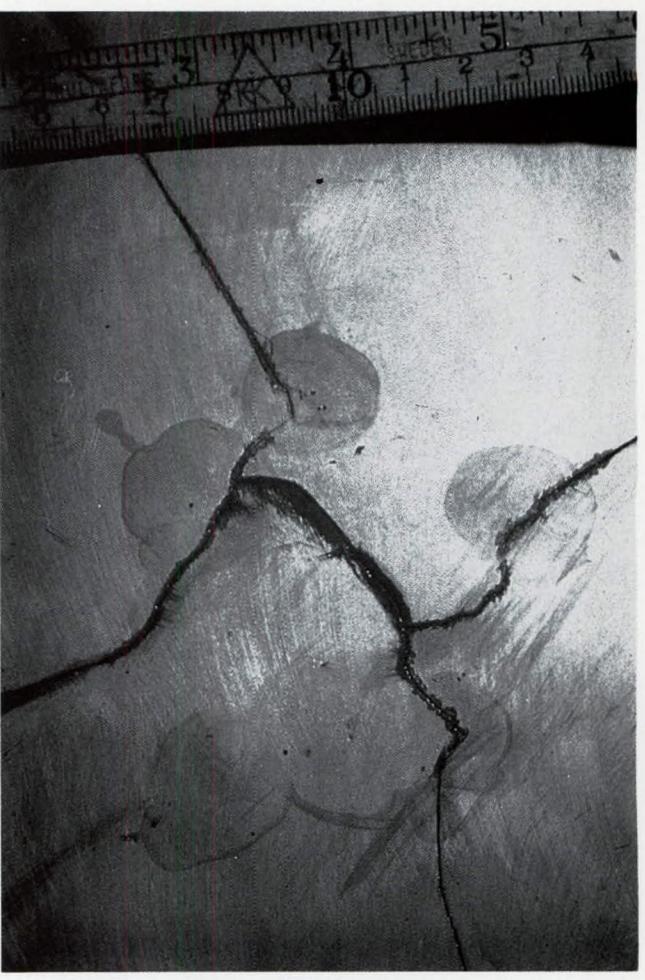
FIG. 24

Under investigation, the piston was polished and etched and Fig. 24 shows the cracks and the heat-affected zone in way of unofficial weld repairs which had been performed at the steel foundry without consultation with the surveyors.

The piston crown is subject to arduous service conditions, as evidenced in a recent damage investigation in which the metallurgical structure of the centre of the crown had been modified in a manner which showed that the steel had attained sufficiently high temperatures in service to spherodize the carbides, whereas the structure in way of the ring grooves was typical of normalized medium carbon steel. The piston crown had failed owing to the development of thermal fatigue cracks (see Fig. 25) on both the top and underside surfaces and which penetrated the full thickness.

No repairs by welding should be carried out on important steel castings which are subject to survey without prior discussion with the Surveyors, to establish whether or not a proper repair can be made. Having decided that repairs may proceed, then the appropriate procedure is to be agreed, and this will include heat treatment. Any other operation is irresponsible.

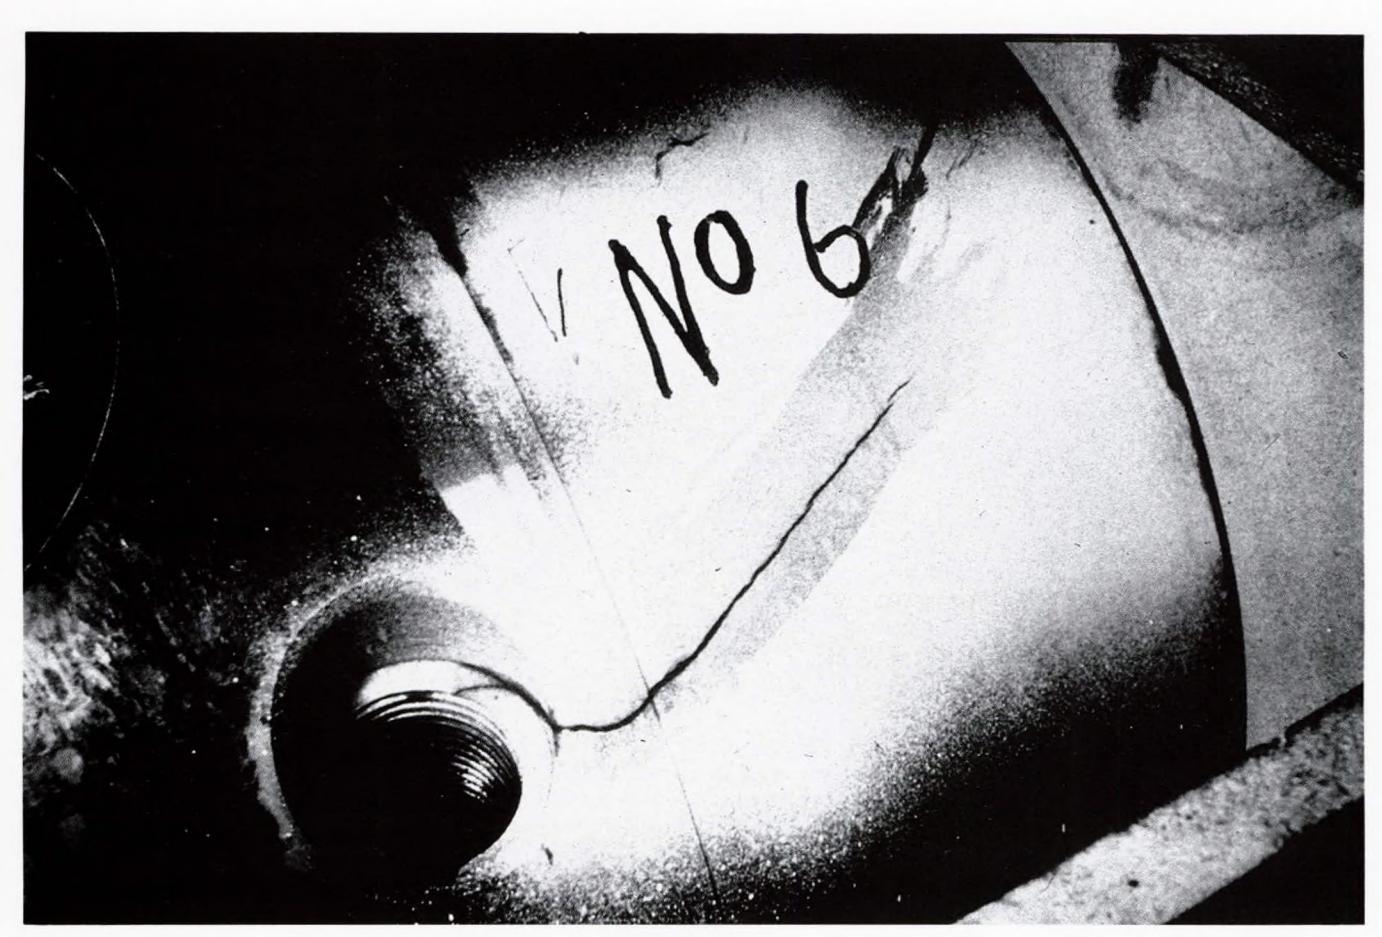
FIG. 26

During a routine periodical survey of Nos 4 and 6 crosshead bearings, the pins were found to be cracked as shown in Fig. 26.

As a sensible precaution, all the remaining crossheads were opened up and all were found cracked in the same manner. These cracks originated in the zone of stress concentration caused by the absence of radius on the tool used in forming the counterbores.

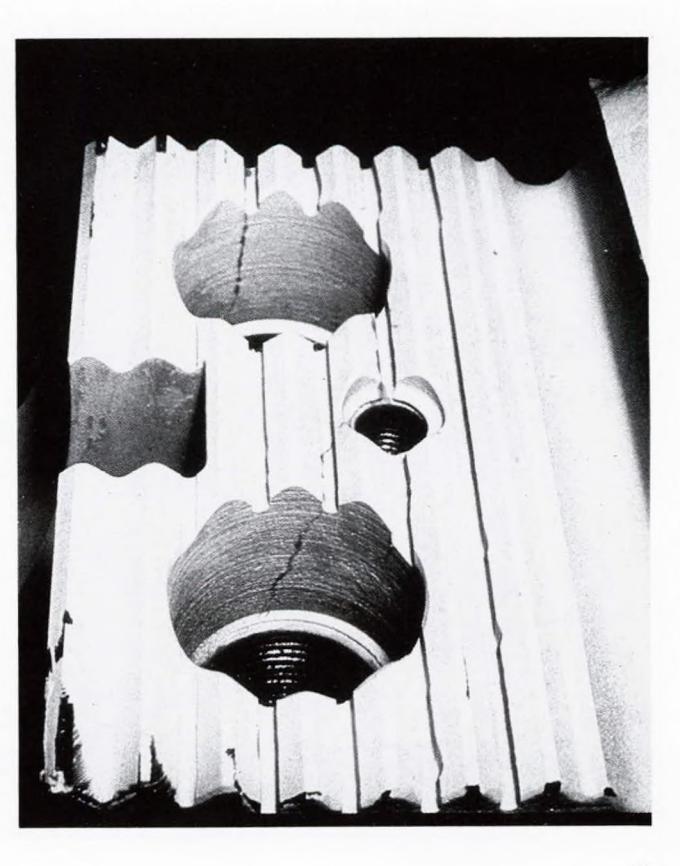
FIG. 27

In this medium speed engine type there were many cracks reported in the grey cast iron bedplates, which were serrated in way of the main bearing keeps, as shown in Fig. 27. A number of bedplates were replaced in nodular cast iron, which was adopted as the material for all future production after the nature and extent of the problem had been recognized. A number of the original bedplates have operated for some years without defect, and many were modified to reduce the stresses in the serrations.

Grey cast iron possesses excellent mechanical properties in compression. The alloy is relatively cheap and is easily cast. However, the metallurgical structure consists of a threedimensional array of graphite flakes in a matrix which is essentially steel. The flakes can act as stress concentrations and the metal has low ductility. It is worth noting that there is virtually no visual difference between tensile overload, impact and fatigue fractures. On the other hand, in nodular iron the graphite occurs as spheroids or rosettes in the steel matrix.

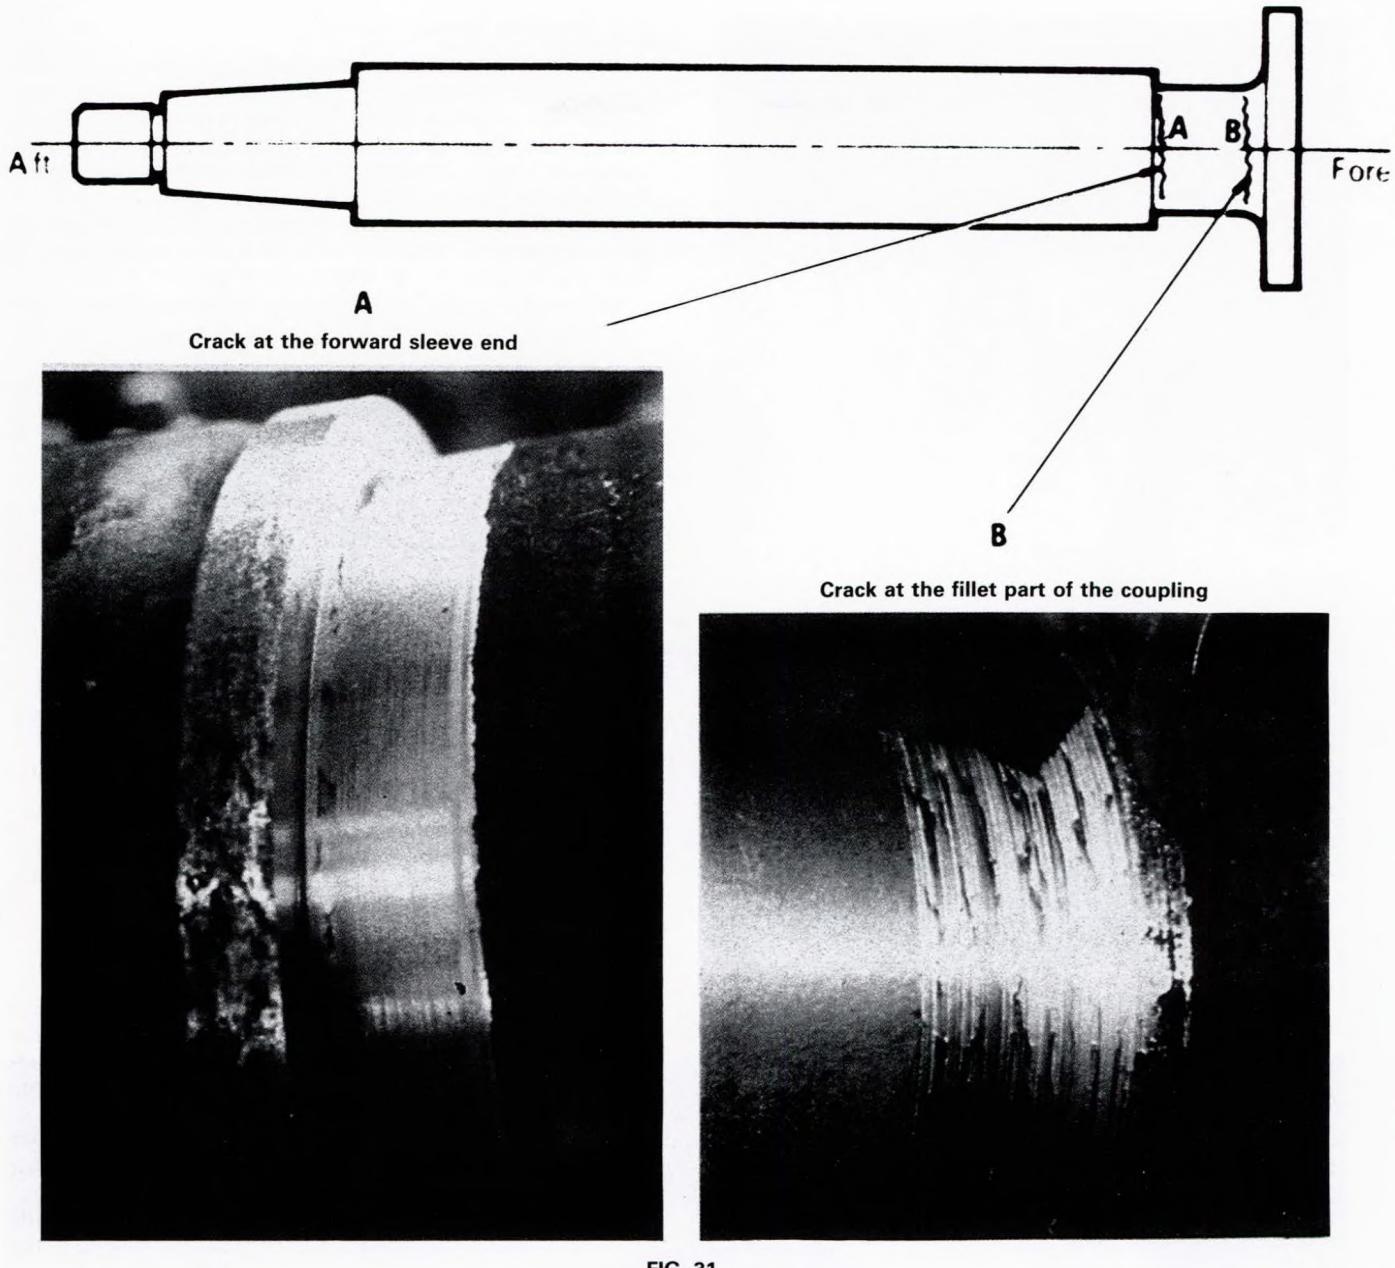
FIG. 31

Figure 31 illustrates a case in which the screwshaft was found to be cracked at the forward end of the shrunk-on bronze liner and also at the coupling. For this case it is probable that misalignment was causing severe bending stresses, resulting in bending fatigue failure in the presence of a corrosive environment.

Operators of ships having continuous liners on the screwshafts are strongly advised to consider protection of the bare steel shafts in way of couplings from the effects of stress corrosion fatigue due to the continuous flow of sea water which is usually experienced as a result of the desire to keep the stern gland packing lubricated and cool.

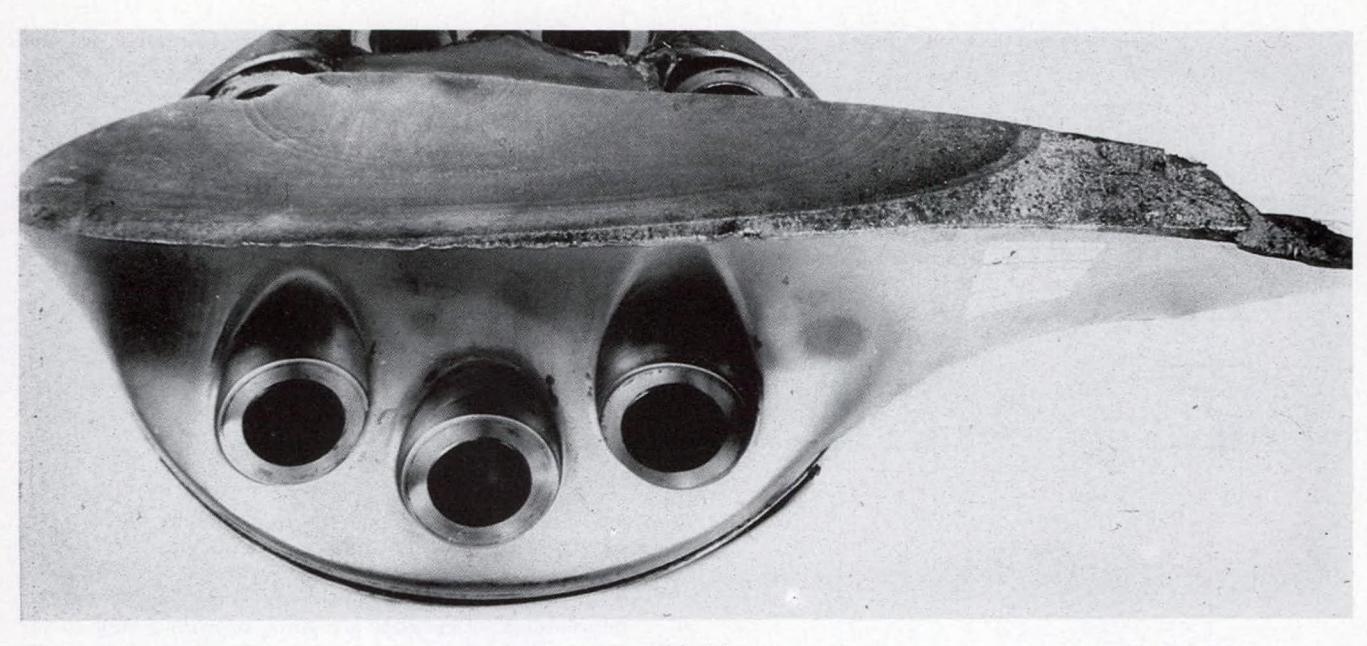
FIG. 42

The propeller blade fracture shown in Figs 42 and 43 is a similar case, in which a stabilised martensitic steel failed by fatigue originating from a small casting flaw on the pressure face. The extent of the fatigue crack prior to final rupture and the small size of the flaw indicate that the principal cause of the failure was cyclic stresses probably slightly greater than the endurance limit of the alloy. Note that this fracture is in a region of high stiffness. Fixed-pitch propeller blades made in copper alloy examined by the Society's laboratory have been found to fail further from the hub.

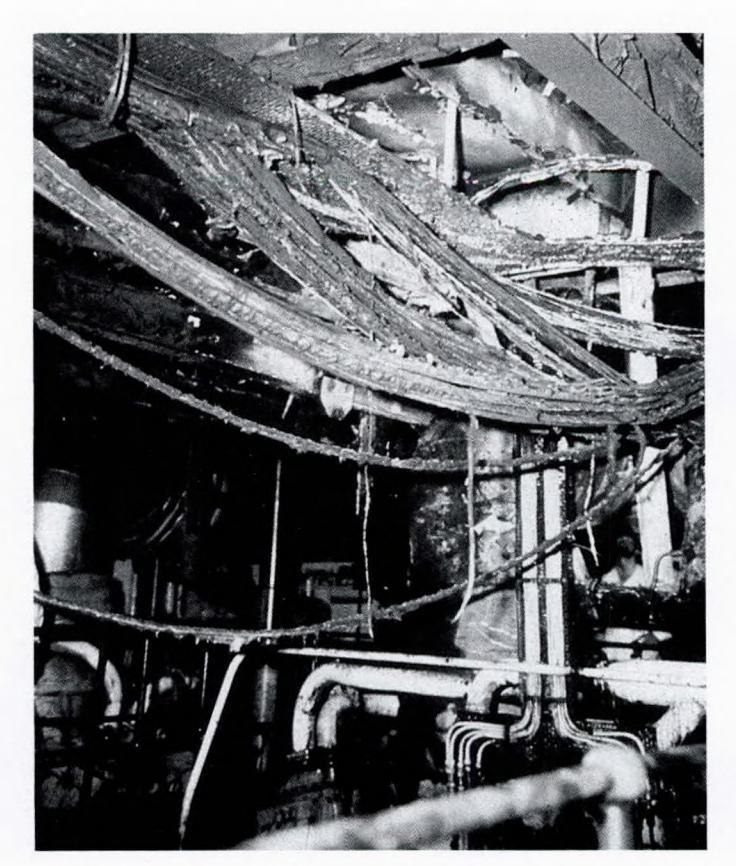
FIG. 48

Figure 48 shows the results of a severe engine room fire which broke out in a medium speed engined container ship when a fuel pipe broke at the cylinder tops. When the pilot is on board and 'Stand by' is rung on the telegraph and the engineers are tidying up after some routine planned maintenance, it is essential that the 'Stand by' signal is not accepted until all pipe clips and shields are replaced. Once the passage has begun, these vital items are liable to be overlooked and the consequences may be disastrous.

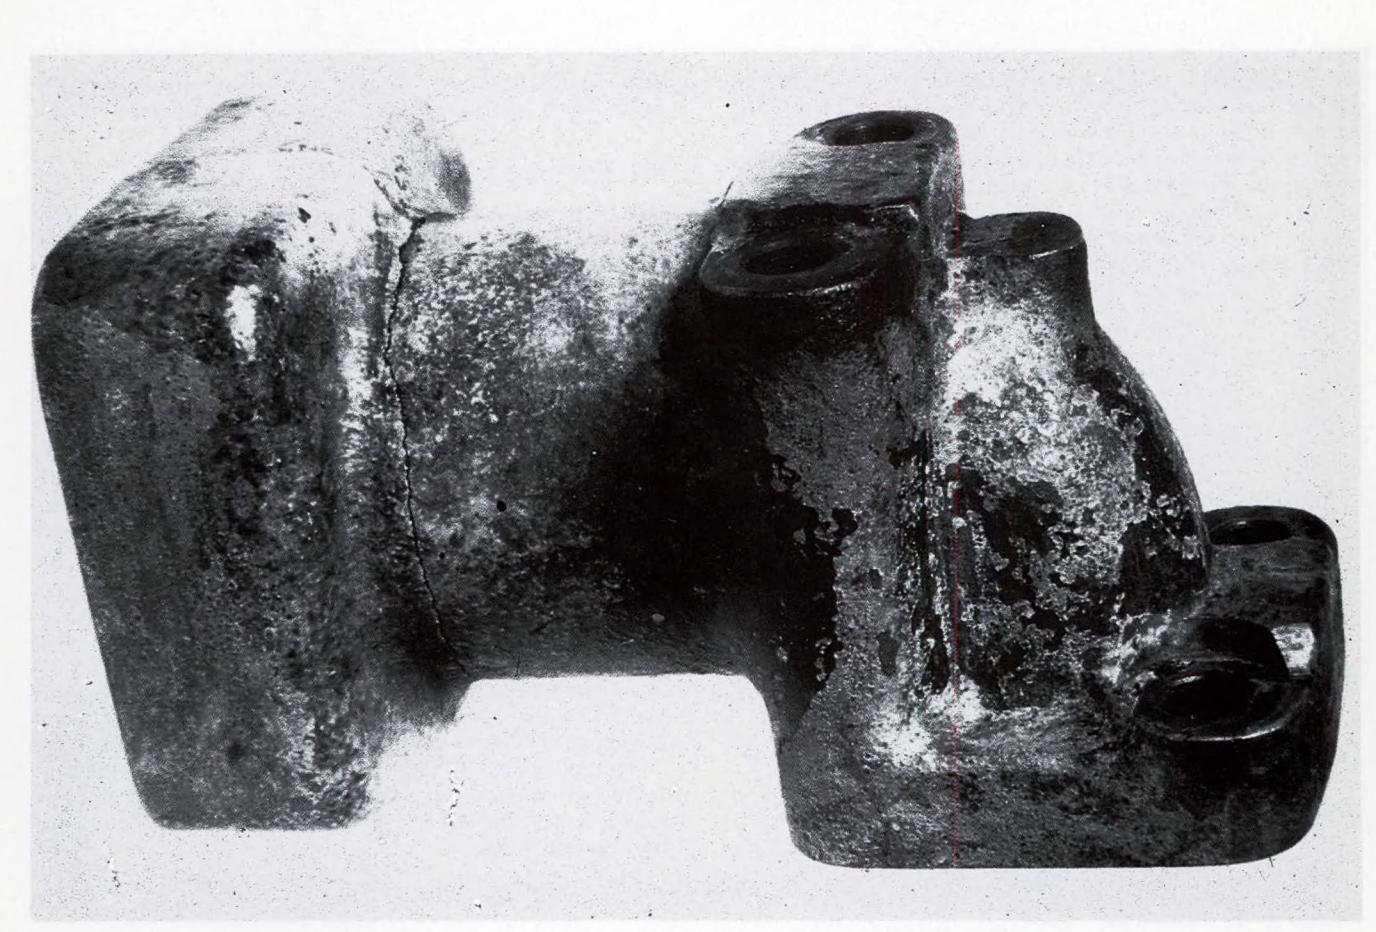
FIG. 49

This is a clear example of the dangers of introducing stress concentrations into a component subjected to fluctuating stress in service (see Figs 49, 50 and 51).

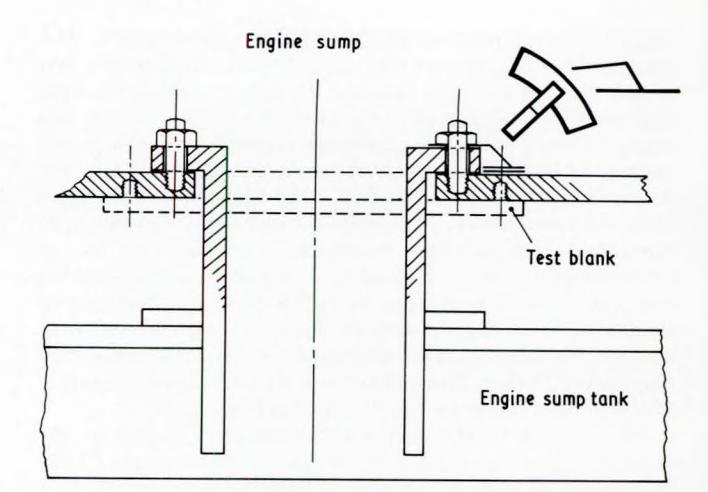
FIG. D1 Repair of engine sump to stop leakage

Thermometer pockets. I must confess some surprise in reading that this type of fitting, relying solely on a gland for securing, was ever installed. I had always understood that glands were considered as a pressure-retaining item, not a means of securing a piece of equipment. Whilst dealing with lubricating oil systems, I would comment on a mild encounter experienced at sea. While I was serving on a particular ship a heavy loss of lubricating oil was evident. All the usual possible sources of leakage were examined and dealt with as necessary, but still the loss continued, reaching, if I recall correctly, up to 20 gallons (90.0 l) per day. Tracing the leak path back to its source indicated the leakage was from the engine sump itself in way of the drain pipe from the engine sump to the doublebottom service tank. Examination of the crankcase at our next port (Manaus up the Amazon) indicated what at the time was thought to be small crack. This was patched up in the manner shown in Fig. D1 and proved successful in that the leak was

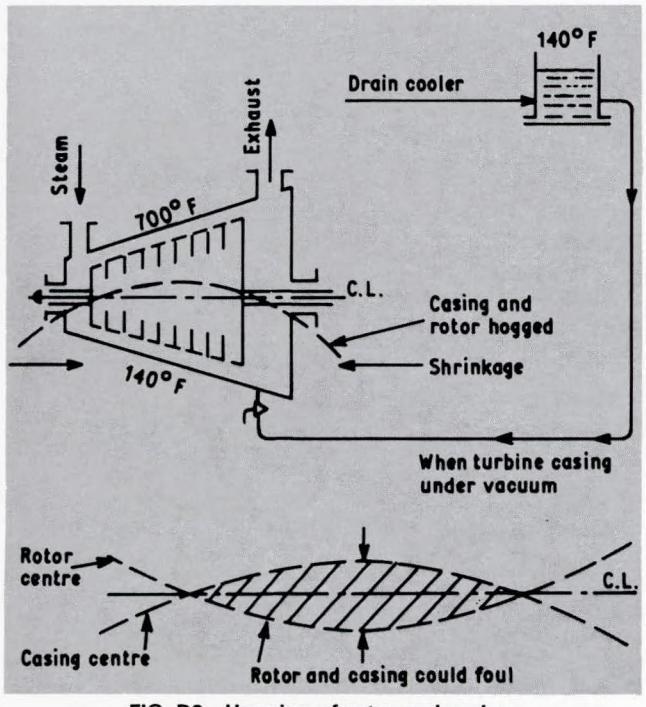
FIG. D3 Hogging of rotor and casing

During the preliminary trials of a single-screw passenger/ cargo ship of about 9000 dwt and 8500 shp, built about 1968 (with steam conditions 450 lbf/in^2 g and 825°F), it was noted

The trials were delayed about 20 days whilst a spare HP ahead rotor, already in production for a similar ship, was completed and fitted. The ship duly completed her sea trials satisfactorily and went into service for about a year. Then the

HP ahead turbine again commenced to vibrate, but not as badly as previously. The rotor was removed upon arrival in the UK and was straightened by heat treatment, rebalanced and refitted, all without loss of ship's service time.

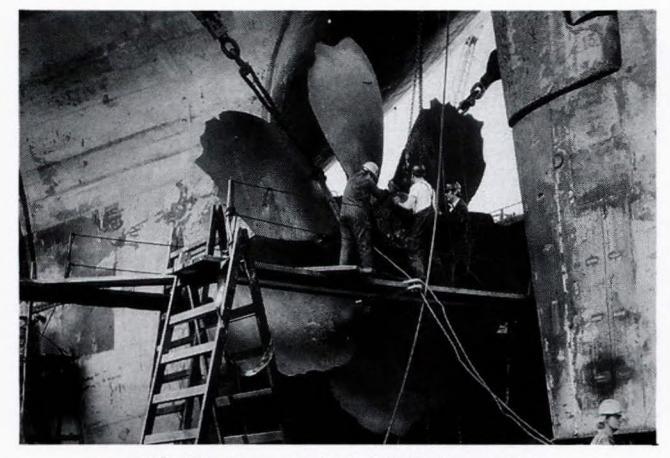
FIG. D9 Damaged six-bladed propeller

Figure D9 shows the severe damage sustained by the sixbladed propeller of a large container ship when it struck the
