# H.M.S. 'GUERNSEY'— GROUNDING AND SALVAGE

## E. C. M. HAIG, C.ENG., F.R.I.N.A., R.C.N.C. (Sea Systems Controllerate)

#### ABSTRACT

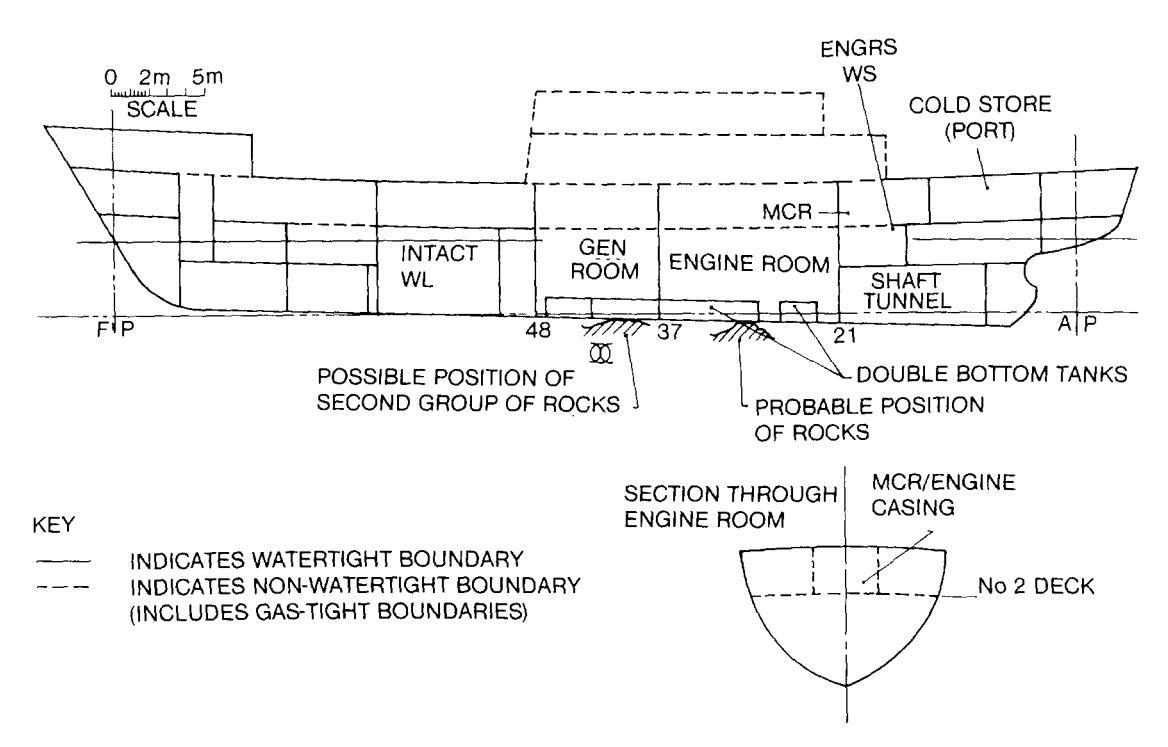
FIG. 2-H.M.S. 'GUERNSEY', PORT PROFILE

point for design and calculations. The required reserves of freeboard were achieved by the subdivision shown in FIG. 2. It will be seen that 2 Deck was not required to be watertight other than where required by tanks, and was gas-tight but not watertight over machinery spaces. Bulkheads were watertight to the underside of 1 Deck. Bulkhead doors were specified to MOD standards of watertightness; doors to machinery spaces were specified to commercial standards of gas-tightness. Systems were specified to commercial standards including the extent to which they were fitted with isolation valves at bulkheads and watertight decks (but not at non-watertight bulkheads and decks) to prevent secondary flooding. This sets the scene for the subsequent events in H.M.S. *Guernsey* on 17 April 1987.

The ISLAND Class was designed with subdivision in the form of watertight bulkheads but not with watertight decks. H.M.S. *Guernsey*'s incident reinforced the need for double bottoms or, where double bottoms are not necessary or practicable, the lowest deck should be watertight. In the case of the ISLAND Class there is a limited double bottom and 3 Deck is also watertight over its limited extent. In addition the deck on or nearest above the intact waterline (2 Deck in ships such as the ISLAND Class) should be designed to be waterlight to limit the upward spread of flooding from damage below the waterline. This would preserve buoyancy and would ensure positive stability in all cases of underwater damage. In the ISLAND Class, 2 Deck is non-watertight unless required watertight in way of deep tanks, and the resulting penalty was unnecessary spread of flooding, unnecessary water damage, and an unnecessary proximity to loss of the ship. In warships policy results in the creation of the 'damage control deck'. The same design policy may be a good insurance against peace-time risks.

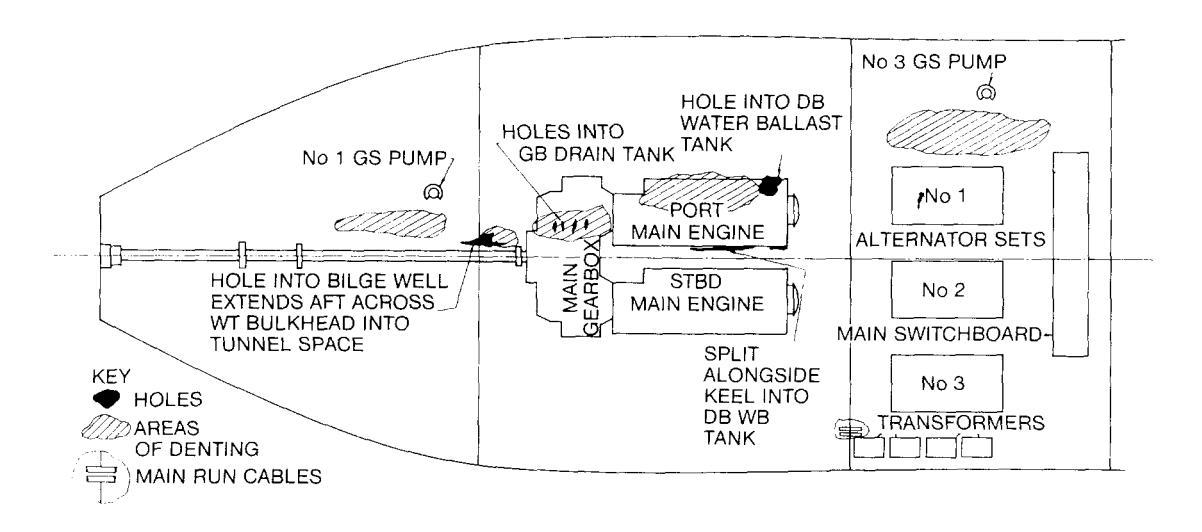
FIG. 3—LOCATION OF HOLES AND DENTS

The full extent of structural damage was determined during the docking after salvage and is shown in FIG. 3 in plan and FIGS. 4, 5 and 6 in section. Some of the indentations may have been caused while the ship sat on the rocks before salvage at 1630 BST but there is no evidence that any additional holes were made during that period rather than at the time of grounding. The hull showed longitudinal score marks; some of these were consistent with astern motion at the time of grounding; others may have been caused during grounding or during salvage but evidence is insufficient to allow a conclusion. Again there is no evidence that any additional holes were made during the salvage at 1630.

Grounding holed the outer bottom as follows (shown in FIGS. 3 to 6):

- (a) A gash about 0.7m wide across the bulkhead between the shaft tunnel and the engine room.
- (b) A hole about 0.6m diameter into the water ballast tank in the engine room double bottom.
- (c) A split about 2m long by 0.01m wide at the join of the vertical keel and the garboard strake into the same tank.
- (d) 4 splits each about  $0.15m \times 0.01m$  at frames in the bottom of the gearbox lub oil drain tank.
- (e) A split about  $0.25m \times 0.05m$  into the double bottom water ballast in the engine room.

The subsequent flooding was almost entirely due to the first of these holes. The splits under the gearbox lub oil drain tank would have contributed to flooding the engine room through the gearbox but their effect would have been small compared with the gash in the hull at the engine room/tunnel bulkhead. Flooding from the other holes was confined by the tank tops.

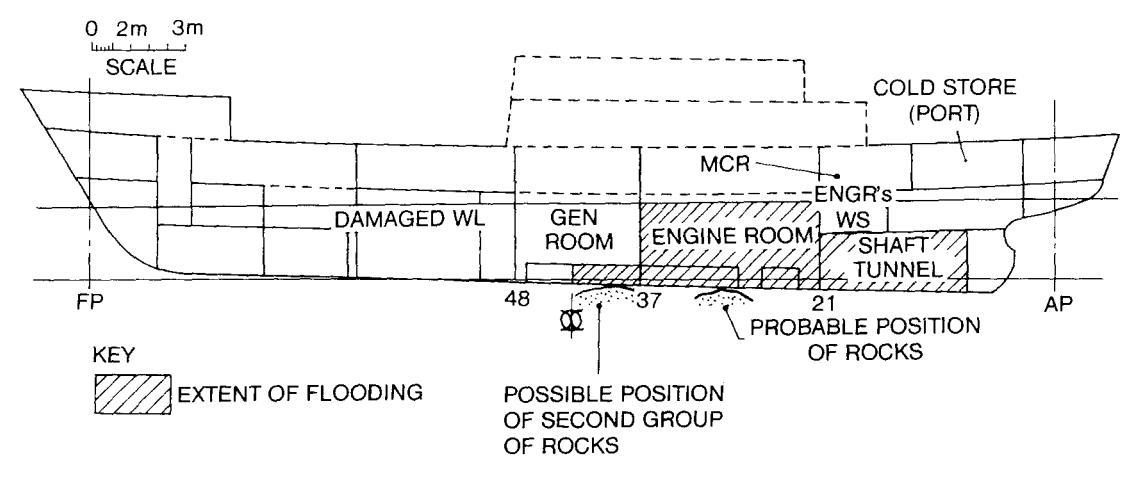
FIG. 7—Ship condition at 1300

By the time uncontrollable flooding had run its course in the tunnel and engine room the depth of water over the rocks was about 4.515m and the tide was still rising. The ship had lost about 440 tonnes of buoyancy (assuming no flooding in the workshop yet). MOD has attempted to deduce the position of the rocks relative to the ship and their depth below chart datum. These deductions are shown in FIG. 7 for the tide at 1300. FIG. 7 also shows the extent of flooding observed at the time, assuming negligible flooding in the workshop.

The stability of the damaged ship balanced on a rock is very sensitive to the assumed position of centre of gravity, to the assumed longitudinal position of the rocks, and to the immersion of the rocks below the waterline. Various estimates of upright stability were made and produced estimates of GM of between +0.7m and -0.55m. Since the ship remained upright in

the condition shown in FIG. 7 then either GM was positive or the ship was cradled on the rocks. Since all the holes and indentations were in the port half of the hull the upward force exerted on the hull would lead to a heel to starboard. Since there was no heel to starboard it is a reasonable but not certain judgement that the ship was cradled on the rocks and may have been held in that position by the southerly tidal current acting on the starboard side. If the ship had not been cradled on the rocks she would have heeled to an angle noticeable by the ship's company. It is not possible to produce a GZ curve for the ship in this condition because of the sensitivity of GM and GZ to the assumed position of the rocks and because of the probable cradling of the hull by the rocks.

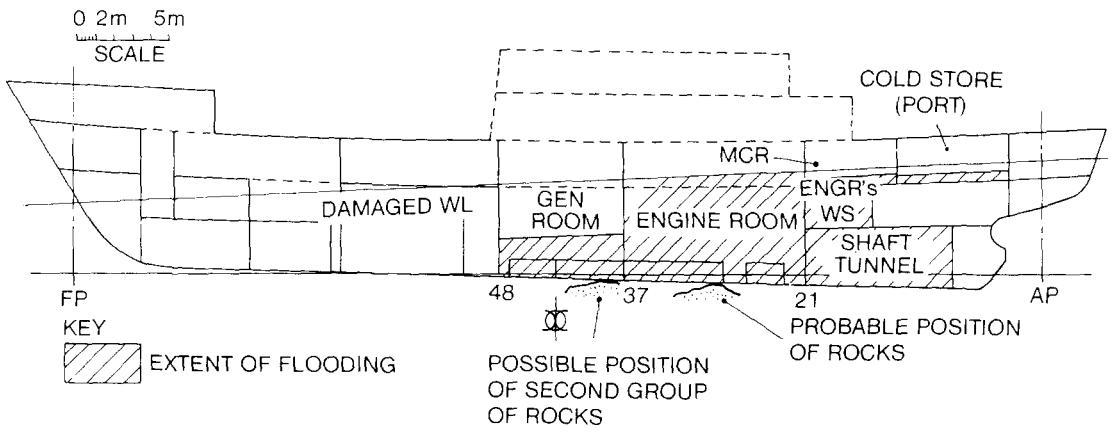
FIG. 9-SHIP CONDITION AT 1530

By around 1400 the ship was in a parlous condition and the prospects for H.M.S. *Guernsey* were poor. The tunnel, engine room and workshop were fully flooded. The generator room was flooding at about 120 tonnes per hour and secondary floodwater was invading 2 Deck aft of 37 bulkhead. All electric power had been lost. Pump capacity consisted of one diesel Spate pump (one having seized) and the equivalent of a Spate pump brought by a lifeboat. Secondary flooding was winning. Spread of flooding probably reached its greatest extent at about 1530 before the pumps started to gain after leak-stopping. The ship's condition and extent of flooding is shown in FIG. 9, with the height of tide at that time.

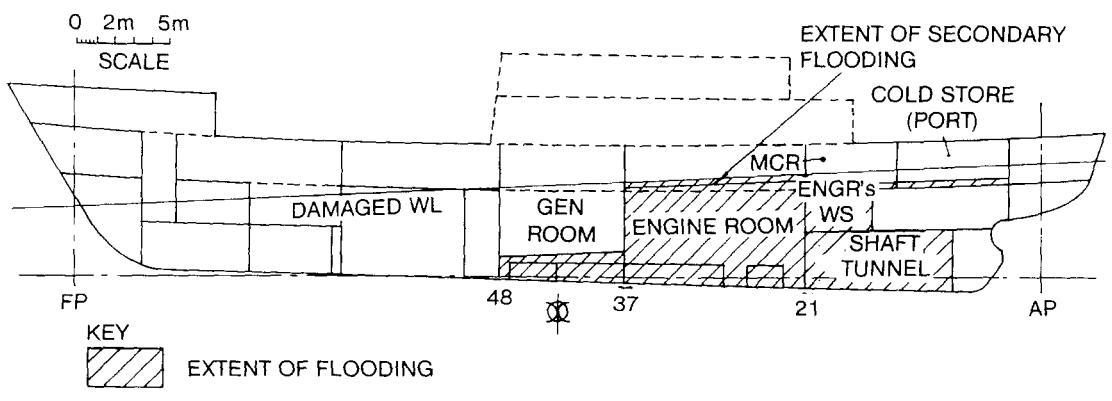
FIG. 10—Ship condition immediately after salvage

The incoming tide peaked in the period 1600 to 1640, with nominal high tide at 1621 BST. In this period the leak-stopping on 2 Deck and in the generator room allowed the pumps working on these spaces to reduce the level of water, particularly in the generator room where the level was reduced from about 1 m to about  $\frac{1}{4}$  m. The height of tide over the rocks was not enough to float the ship off but bumping was felt, indicating that the ship was almost afloat. Lines were passed to the two tugs then in attendance and at 1630 H.M.S. *Guernsey* was simply pulled off the way she came, settling in the water by a few inches once clear of the rocks. The estimated draughts and extent of free and secondary flooding are shown in FIG. 10 and the

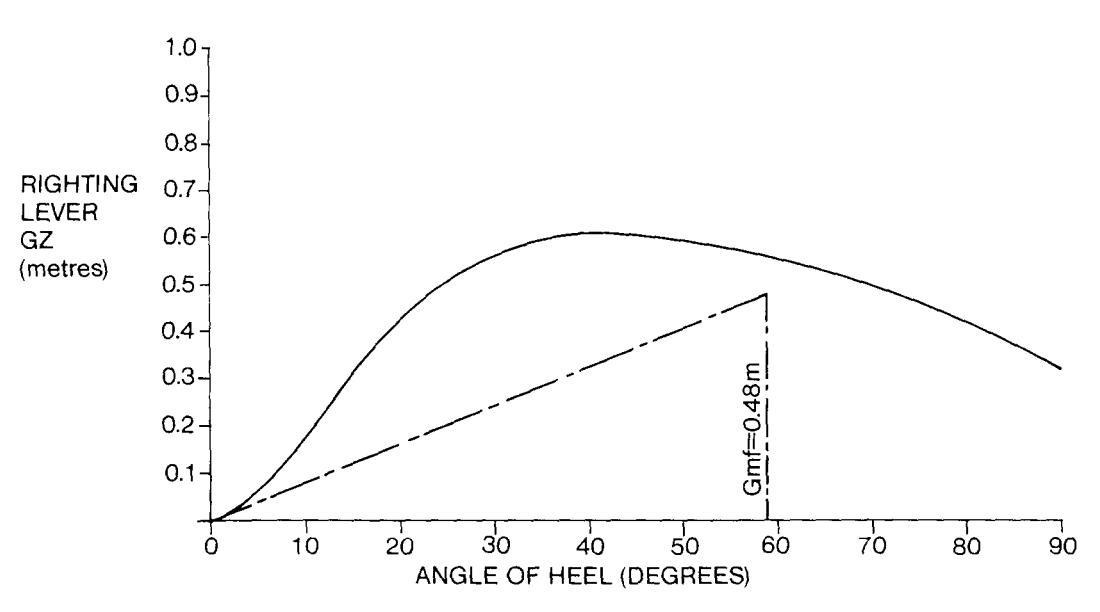
Fig. 11—Stability at salvage. This GZ curve takes account of trim and free surface effects

estimated stability characteristics are shown in FIG. 11. The reserves of buoyancy before the loss of the ship would have been inevitable were about 700 tonnes. *Guernsey* was towed into Aberdeen harbour (FIG. 12) and she was secured alongside Hall Russell's yard where she was built ten years before.
