NYLON PIPE JOINTS IN HYDRAULIC SERVICES

LIEUTENANT-COMMANDER D. H. CAMERON, R.N., A.M.I.MECH.E., M.I.MAR.E.

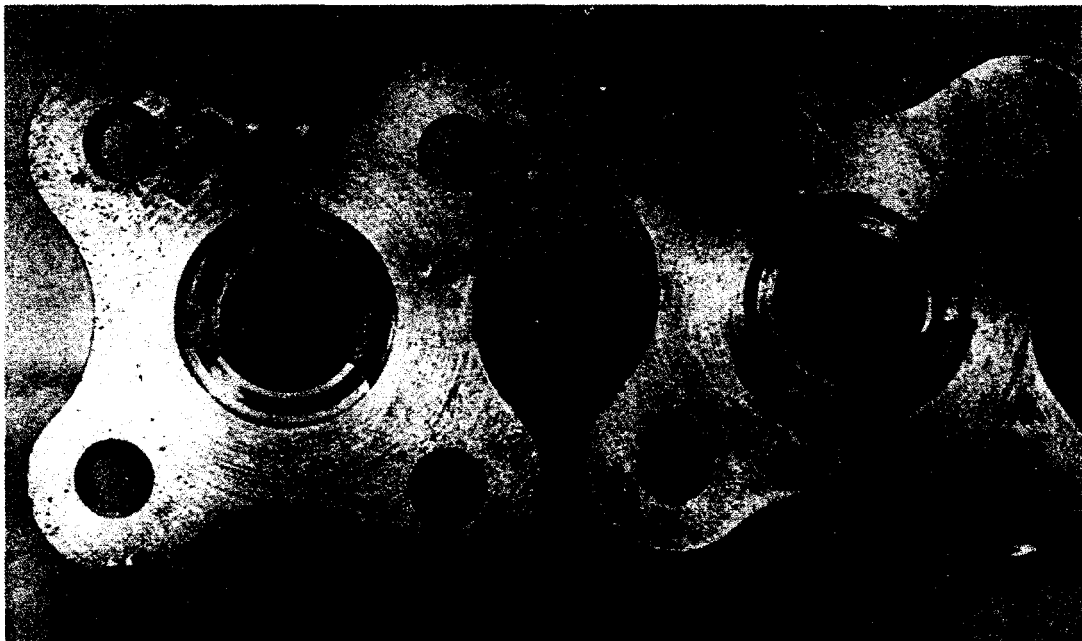
FIG. 10—DIAMOND NYLON JOINT RINGS AFTER TEST

During the misalignment tests, several leaks occurred up to three degrees and on inspection after trial, the rings were found to be broken and embedded in the bottom of the 'Vs' as shown in FIG. 10.
