# THE INSTITUTE OF MARINE ENGINEERS

1962, Vol. 74

### The Properties and Service Performance of Quarl-block Materials

W. McCLIMONT, B.Sc. (Member)\* and H. M. RICHARDSON, B.Sc.†

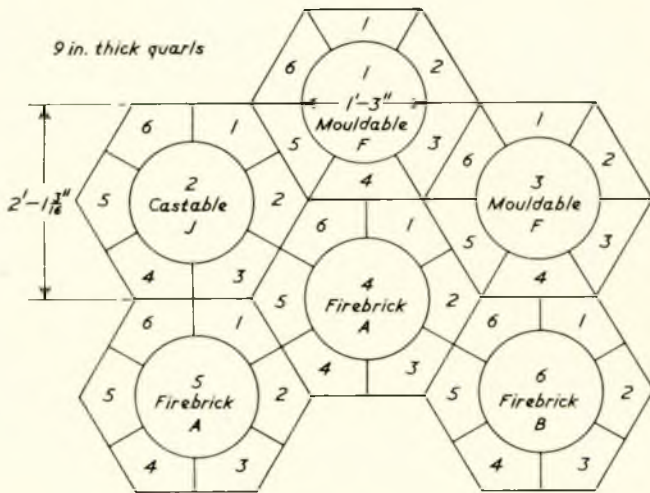
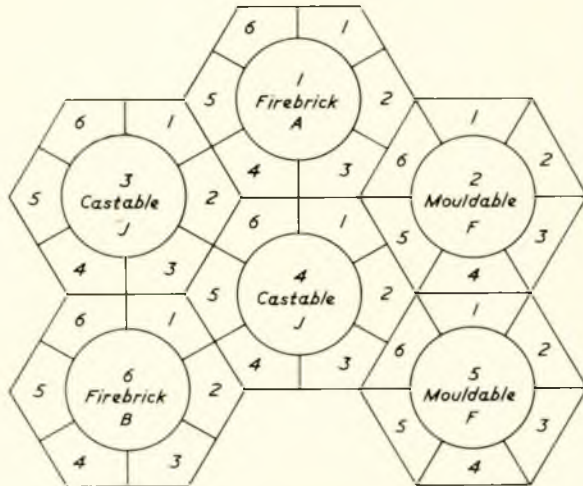
FIG. 1—Ship 1. Arrangement and size of quarls

The steamer has two Foster Wheeler D-type boilers, each with six Wallsend burners; each burner usually has six quarl bricks. The arrangement and size of the quarls are shown in Fig. 1, which also gives the materials used at the commencement of the trial in May 1957. Firebricks A and B spalled after relatively short periods of service; it was therefore possible to replace these and, at later dates, the castable quarls with castables G and V, mouldable C, sillimanite bricks, and also a castable of type H. The condition of some of the quarls in December 1957 is shown in Fig. 2, and the condition of all the quarls of the starboard boiler in April 1958 is shown in Fig. 3.

PORT—LOOKING FROM INSIDE FURNACE

STARBOARD

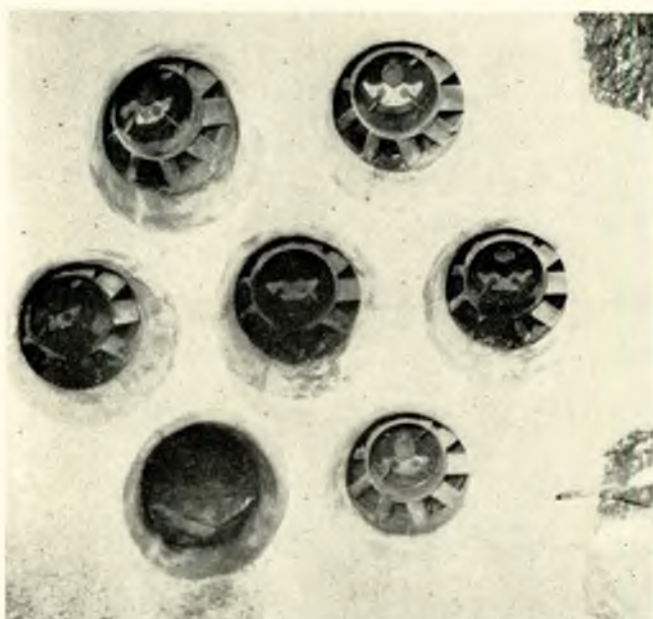
FIG. 5—Ship 2. Condition of front wall in December 1957

workman. The wall was inspected after moulding and after the first firing and both sections appeared to be in very good condition when the ship went into service on 30th December 1957. Fig. 5 shows the condition of the front wall at this time and also serves to indicate the burner arrangement. After three weeks service, in which daily sailings across the Channel had been made, the boiler was again inspected. A crack had now appeared at the junction of the two materials, but both had behaved in a similar way. The wall was in good condition, but a few small cracks had formed down the quarl cone radially, but not parallel to the wall surface. The cracks appeared in about equal numbers in the two materials, in

The boiler was again inspected on 17th April 1958; the ship was still in service, making one Channel crossing per day, except during the Easter period when extra sailings were required. Material X was still in very good condition, with some radial cracks at the quarls, but none parallel to the wall surface. Material E was now friable and weak; it had cracked parallel to the wall surface in at least two places, with the result that pieces of the rammed quarls were now loose. Carbon had been deposited on some of the cones and the poker had abraded some of material E away.

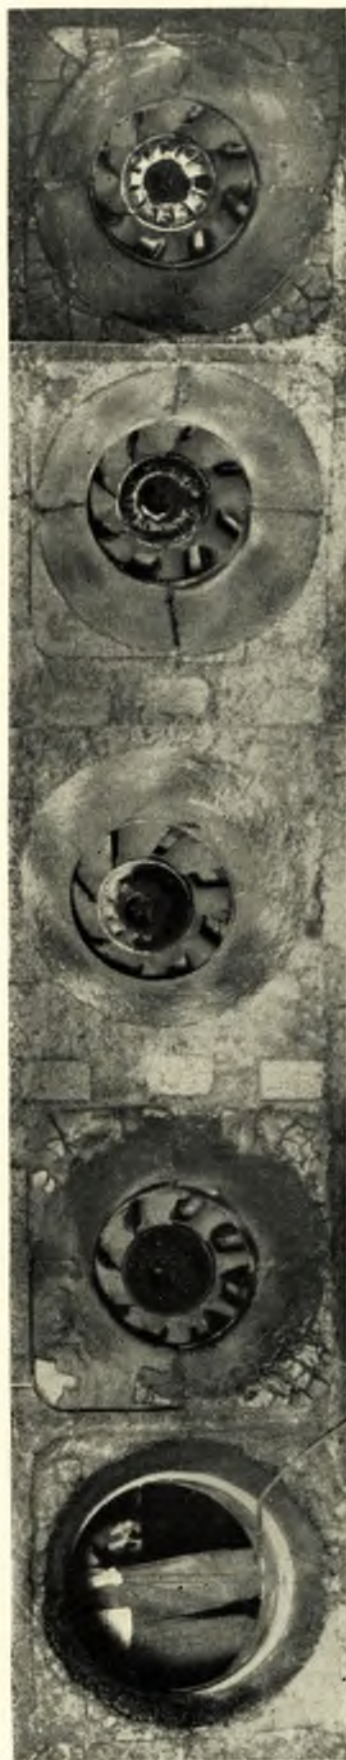
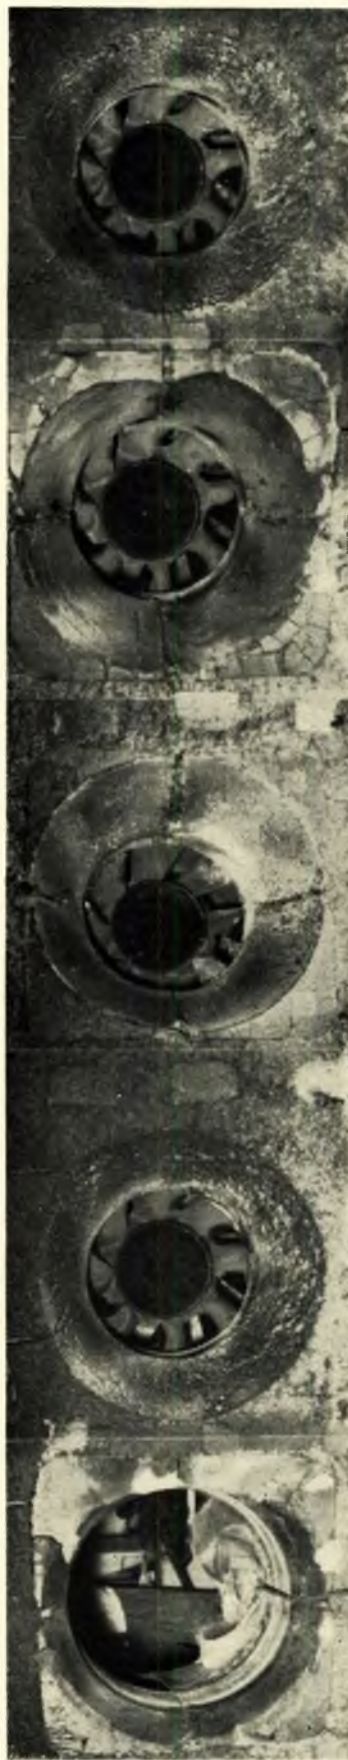
FIG. 7(a) and (b)—Ship 5. Condition of quarls in January 1958 after one return voyage

(a) Port aft boiler

(b) Starboard aft boiler

The results of the trials in the two aft boilers are shown in Fig. 6 and again the superiority of the mouldable material is apparent. The access quarls have not been included because they were different from the other burner quarls in shape and size, and cracked material could be easily displaced. However, it was very apparent at the first inspection, after only one return voyage, that castable Z was not refractory enough for the required service; the quarls had fused severely. The condition of all the quarls in January 1958 after one return voyage is shown in Fig. 7.

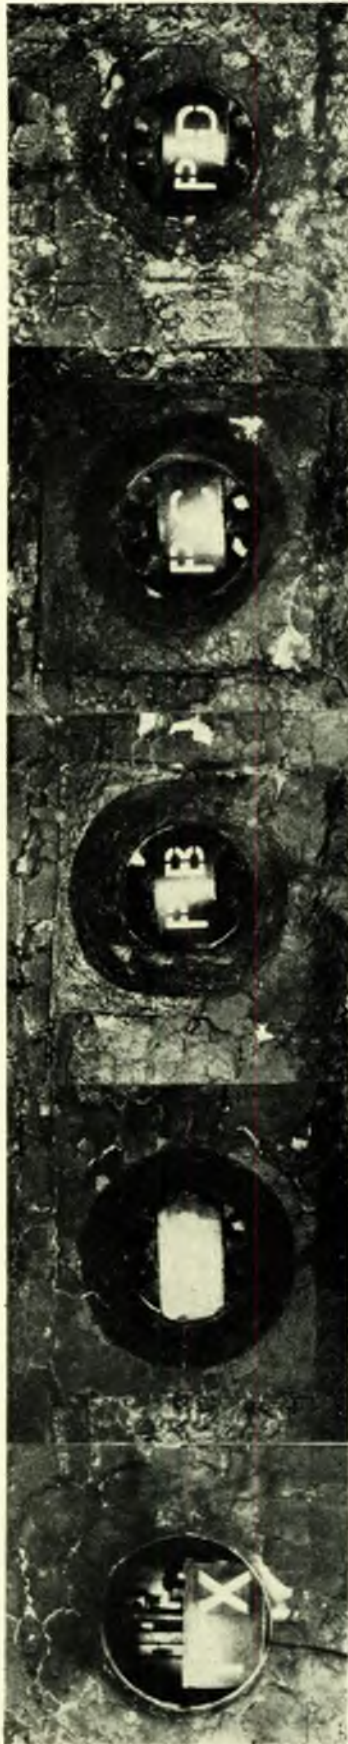
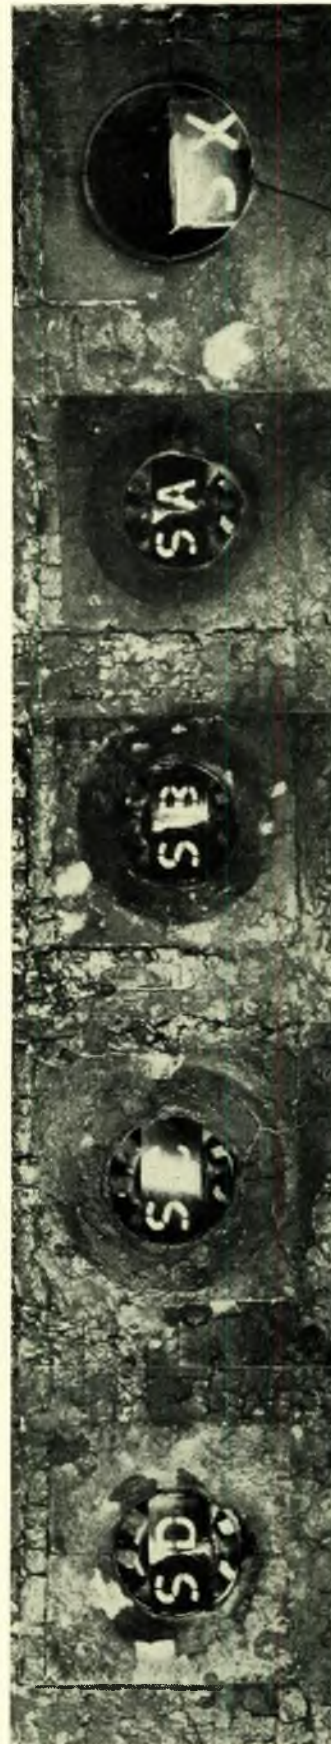
FIG. 8(a) and (b)—Ship 4. Condition of quarts in November 1959

The quarl block trial commenced when quarls were fitted in June-July 1958, and inspection was made in October 1958 after the first return journey to South Africa and subsequent inspections of the quarls were made in March, August and November 1959. The condition of the quarls in November 1959 is shown in Fig. 8.

(a) Port boiler

(b) Starboard boiler

During the quarl trials in this vessel, only firebrick A material had needed renewal, the mouldable and castable materials were still in service in November 1959. The firebrick A quarls in both access burners were renewed in March 1959 and the firebrick in No. 2 port boiler was renewed in November 1958. These quarls had been replaced by new firebrick A blocks and these again needed renewal in August 1959. The firebricks had spalled and pieces of brick had fallen away from the burner blocks. One brick quarl, starboard boiler No. 3, had given one year's service, but it was badly cracked and its condition was not good. Castable Y, of recommended service temperature 1,550 deg. C., had not developed sufficient strength during service, the surface of these quarl blocks was always friable and weak, but the blocks had not cracked although some granular material had worn away from the face of the blocks. The upper segments of castable G<sub>1</sub> quarls were in very good condition, but the surface of the lower segments had fused; heat reflected from the furnace floor or flame impingement with pick-up of fuel ash may have caused the temperature limit of this material to have been slightly exceeded. The mouldable C quarls had not spalled and had given good service; the material tended to vitrify and became very strong, but the lower surface tended to peel where a small amount of slag, or possibly wash from the upper brickwork, had been deposited. The castable and mouldable materials had been abraded away in the throat by the poker that was used to dislodge carbon; the poker had no effect on the firebrick.

The mouldable C, of similar alumina content to the firebrick A, had given better service than the latter, in spite of the fact that expansion cuts had not been made and some contraction cracks had formed. The castable materials had not spalled, but in this experiment they showed a limited tolerance to temperature; castable Y did not develop sufficient strength and castable G<sub>1</sub> tended to fuse. Practically no slag had been deposited on the quarls in this vessel and slag attack was not a cause of quarl failure.

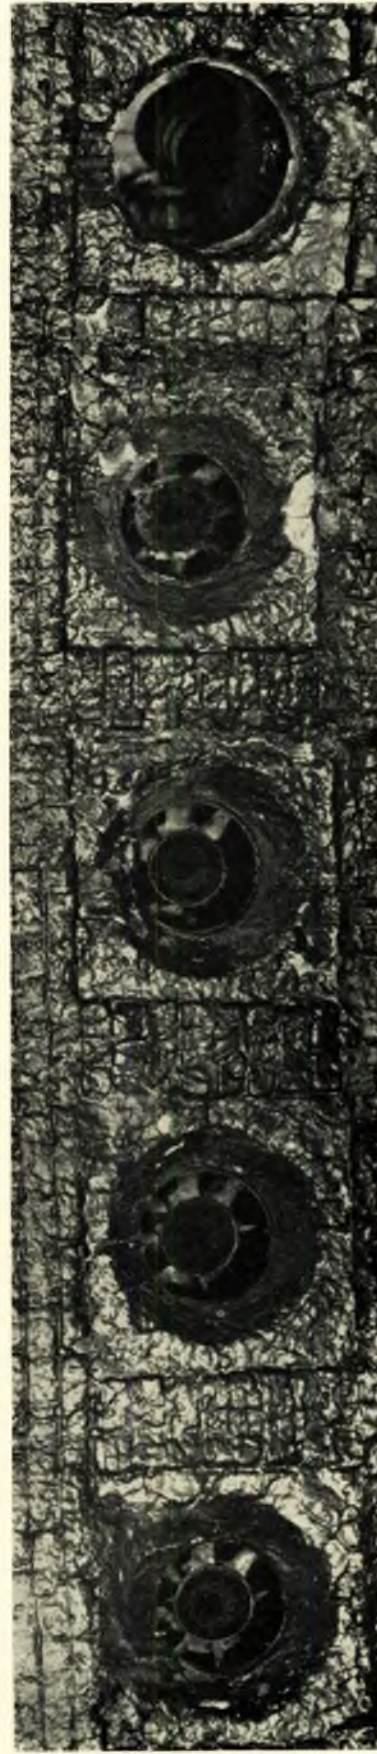
FIG. 9(a) and (b)—*Ship 5*. Condition of quarts in November 1959

(a) Port boiler

(b) Starboard boiler

The condition of the quarls in November 1959 is shown in Fig. 9.

In the port boiler the mouldable C quarls were still in position at the end of the fourth voyage, some contraction cracks had formed and the wash had caused the surface to

become glazed. This glaze tended to peel away taking mouldable material with it. Expansion cuts had not been made in the mouldable quarl and therefore contraction cracks had formed; patches were necessary at burners 2 and 5 in March 1959. Castable Y was very friable and weak after the first voyage and the firebrick A material had spalled and cracked badly at burners 3 and 4. These were replaced by brick and by chemically-bonded mouldable quarls. The chemically bonded mouldable was of similar composition to mouldable C, but the addition of a chemical bond enabled preformed quarls to be made. After only one voyage the chemically bonded material was replaced by firebrick A because insufficient strength was developed at the service temperature and the quarls tended to crumble. At this time a second chemically bonded material (containing a different bond) was installed to replace spalled brickwork in the adjacent quarl. At the end of the fourth voyage both the firebrick A, which was cracked but glazed, and the chemically bonded material were still in position. The chemically bonded material was glazed, but abraded in the throat by use of the poker.

In the starboard boiler it was necessary to rebuild the front wall and, therefore, to replace the quarl blocks after the first voyage. At this time, the firebrick A quarls were badly cracked, but glazed by the wash, and the mouldable C was in good condition. Castable G<sub>1</sub> had been attacked by the wash and was now badly fused and castable Y was again weak and friable. On rebuilding, firebrick A quarls were used around all burners except No. 4 which was built with the original type of preformed mouldable quarls. These chemically bonded quarls were removed after one voyage because they lacked strength and tended to crumble. The firebrick A quarls were badly cracked, but the wash had glazed the surface so that cracked pieces were held in position.

In this vessel the castable materials were adversely affected by the fusible wash used on the front wall brickwork. The mouldable C material again gave good service, but tended to be attacked by the fusible wash. Firebrick A was aided by the wash in that spalled pieces were held in position by the glazing of the brick surface.
