iWindCr Wireless Sensor System for Corrosion Detection and Monitoring of Offshore Wind Turbine Structures

Synopsis

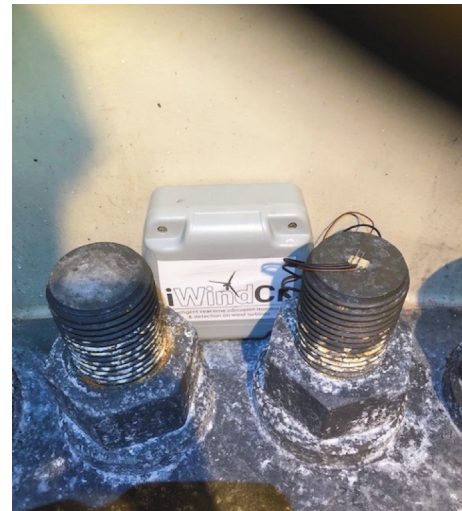
iWindCr sensor made of flexible PolyEther Ether Ketone (PEEK) was attached directly to the M72 stud (not on a polished surface) using silver conductive epoxy adhesive. **Table 1** outlines the characteristic of the sensor.

Fig.3: *iWindCr* system set-up in the MP-TP flanged connection location with the sensor attached to the M72 stud

iWindCr prototype has been trialled in one of the 116 offshore WTs in the UK's south region. The system was used to monitor electrochemical changes in connection to corrosion activities of one of the 84 M72 studs, in the MP-TP flanged connection of the WT. Adapting Scenario 2, an SD card was used to collect and store data over a one-month trial period. This pilot study aims to determine the reliability and stability of *iWindCr* system in the operating/field conditions and environment. The adequacy of data collection in connection to the sensor interface setting i.e. the frequency or number of reading and the quality of the reading needed for the OCP and ZRA analysis could also be assessed. The corrosion threshold database that has been developed extensively through in-house laboratory testing would be used

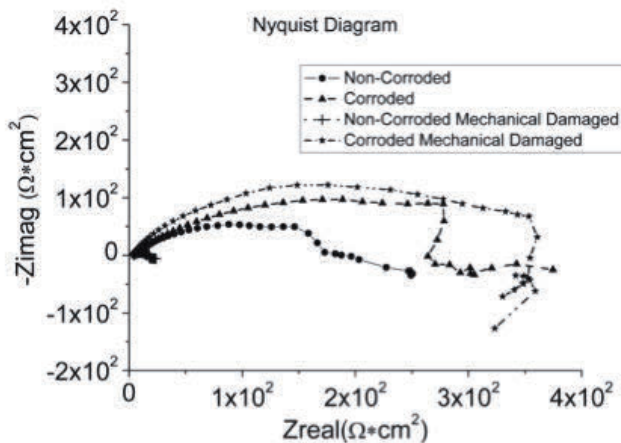
The Nyquist diagram which is a parametric plot of a frequency, and Bode diagrams that plot gain and phase responses of all the 10.9 Galvanised Steel test samples are shown in **Figures 4 and 5**.

Fig.5: Nyquist Diagram of the 10.9 Galvanised Steel Samples from the EIS analysis following the artificial seawater (SW) immersion testing
