STERN BEARINGS AND SEAL FAILURES

H. O. Koons,* M.S.N.A.M.E., M.A.S.M.E., M.A.S.T.M.

ANALYSIS OF BEARING FAILURES

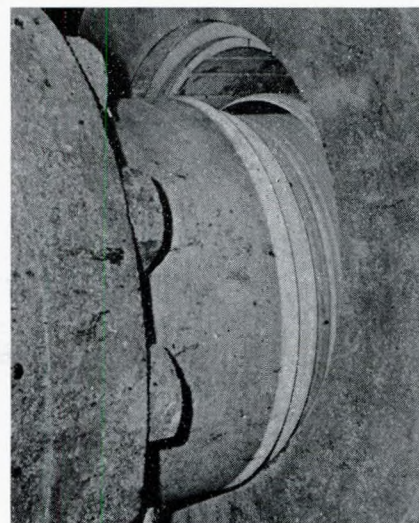
FIG. 2—Worn lignum vitae water lubricated bearing

It is difficult to define and catalogue the reasons for stern bearing failures. A review of performance records and ship histories reveal many reasons for failure. Some failed bearings exhibit characteristics of a slow failure rate, such as lignum vitae which fails primarily due to excessive wear, and rubber and plastic bearings which fail in a similar but more rapid manner. The oil lubricated bearing can fail quite rapidly under adverse conditions and is thus more sensitive to the elements which cause failure (See Figs 2, 3, 4, 5 and 6).

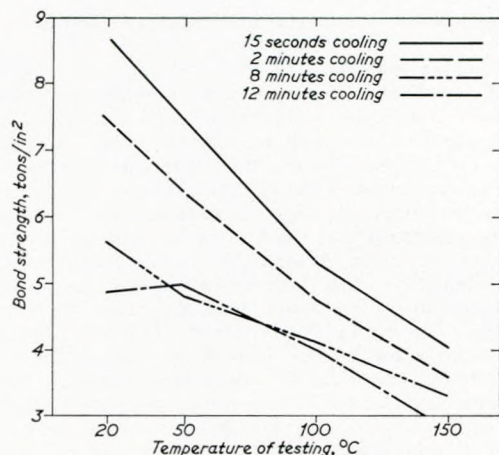
The strength of the bond is dependent upon the duration and temperatures held during the tinning operation. Representative values are shown as reported by Hedges in Fig. 7.

During the tinning cycle of a ferrous shell, an iron/tin compound will be formed at the contact line of the two metals. It is the thickness of this compound which largely affects the strength of the bond. Prolonged exposure to tin, affects the thickness of the compound. It is quite obvious that acceptable

FIG. 7—Influence of rate of cooling on bond strength

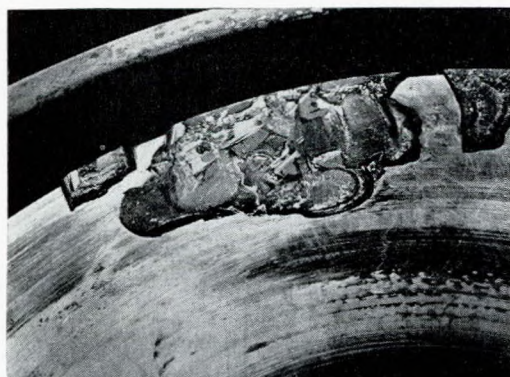
FIG. 9—Distressed area of bearing in Fig. 8
