Low-pressure cold metal spray coatings for repair and protection of marine components

M Pal^{a*} MSc CEng MIMechE

^a BAE Systems, Maritime Services, Portsmouth Naval Base, PO1 3NH, UK

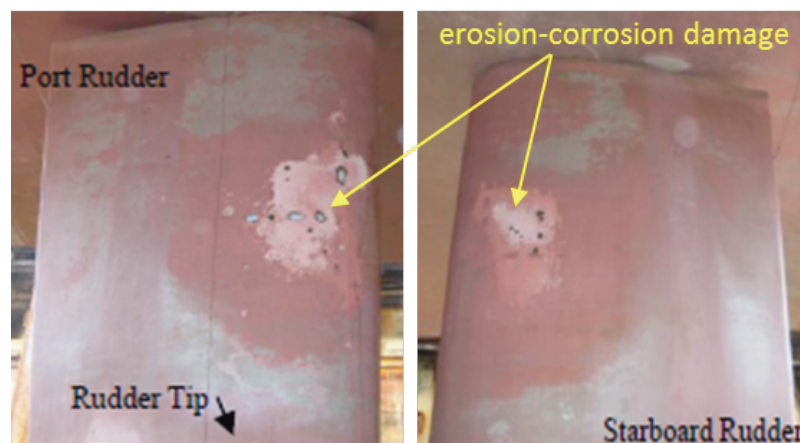
Figure 1: Synergistic erosion-corrosion damage of corvette rudders (Webb, 2017)

As discussed previously, the most devastating form of materials degradation in marine environment result from a synergy between the above mentioned material degradation mechanisms. An example of this synergy is the accelerated erosion-corrosion damage of seawater system components such as valves, pumps, pipework and condensers, and underwater propulsion and control components. The extent of accelerated erosion-corrosion damage is evident in the pictures of the Port and Starboard rudders of HMS Al-Shamikh corvette shown in Figure 1. The damage was accrued after just 40 hours of operation above 20 knots (Webb, 2017). A combination of the propeller tip vortex and the rudder sheet cavitation caused the erosion of the inboard surfaces of the Port and Starboard rudders. The exposure of a freshly eroded surface to the seawater will result in severe corrosion attack that will further weaken the material surface for additional erosion attack - this will cause a vicious cycle of erosion-corrosion synergy resulting in extensive damage of the rudder material.

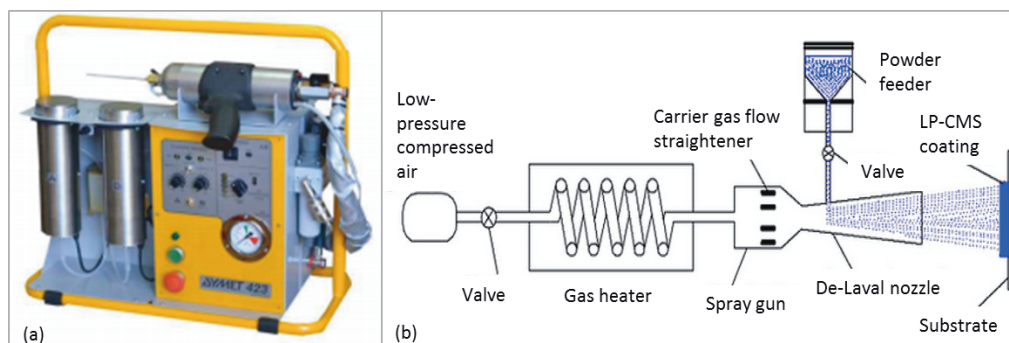
Figure 2: (a) Dycomet™ D-423 LP-CMS coating system, (b) a schematic of LP-CMS coating process adapted from (Papyrin, 2007)

A picture of the Dycomet™ LP-CMS coating system and a schematic of the coating process are shown in Figure 2 (a) and (b) respectively. To achieve the coatings deposition the metal particles are accelerated to very high velocities in a stream of carrier gas. The gas is heated before it enters a convergent–divergent de-Laval type nozzle. The feedstock powder is injected in the stream of carrier gas as it accelerates and cools down in the divergent section of the nozzle due to expansion. The accelerated solid particles then deform plastically upon impact with the substrate to form a dense coating.

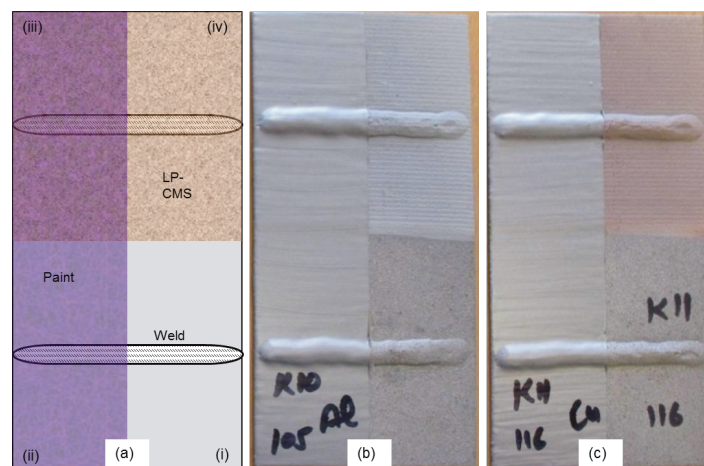
Figure 4: (a) A schematic of LP-CMS test samples, (b) Al-alloy, (c) CuZn-alloy coated test samples

For corrosion test, one-half of the test panel was coated with Intershield-300 paint coating (320 μ m DFT) as shown in Figure 4 (a). This resulted in distinct 4-quadrants on the test panel, comprising: ‘quadrant (i)’ in the bottom right-hand corner – the grit blasted bare steel substrate, and then clockwise from there, ‘quadrant (ii)’ – paint coating + steel substrate, ‘quadrant (iii)’ – paint coating + LP-CMS coating + steel substrate, and ‘quadrant (iv)’ LP-CMS coating + steel substrate.

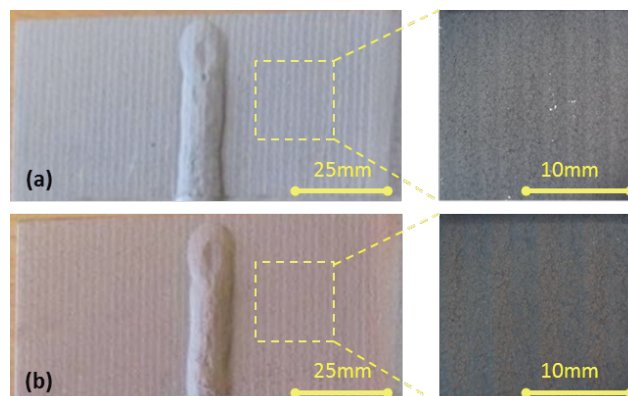
Figure 5: Visual and stereoscope inspection of (a) Al-alloy coating, (b) CuZn-alloy coating

The coating test samples shown in Figure 4 (b) & (c) and Figure 5 (a) & (b) were examined visually with and without aided magnification. Both, Al-alloy and CuZn-alloy, coatings appeared free from any form of surface imperfections such as inclusions, blisters, lifting, cracking or spalling. The direction of the coating spray and ridges from the spray step-over were evident on the surface of both coatings.

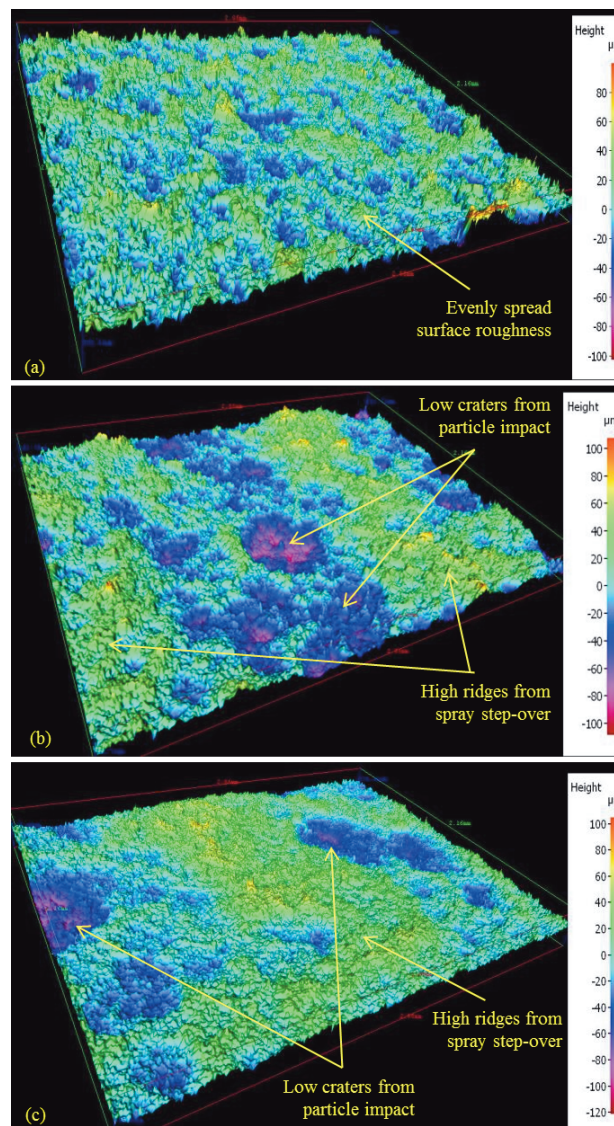
Figure 6: 3D surface scans (3.0 x 2.2 mm): (a) grit blasted steel substrate, (b) Al-alloy coating, (c) CuZn-alloy coating

In this study, for the sake of simplicity only the ' R_t ' surface roughness parameter was considered, it represents the sum of the deepest valley and the highest peak in the measured surface. The measured values of ' R_t ' were 132 μm , 170 μm and 142 μm for the grit blasted substrate, Al-alloy coating, and CuZn-alloy coating surface respectively. The surface of LP-CMS coatings was rougher than the bare steel substrate. The increase in the surface roughness of the coatings is likely to have been caused by the micro-impacts resulting from the sprayed particles and the surface undulation caused by the step-over raster of the spray gun. The scale and spread of the roughness features in the surface of the LP-CMS coatings is apparent from the 3D surface maps shown in Figure 6 (measured with an infinite focus Alicona microscope).

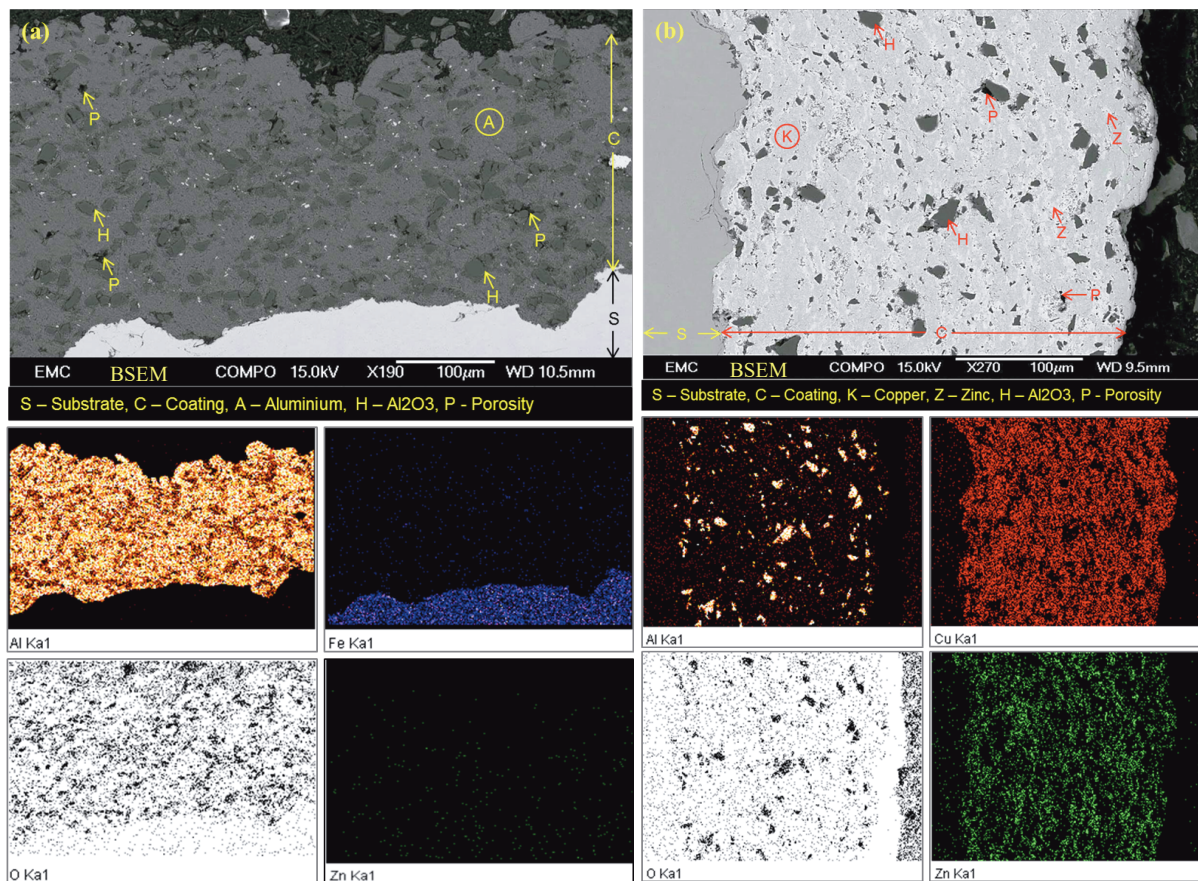
Figure 7: BSEM and EDX images of microstructural analysis, (a) Al-alloy coating, (b) CuZn-alloy coating

The backscattered scanning electron (BSEM) images and EDX elemental maps of the Al-alloy coating are shown in Figure 7 (a). The dark-grey Al_2O_3 (alumina) particles are distributed evenly within the overall light-grey Al matrix of the coating. The very dark black spots represent the porosity, which is mainly concentrated around the alumina particles and at the substrate-coating interface. It is observed that the coating porosity may have been caused by the shadowing effect from the alumina particles. The darker black/brown areas in 'O' and 'Al' Ka1 elemental maps shows the spread of alumina particles. The light yellowish/orange colour areas in 'Al' Ka1 map represent the Al matrix. The two major constituents of the Al-alloy coating, Al and alumina, are distributed well within the coating matrix.

The BSEM image and EDX elemental maps of the CuZn-alloy coating are shown in Figure 7 (b). In the BSEM image, copper is shown as light grey colour, zinc as bright whitish colour, alumina particles as dark grey irregular shape spots, and very dark spots (mainly around alumina particles) is the porosity. The EDX elemental maps also show a good distribution of the coating main constituents – Cu, Zn, and alumina. The dark black spots in 'O' Ka1 elemental map and bright orange spots in 'Al' Ka1 map represents the alumina particles. The green colour in 'Zn' Ka1 and red colour in 'Cu' Ka1 maps represents the distribution of Zn and Cu respectively.

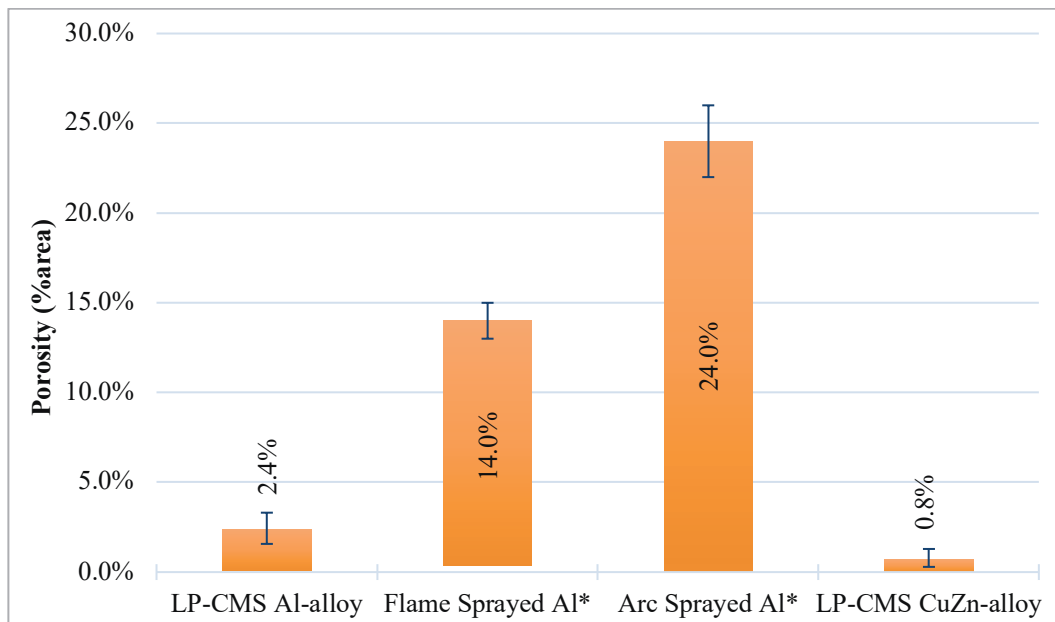
Figure 8: Porosity comparison of LP-CMS and flame/arc sprayed TMS coatings (*Kawaguchi et al, 2017)

The porosity of LP-CMS coatings was measured with an image analysis technique similar to the one described in ASTM E2109-01 “test methods for determining area percentage porosity in TMS coatings”. Several images of the coating microstructure were analysed with ‘ImageJ’ software. The results of the average area porosity of the coatings are presented in Figure 8. The porosity in Al-alloy coating was measured ~2.4%. In comparison, the flame and arc sprayed Al-alloy coatings have been reported to possess ~14% and ~24% porosity respectively (Kawaguchi et al, 2017). The porosity in CuZn-alloy coating was measured as low as 0.8%. It is desirable to have the coating porosity as low as possible to achieve better mechanical and corrosion performance in the marine environment.

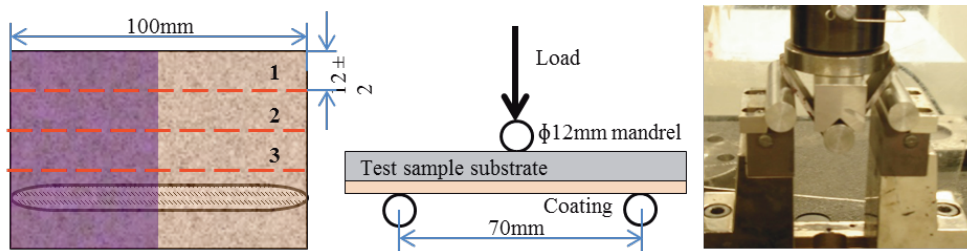
Figure 9: 3-point bend test used in qualitative assessment of adhesion and ductility of LP-CMS coatings

A 3-point bend test was performed as per ASTM E290 standard to assess adhesion and ductility of the LP-CMS coatings. A schematic of the 3-point bend test and the test samples is shown in Figure 9. For both coatings, 3-off test samples were bent transverse to the direction of the coating deposition. The test samples were bent over a $\phi 12$ mm stainless steel mandrel with coating facing away from the mandrel in one rapid downward stroke (10 mm/sec) to produce $\sim 110^\circ$ bend. The coating is considered to have good adhesion and ductility if it does not completely delaminate from the substrate. The through thickness cracks in the coating along the bend edges are considered acceptable as long as there is no coating delamination from the substrate.

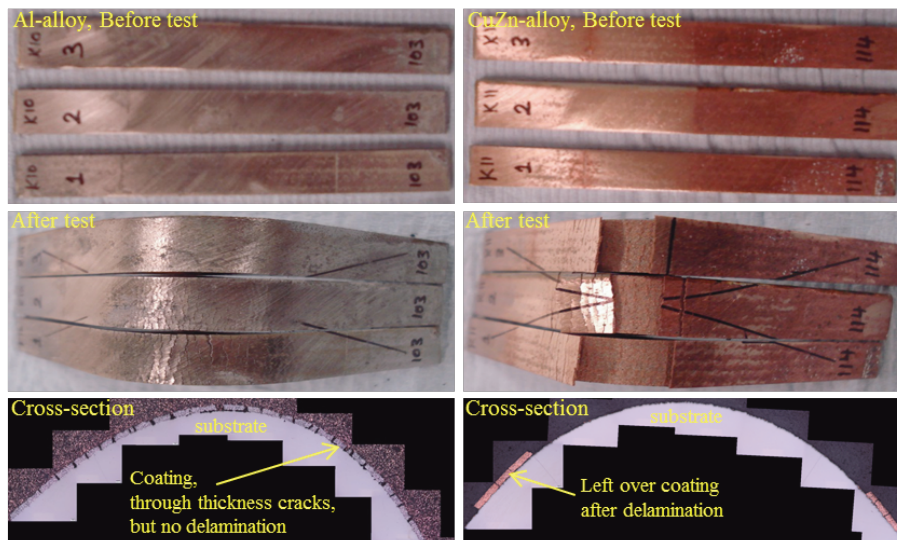
Figure 10: Al-alloy and CuZn-alloy test samples after 3-point bend test

As shown in Figure 10, the Al-alloy coating showed the best adhesion and ductility. There were some through thickness cracks in the coating along the bent radius, but no coating delamination from the substrate. The through thickness cracks did not stretch along the whole width of the test sample, they were rather concentrated at the side edges where the stresses and strains were the highest due to bending. However, CuZn-alloy coating did show complete delamination from the substrate along the bent radius. A pull-off adhesion test

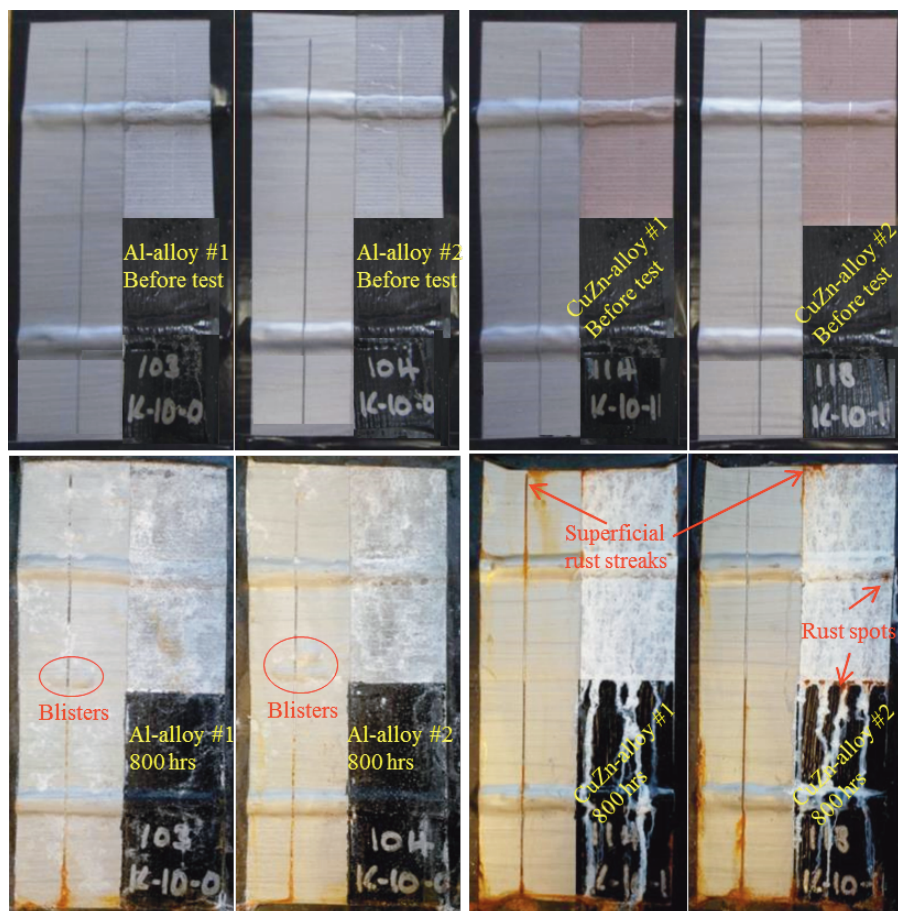
Figure 11: Accelerated salt-spray (ASTM B117) corrosion testing of Al-alloy and CuZn-alloy LP-CMS coatings

For Al-alloy coating ‘quadrant (iv)’ showed copious amount of clear gel like Al hydroxide on its surface after 800 hrs of salt spray test, but there were no rust marks on the coating surface as is shown in Figure 11. This implied that the Al-alloy coating was protecting the substrate underneath from the corrosion. On quadrant

(iii) Al-alloy coating with scored paint coating, there were blisters around the scribe damage in the paint coating. The forming of blisters in the paint coating caused accelerated depletion of the Al-alloy coating underneath. This is a well-understood form of corrosion in marine environment (Sumon et al, 2013). The blisters started to grow parallel to the substrate after just 96 hours of salt spray. However, when the blisters in the paint coating were taken-off, no corrosion to the steel substrate underneath was observed, but the Al-alloy coating under the blisters was fully consumed. In quadrant (ii) as expected, the steel substrate corroded extensively along the scribed damage created in the paint coating.

For CuZn-alloy coating, 'quadrant (iv)' also showed large build-up of Zn hydroxide on the coating surface. The zinc from CuZn-alloy coating sacrificially protected the steel substrate and the more noble element 'copper' within the coating matrix. Test sample #2 showed some rust spots close to the root of the weld seam and on the border with the painted 'quadrant (i)'. The other rust streaks on the test panel were superficial, likely to have been caused by the poor sealing of the side edges and back surface of the steel substrate. Further investigation of the rust spots on the test sample #2 confirmed there was a defect in the CuZn-alloy coating close to the root of the weld seam. The shadowing of coating spray by the weld seam possibly caused the defect in the coating. The paint coating applied to 'quadrant (i)' did not fully seal the border with the CuZn-alloy coating, thus causing spots of local corrosion on the unprotected steel substrate. The results of accelerated salt-spray testing (atmospheric corrosion) showed that both, Al-alloy and CuZn-alloy, coatings will sacrificially protect the steel substrate.

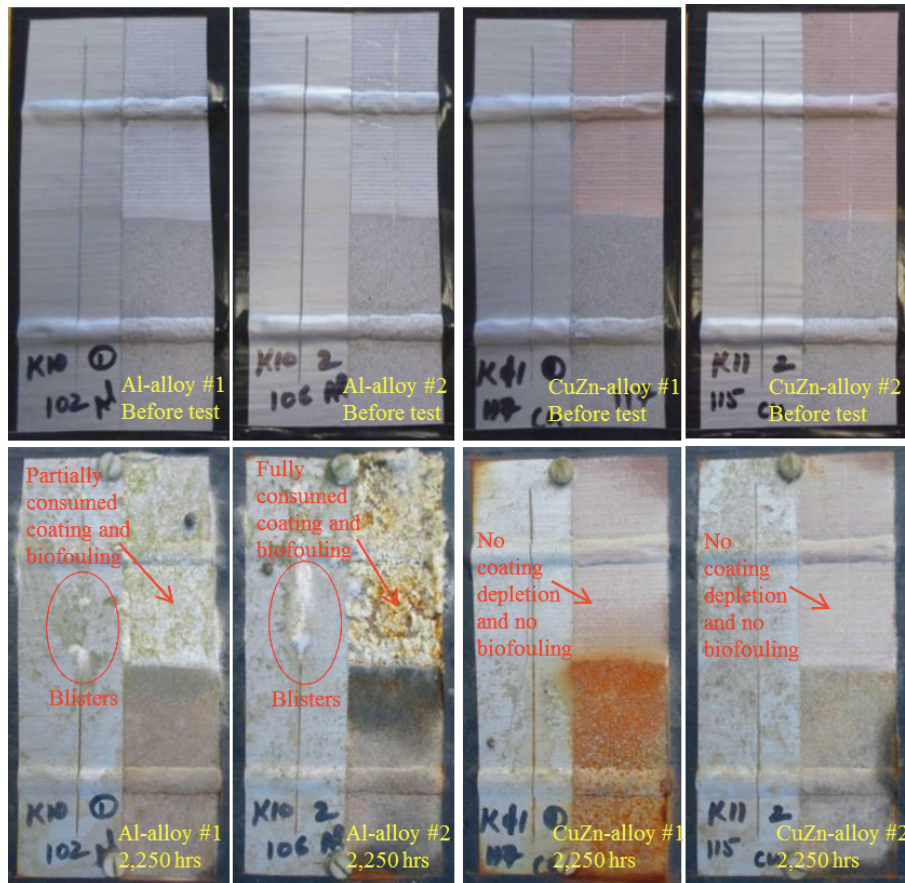
Figure 12: Natural immersion corrosion testing of Al-alloy and CuZn-alloy LP-CMS coatings

The CuZn-alloy coating showed no signs of depletion and no build-up of biofouling at all after 3 months of immersion. The coating appeared in as good condition as it was before the test. The zinc from the CuZn-alloy coating sacrificially protected the steel substrate, and copper prevented the build-up of biofouling. The bare steel 'quadrant (i)' on sample #1 rusted because of the sodium chloride drying on its surface. This test sample spent 1/3rd of its total test time out of the seawater.

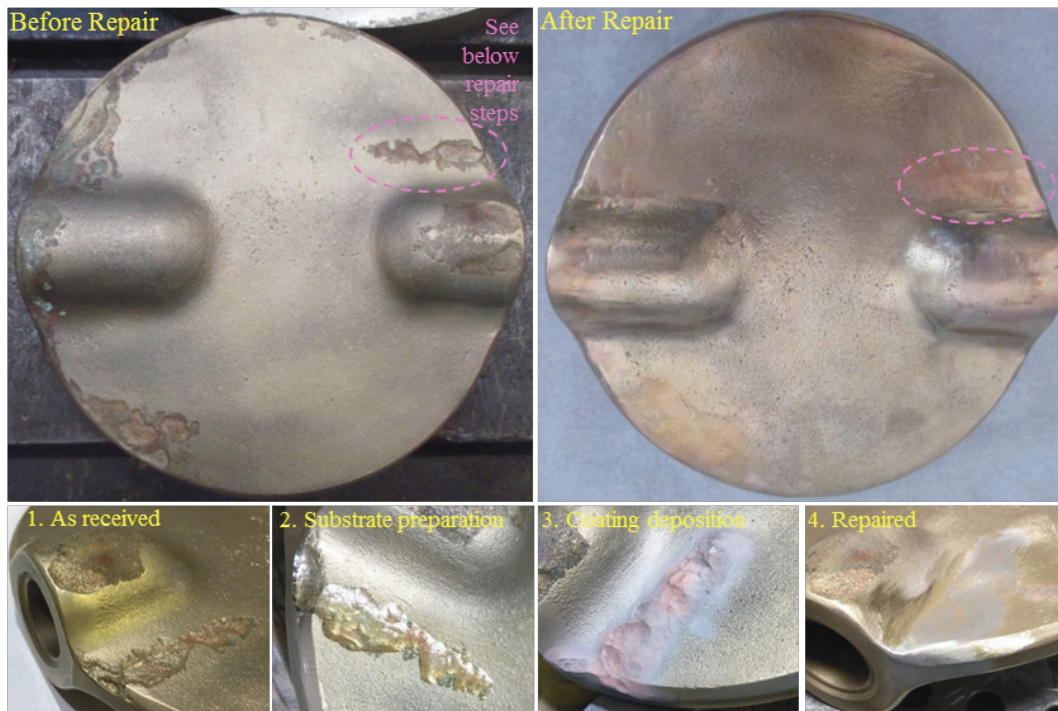
Figure 13: Repair and restoration of a seawater valve disc with LP-CMS coatings

A seawater valve disc before and after the LP-CMS coating repair is shown in Figure 13. The bronze valve disc had extensive erosion-corrosion damage, which in places was up to 2 mm deep. The damaged surface/profile of the valve disc meant that it was not sealing properly with the valve seat, thus passing seawater when it should not be in the fully shut position.

The damaged areas in the valve disc were locally grit blasted or prepared mechanically to receive CuZn-alloy coating. The main steps of LP-CMS repair process are also shown in Figure 13. The repaired valve disc passed two qualification tests: non-destructive dye penetrate test was performed to check whether there were any defects in the repaired areas, and 1.5 x operating pressure test was performed to check the repaired valve disc will operate safely in a functional system valve. There is now a plan to install the repaired valve disc on a harbour ship as part of a minor trial.

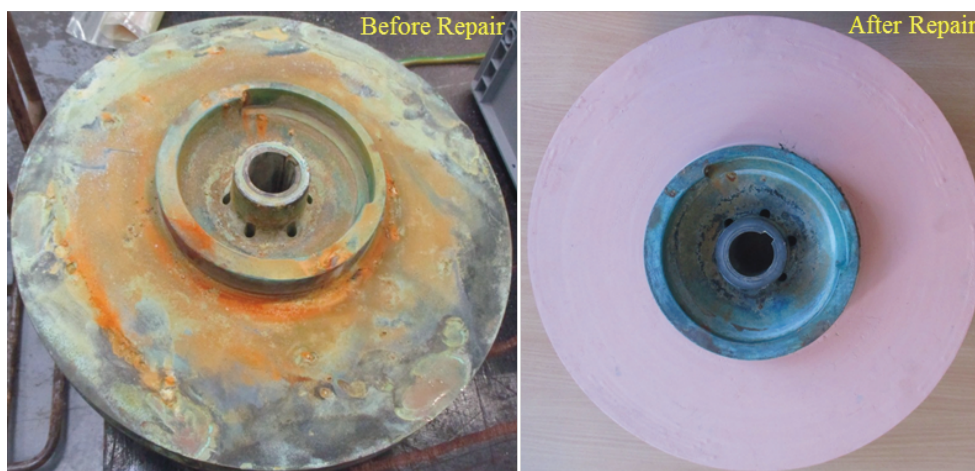
Figure 14: Repair and preservation of a HPSW pump impeller

High-pressure seawater (HPSW) pump impeller before and after LP-CMS repair and application of an antifouling coating is shown in Figure 14. The bronze impeller had extensive material degradation in form of both shallow and deep corrosion pits. The damage appeared to be similar to microbial induced corrosion (MIC). The stagnated seawater conditions created by infrequent operation of some HPSW pumps can leave them vulnerable to MIC attack.

The damage in the impeller disc was repaired with CuZn-alloy coating and then a $\sim 100\ \mu\text{m}$ Cu-alloy coating was applied as an anti-microbial preservation surface. The reasoning for using Cu coating was that it will function as an anti-microbial surface thus preventing the attack of MIC. The sprayed Cu coating is fully dense, therefore, it is expected that it will not cause any worse release of Cu ions than the commonly used Cu and CuNi90/10 tubing in on-board seawater systems.

Unfortunately, the impeller repaired in this case study had some large fatigue cracks in the disc and the impeller hub. Although, the cracks were repaired, the impeller is considered unsafe for any in-service minor trials until further testing is done to validate the integrity of the repair scheme. However, this case study does show that it is possible to deposit functional coatings such as antifouling Cu coating on a component to reduce the risk of in-service material degradation such as MIC. Other customised surface engineering coatings can be applied with the LP-CMS coating process to target the specific material degradation mechanisms and operation environments.
