THE VANGUARD CLASS MAIN CIRCULATING WATER PUMP SUPPORT ARRANGEMENT

M.W. BARBOUR, BSC (HONS), CENG, MIEE
(*ASLTEC Ltd, MCWP Project Manager*)

ABSTRACT

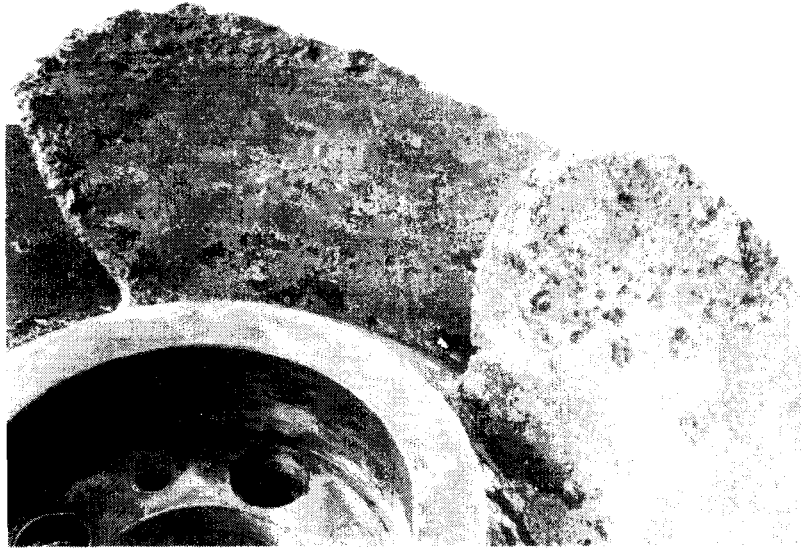
FIG.3 CORRODED NAB IMPELLER

Pump impellers are made from Nickel-Aluminium Bronze (NAB) and have exhibited high corrosion rates, up to approximately 300g/year (FIG.3). The resulting loss of profile adversely affects pump performance in terms of head, flow rate, motor speed, temperature and noise. The worst case resulted in an impeller running out-of-balance. Impeller corrosion is life limiting.

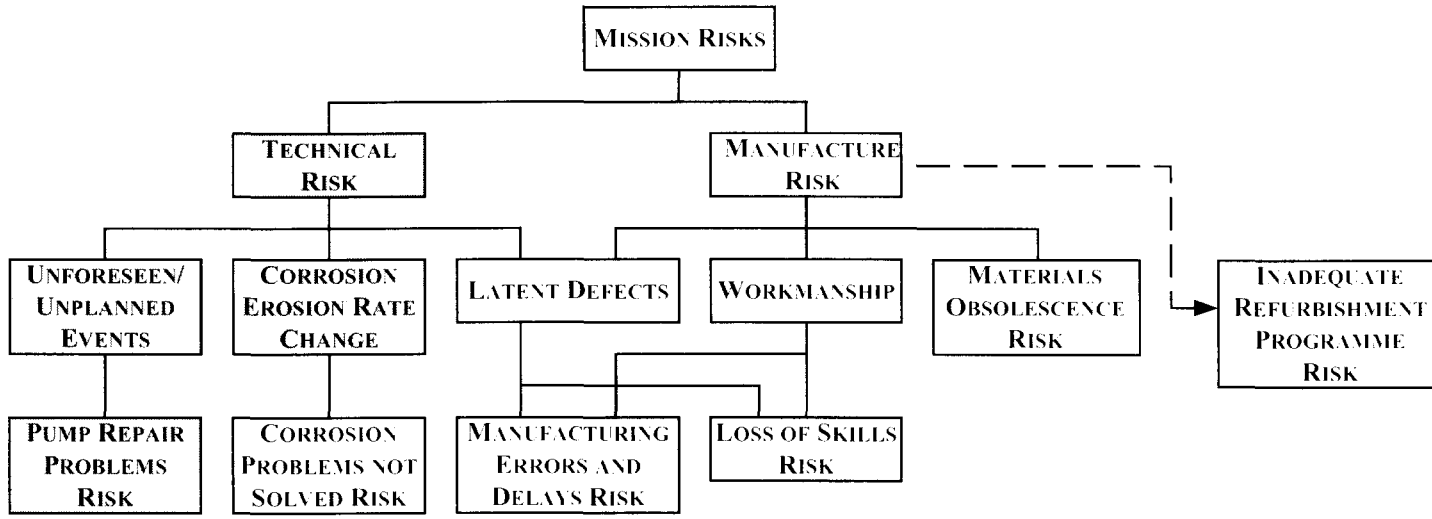
Fig 4 GENERIC RISKS

Risk management forms an integral part of the Support Arrangement and a common project risk register was established at the outset to record the key risks for both ALSTEC and other Stakeholders. An output from the management tree is shown in (FIG.4).

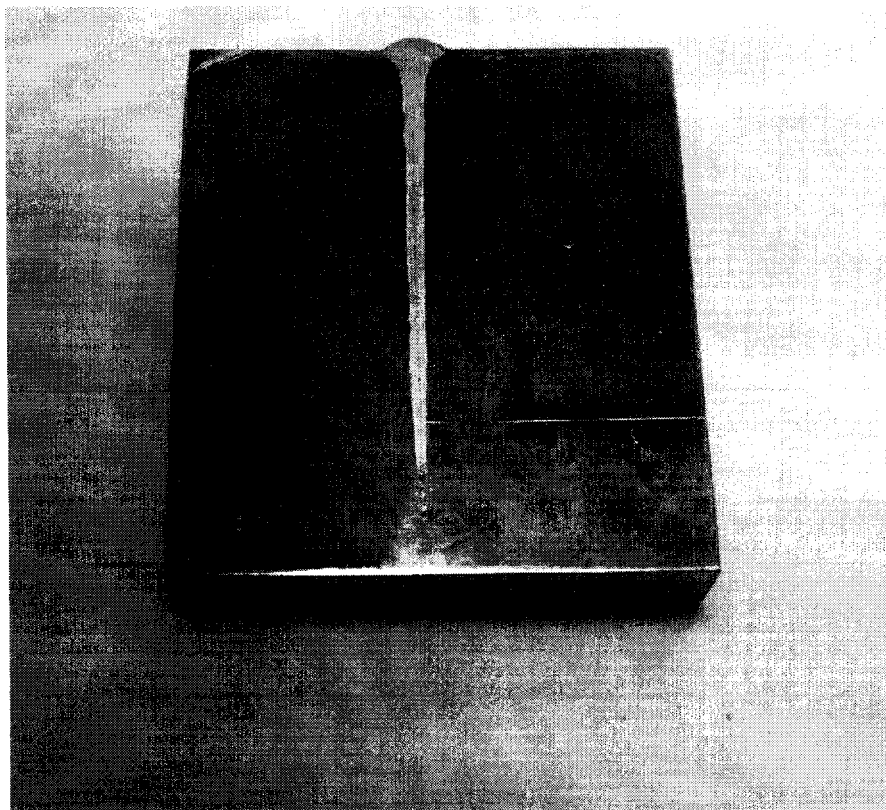
FIG.5 MACRO SECTION THROUGH A TEST EB WELD

The assembly is carefully cleaned and aligned prior to EB welding. The power, feed rate and position have to be carefully controlled during the welding process, since the EB produces a thin tapered weld approximately 0.5mm in thickness at the root (Fig.5).
