**LLOYD'S REGISTER'S TECHNICAL
INVESTIGATION DEPARTMENT
SOME INTERESTING INVESTIGATIONS
AND
EXPERIENCE GAINED
FROM
50 YEARS OF OPERATION**

J.S. CARLTON
and

I. BANTHAM
(*Lloyd's Register Marine Division*)

This is an edited version of the paper first published in the Transactions of Lloyd's Register's Technical Association, Session 1997/8, October 1997.

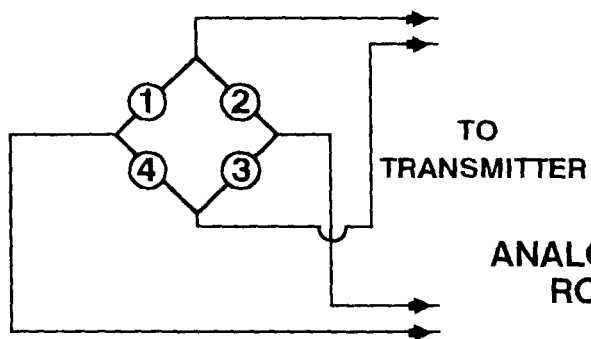
TYPICAL WIRING DIAGRAMS OF STRAIN GAUGES

ANALOGUE RECORD OF TOOTH ROOT BENDING STRAIN

FIG. 8—Gear tooth strain measurements

To interpret the large quantities of measured data satisfactorily, computer based statistical techniques are employed in order to separate the mean load distributions from the tooth to tooth variations inherent in the meshing process. In these trials the absolute strain levels are of less importance than their qualitative variation with loading and running conditions.

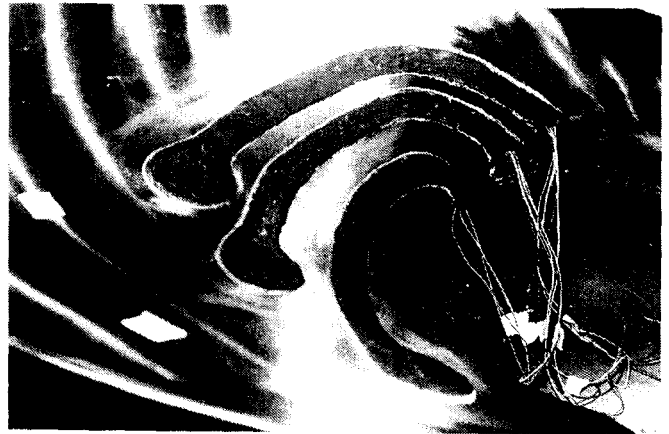
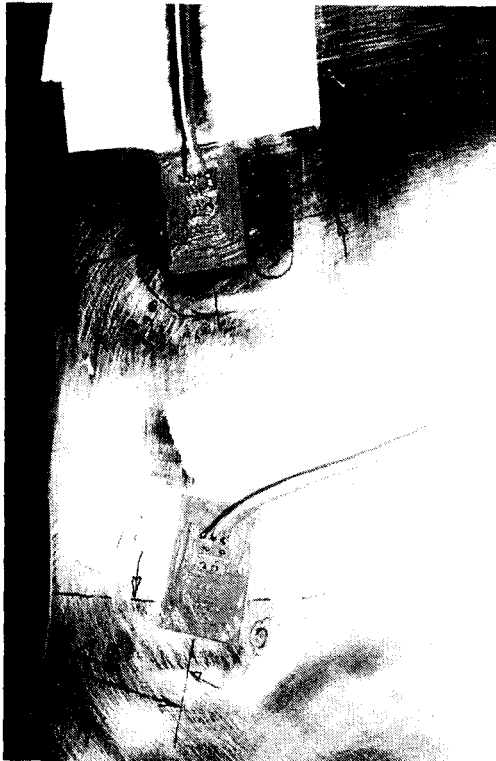
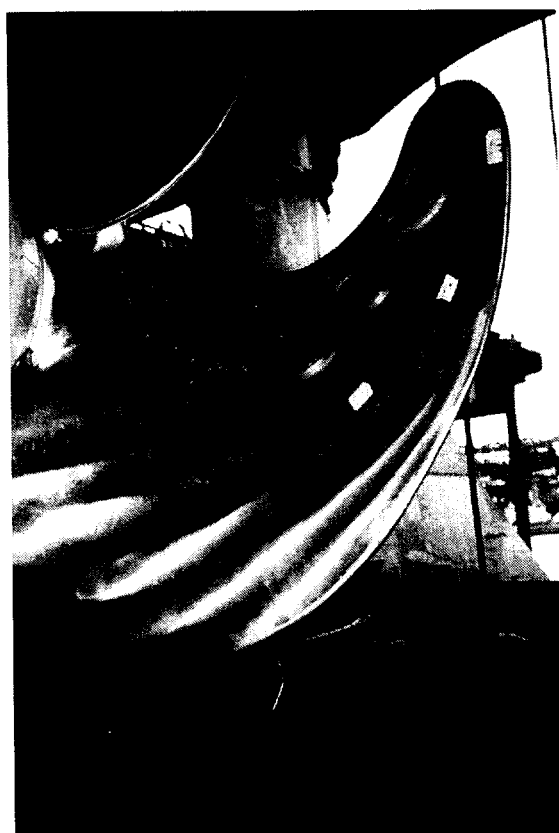
FIG. 10—STAGES IN THE INSTRUMENTATION OF PROPELLER BLADES

FIG. 10—
STAGES IN THE INSTRUMENTATION
OF PROPELLER BLADES

To carry out blade strain measurements the propeller is normally marked out and gauged in a dry dock, preferably with the propeller removed from the shaft although this is not a constraint on the use of the method. Following the gauging process the waterproofing and cavitation resistant coatings are applied. This centres around a two-coat protective system for the strain gauges and their signal leads. The signal leads from the gauges are connected to individual FM transmitters housed in a purpose designed casing mounted on the propeller boss at either the forward or after end, depending on the space available. From there the signals are led to a common transmitting aerial mounted on the forward end of the boss under the rope guard. Facing it, is a receiving aerial which can be mounted up to 20 mm distant. The FM signals are transmitted across the water gap, and then conducted through leads, protected by metal conduit, around the stern of the ship to the recording instrumentation. The collage of pictures in (FIG. 10) shows the various

instrumentation stages. Although subjected to hostile conditions and installed under less than ideal conditions, the protective encapsulation on the propeller blades generally survives for several months at sea. Notwithstanding its successful use in measuring propeller blade strains, the method has also been used for measuring bending strains in the shafting aft of the stern seal and can be applied to other similar situations in hostile environments.

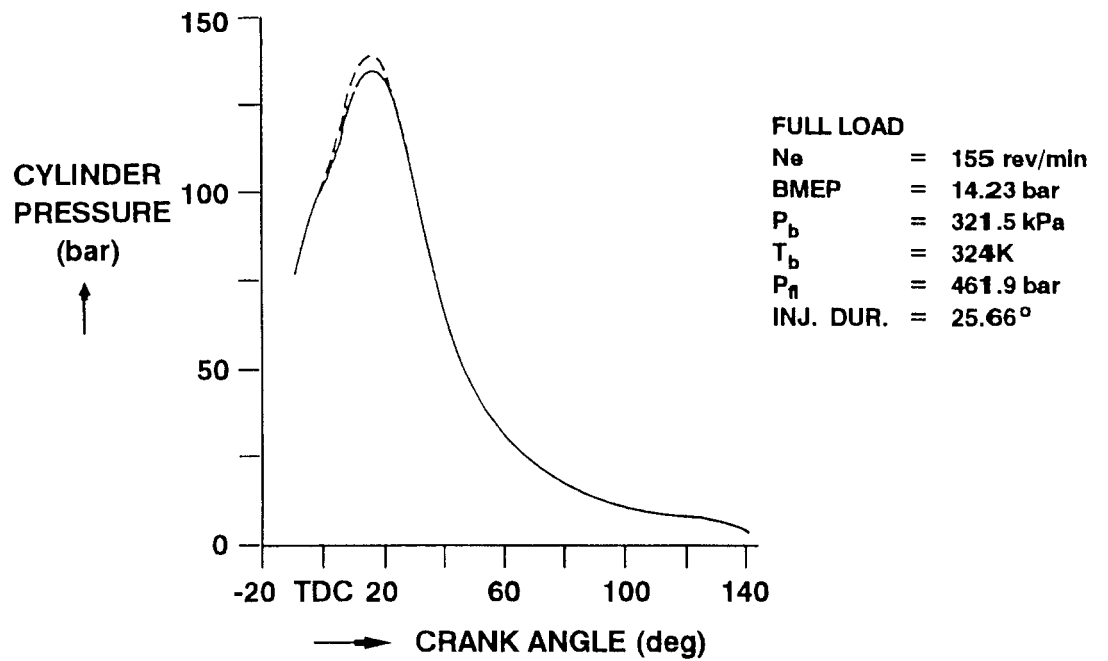
FIG. 16—COMPARISON OF MEASURED AND PREDICTED CYLINDER PRESSURE AND EXHAUST EMISSIONS FOR THE TWO-STROKE ENGINE AT FULL SPEED, EXPRESSED ON VOLUMETRIC, DRY BASIS AND CORRECTED TO 15% OXYGEN

The MERLIN-DEEPC software is a one dimensional, transient capability primarily developed for engine performance evaluation and exhaust gas emissions prediction from a wide range of diesel engine and pressure charging systems. The range of engine types that can be modelled embraces high, medium and slow speed engines together with flow path modifications such as, for example, exhaust gas recirculation. (FIG. 15) shows a typical MERLIN idealization of a diesel engine while (FIG. 16) shows a comparison of the experimentally measured and predicted results for a two-stroke marine diesel engine.

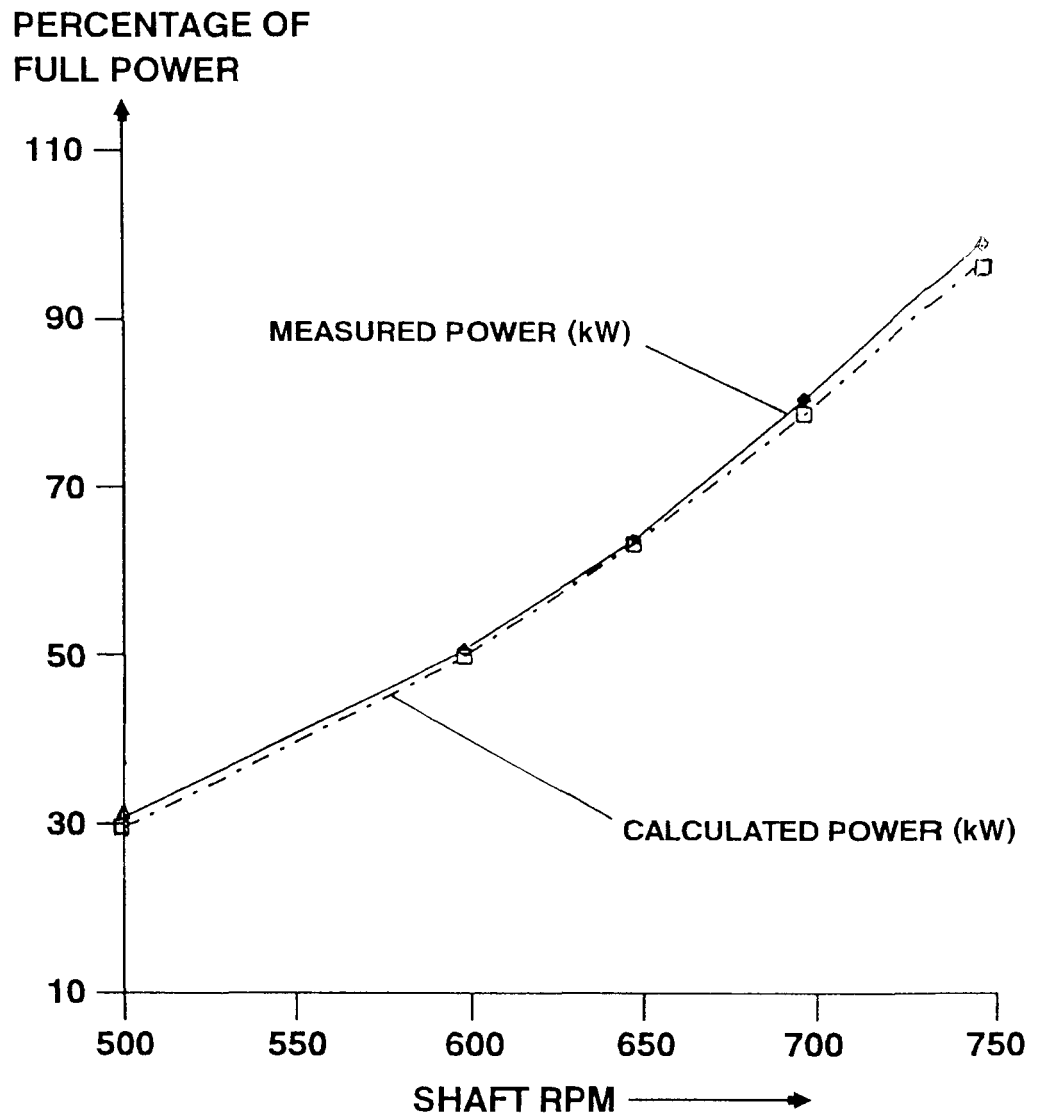
FIG. 18—COMPARISON OF MEASURED AND PREDICTED POWER ABSORPTION

During the development of the present hydrodynamic model, the kernel finite difference schemes were validated against published case studies and specific CFD studies. The surface vorticity used in the cascade model was verified against published aerofoil and cascade data, while the torque characteristics of a waterjet unit were verified by comparison with data from sea trials undertaken by the Department. (FIG. 18) shows the predicted and measured power consumption of a three bladed waterjet unit fitted to a high speed catamaran.

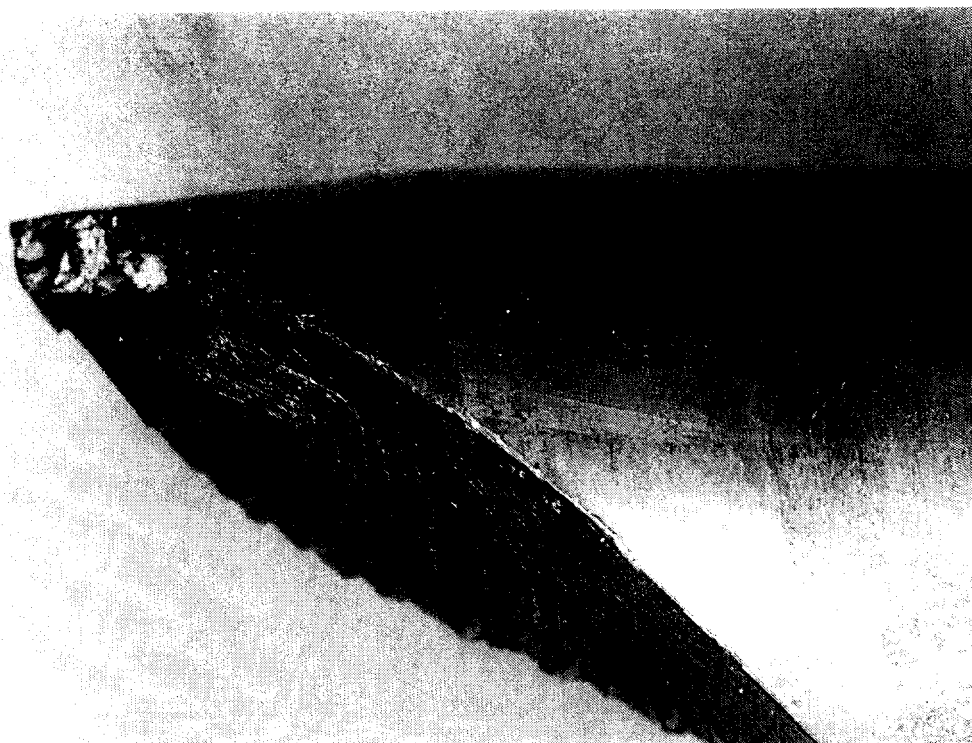
FIG. 22—FRETTING TORSIONAL FATIGUE OF A SHAFT

(FIG. 22) shows two views of an example of fretting torsional fatigue which caused the failure of a shaft. This failure occurred on the cone end of the screwshaft and not in the keyway and was induced by an inadequate interference fit between the shaft and the bore of the mating part.

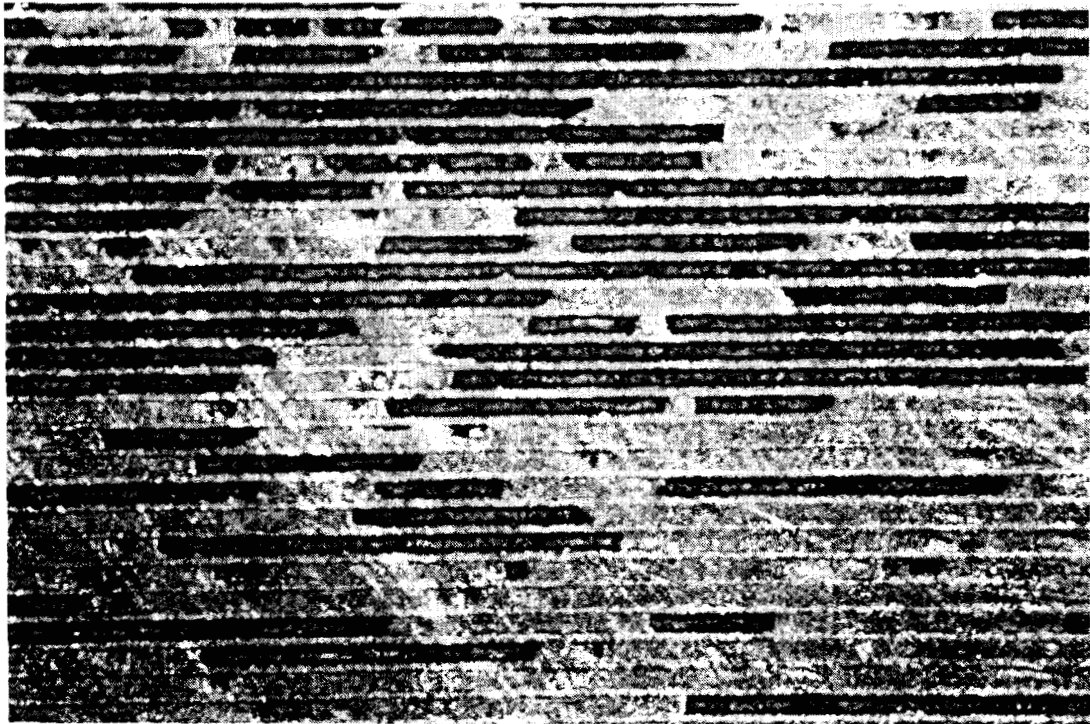
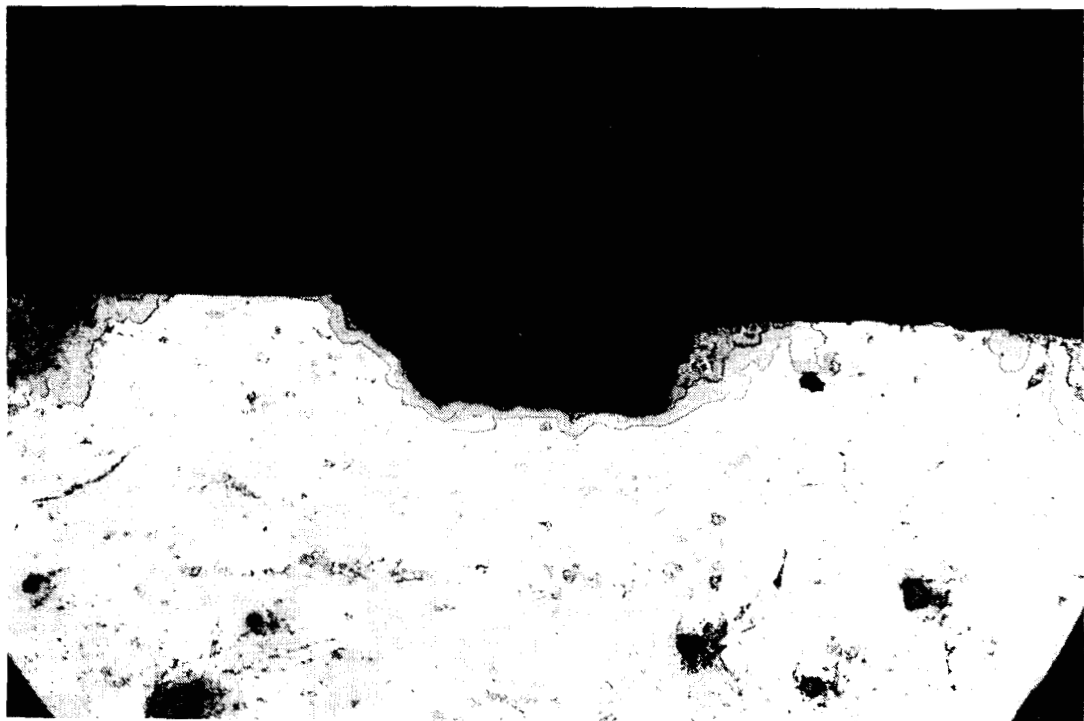
SURFACE DAMAGE CAUSED BY REMOVAL OF OVERLAY

SECTION THROUGH RILLENLAGER GROOVE SHOWING LOSS OF OVERLAY

The Rillenlager type bearing was designed to counteract overlay wear problems for engines burning residual fuels, (FIG. 30). Fatigue cracking and consequent premature loss of the overlay from the grooves of such bearings have been found in a connecting rod application, (FIG. 31), which required a stronger but harder overlay material.

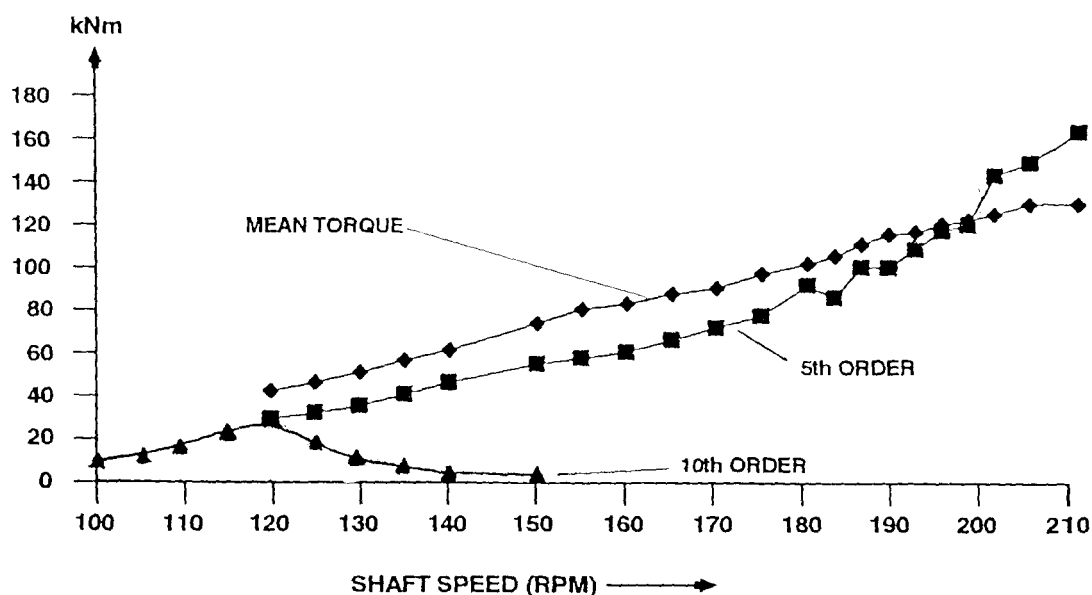
FIG. 33—INTERMEDIATE SHAFT MEAN AND VIBRATORY TORQUE

A shipowner reported that, on board one of their new ships, there were excessive levels of vibration in the accommodation and localised cracking of various tanks and support brackets due to vibration. The vessel's power was supplied by a five cylinder, two stroke diesel engine, developing 2942 kW at 210 rpm with the power being directly transmitted to a five bladed fixed pitch propeller. An investigation, prior to the ship's guarantee dry docking, in which the linear vibration characteristics of the hull, superstructure and engine were quantified, in addition to torsional characteristics of the main engine shafting system, showed that fifth order vibrations measured in the accommodation spaces at some operating conditions were at a level where complaints regarding habitability were considered likely to occur. Furthermore, vibratory torques which were measured in the intermediate shaft exceeded the mean torque at higher shaft speeds, (FIG. 33). Associated with these vibratory torques was a corresponding increase in axial vibration of the intermediate shaft.

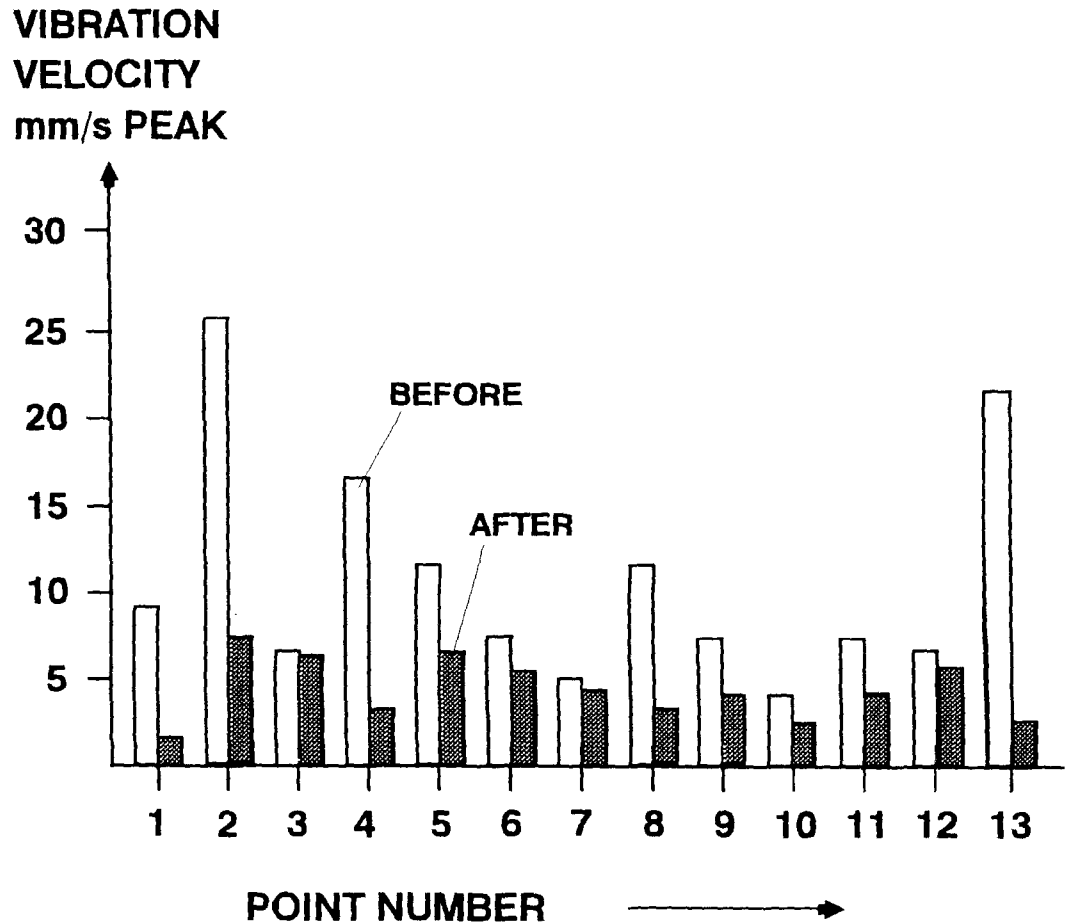
FIG. 34—COMPARISON OF 5TH ORDER VIBRATION MEASUREMENTS AT SELECTED POINTS BEFORE AND AFTER FITTING OF COMPENSATOR

It was recommended that global vibration of the ship could be reduced by either a re-tuning of the shafting torsional vibration characteristics which would entail the installation of a torsional damper, a change of shafting and possibly a barred speed range or, alternatively, the installation of an electrically driven, independently mounted, fifth order thrust compensator. The vessel's owners elected to adopt the latter recommendation and the modification was implemented. Subsequent vibration measurements indicated that vibration levels throughout the vessel had fallen to a level below those where complaints regarding habitability were likely as seen by (FIG. 34).

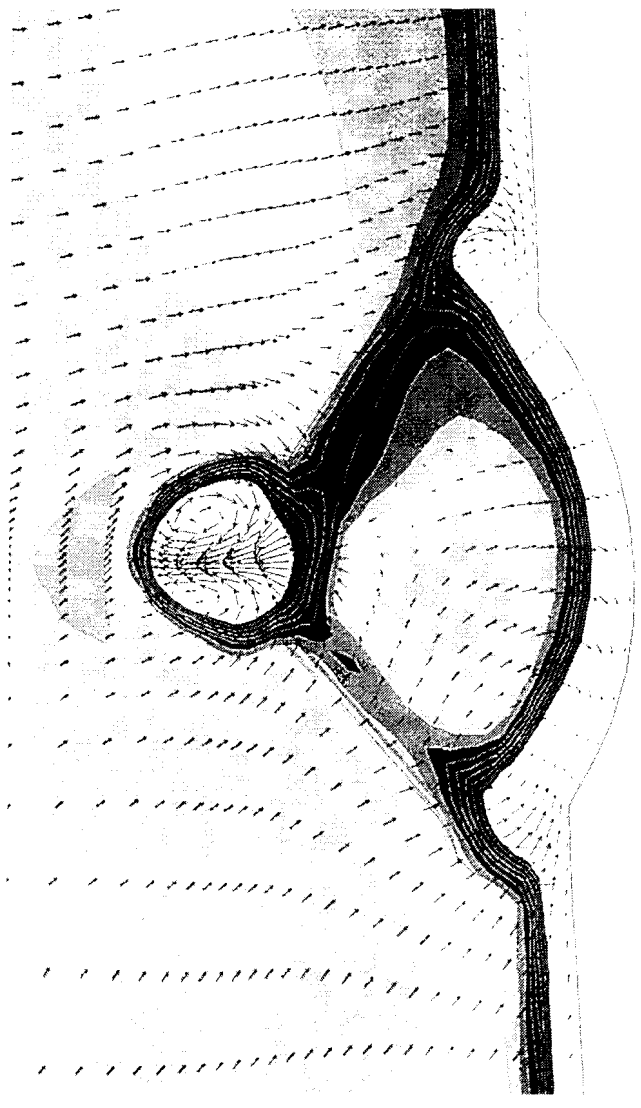
COMPUTED VELOCITY CONTOURS AFT OF ORIGINAL BRACKET

COMPUTED VELOCITY CONTOURS AFT OF MODIFIED BRACKET

Subsequent vibration measurements following the modification to the A-brackets confirmed that an acceptable vibration characteristic had been achieved.

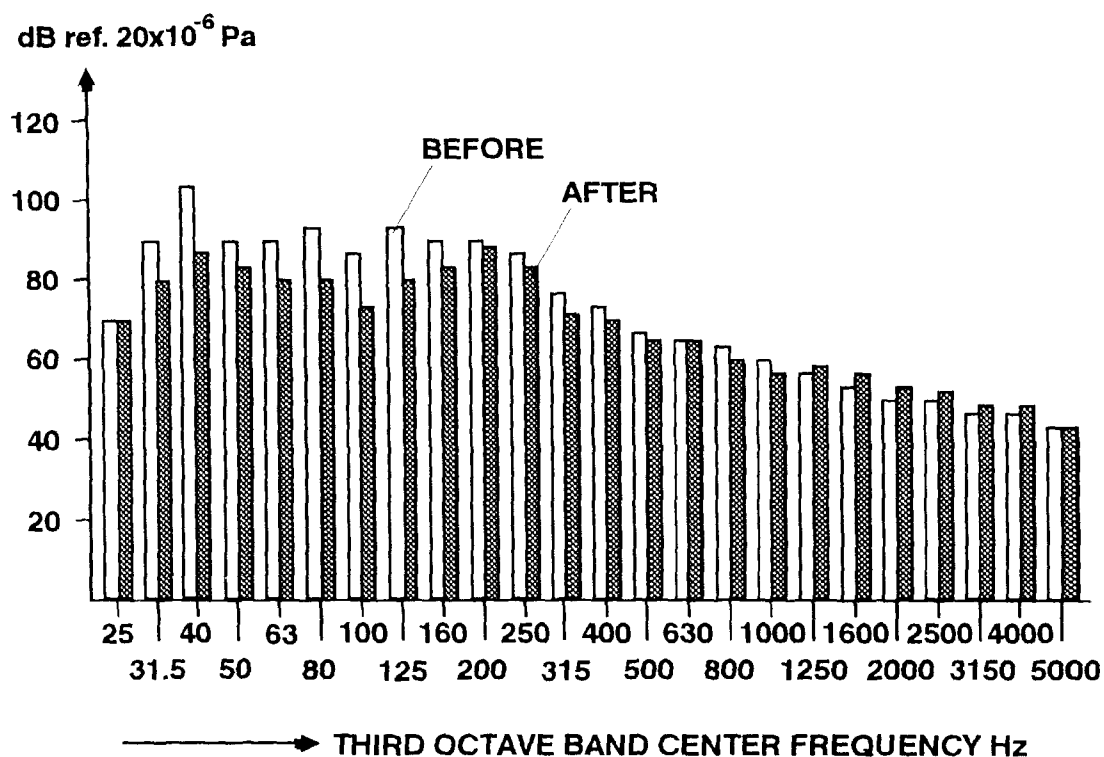
FIG. 38—EXHAUST GAS SOUND PRESSURE LEVELS AT 4M FROM FUNNEL OUTLETS

The measurement and calculation results were then used by a silencer manufacturer to design a secondary silencer and these were fitted in each of the four exhaust trunkings. Follow-up measurements confirmed a significant reduction in low frequency noise components, (FIG. 38).

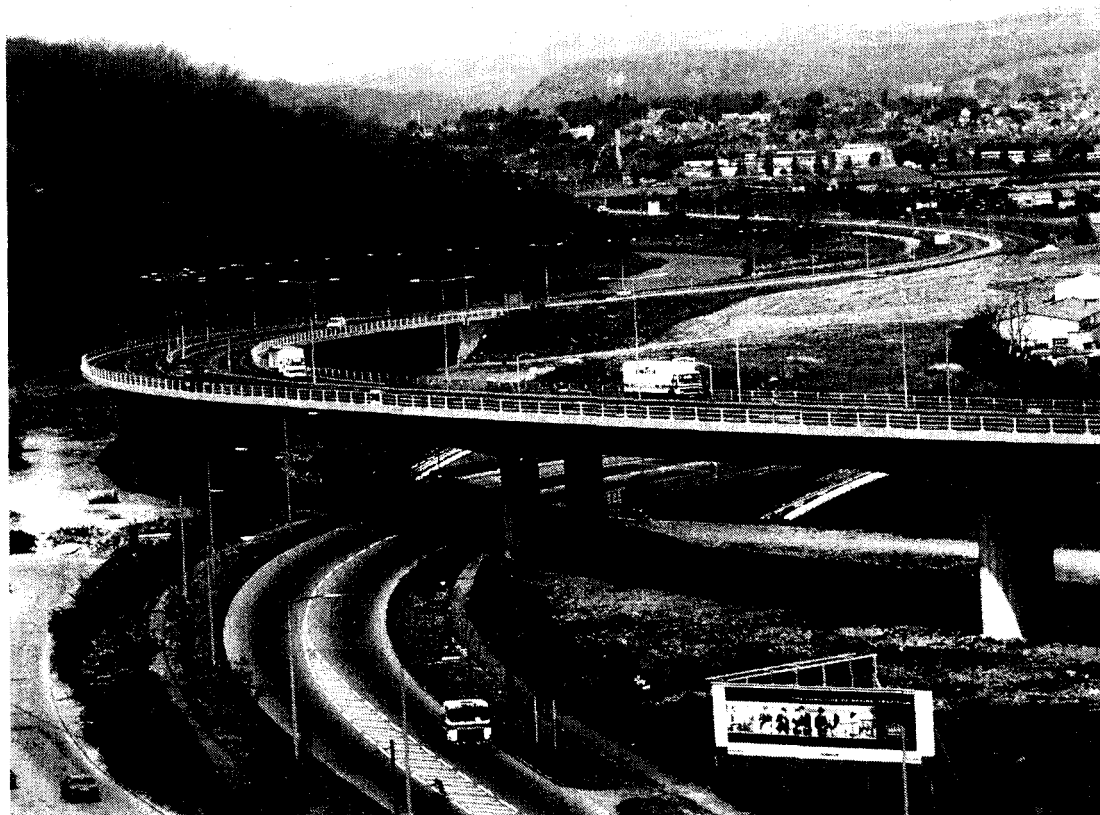
FIG. 44—SEGMENTAL PRE-STRESSED CONCRETE VIADUCT
