## ARCTIC HELICOPTER OPERATIONS

LIEUTENANT-COMMANDER G. D. PAY, M.A., M.Sc., C.ENG., M.R.AE.S., R.N.  
*(Formerly Mountain and Arctic Warfare Air Engineer Officer,  
 707 Naval Air Squadron)*

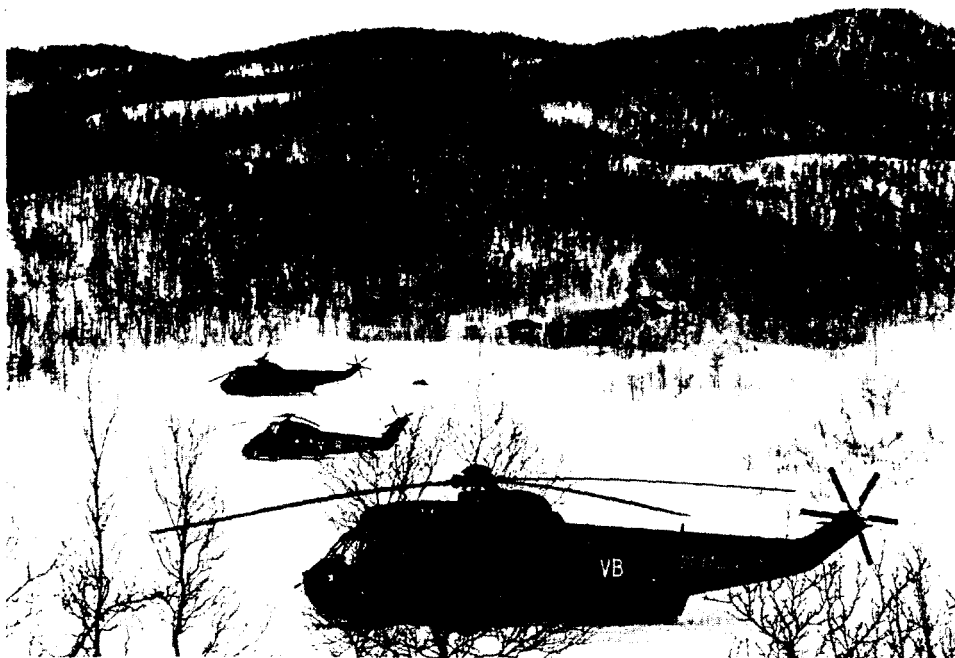
FIG. 4—A TYPICAL FORWARD OPERATING BASE

the H.Q. for tasking by means of mobile VHF radios or field telephones. This concept reduces significantly the total amount of tentage and domestic support required and greatly improves the reaction time for moving the FOB to another site. FIG. 4 shows a recent training FOB with Wessex and Sea King aircraft. The H.Q. is located in the edge of the tree line at the base of the hill beyond the aircraft. Spacing between aircraft would normally be greater than that shown here.

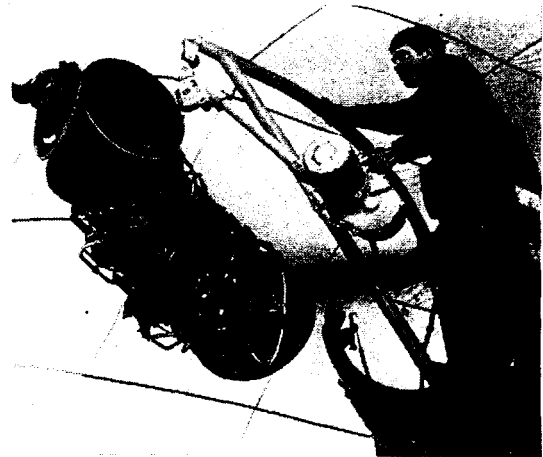
FIG. 5

ENGINE CHANGE IN PROGRESS ON A SEA KING

bare hands are necessary for awkward and fiddly jobs, a simple cover (e.g. a parachute) thrown over the work area into which warm air can be ducted provides a comfortable working environment. FIGS. 5 and 6 show an engine change in progress on a Sea King at Bardufoss. Heat is here being supplied from a mobile, petrol-fired heater of American origin which provides heated, non-toxic air through flexible trunking. The ambient temperature when the photographs were taken was  $-20^{\circ}\text{C}$ .

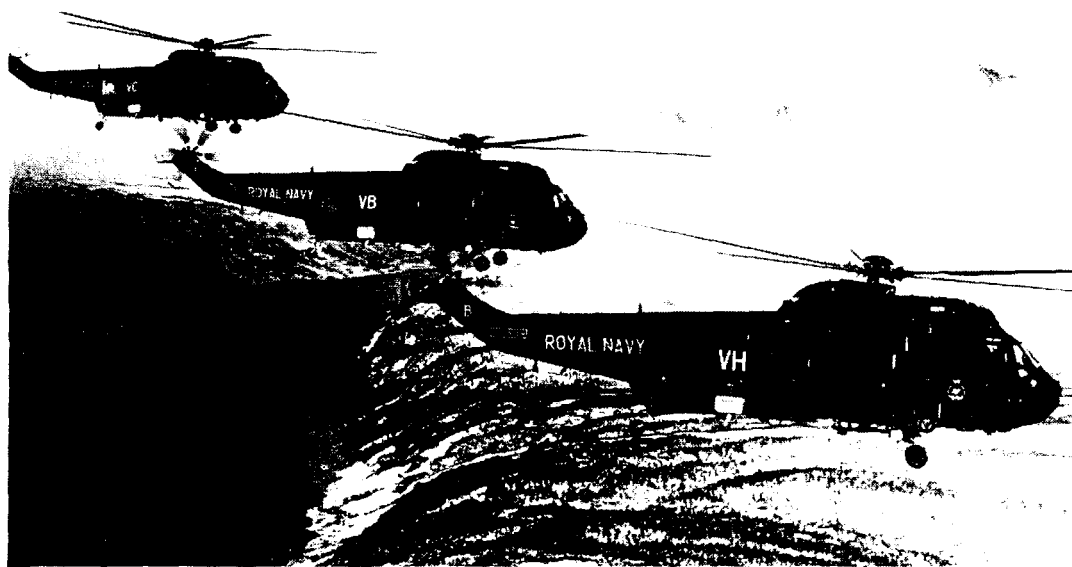
FIG. 7—SEA KINGS HC MK 4 OF 846 NAVAL AIR SQUADRON EN ROUTE TO NORTHERN NORWAY

For some years there had been criticism of the Wessex's inability to lift some of the Royal Marine's heavier equipment deployed to Norway, in particular the new light gun and the Volvo BV 202 tracked oversnow personnel carrier. Funds became available in the summer of 1978 for a purchase of the commando version of the Sea King helicopter, and a rapid development programme enabled first deliveries to be made from Westland Helicopters to the R.N. late in 1979. The first three Sea King HC Mk4 to be delivered to 846 Naval Air Squadron at R.N.A.S. Yeovilton flew up to northern Norway in February 1980 to join in Exercise Clockwork 80 (FIG. 7). This aircraft represents a quantum jump in capability for the Royal Marines, being able to move as many as twenty-two arctic-equipped troops (compared to eight in the Wessex) and having an ultimate lift capability of 8000 lb on the external sling. The Sea King HC Mk4 is also

extremely well equipped with radio and navigational aids, possessing a tactical air navigational system (TANS) with inputs from Decca hyperbolic radio chains as well as independent doppler and air data inputs, VOR, DME, ADF, and ILS. The TANS proved particularly impressive during the flight out to Norway and during the deployment, when accuracies of fifty metres in position were regularly achieved after several hours flying.

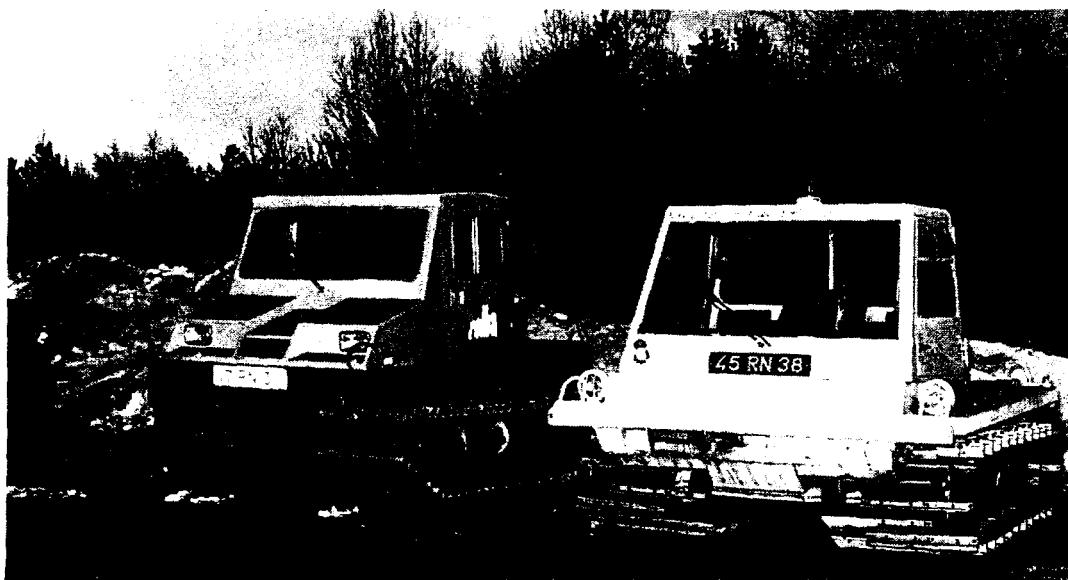
FIG. 8—TWO TYPES OF OVERSNOW VEHICLE USED FOR FORWARD OPERATING BASES

The dispersed FOB concept described earlier leads to a requirement for a small oversnow vehicle to transport personnel and equipment around the dispersed aircraft sites. This needs to be highly manoeuvrable, heliportable, and very reliable. FIG. 8 shows the two types of oversnow vehicles so far used in Norway—the Rolba Prinoth P4 on the right which has been in service for some years, and the Bombardier Bombi on the left which was taken on trial for the

first time last winter. The Rolba Prinoth is based on a Fiat 600 cc engine and transmission but has an unhappy reputation for poor reliability; the Bombi, of Canadian origin, is based on a standard Ford 1600 cc engine and transmission and looks set to be a far more reliable solution to the requirement.
