SEA-WATER COOLING SYSTEMS IN H.M. SHIPS

RECENT DEVELOPMENTS IN DESIGN AND CONSTRUCTION

COMMANDER H. T. LEWIS, R.N.(Rtd.), O.B.E., F.I.M.,
B.Sc., C.ENG., M.I.MECH.E.

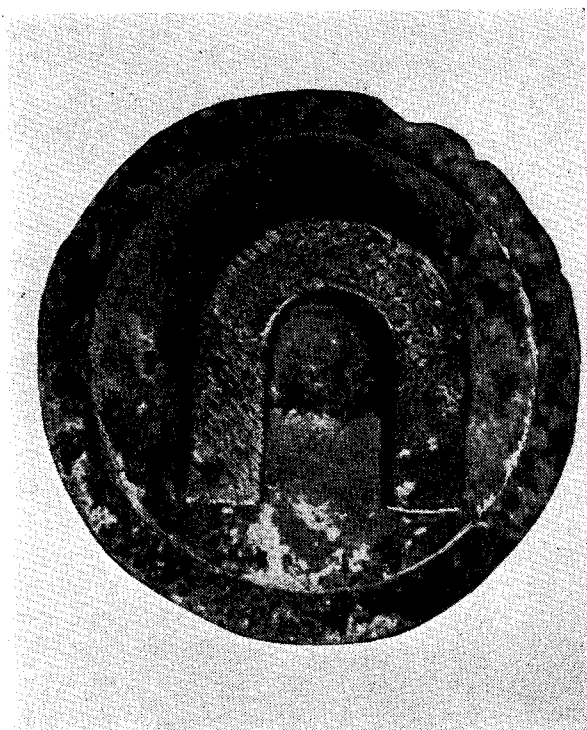
FIG. 1(a)—DETERIORATION OF SEA-WATER VALVE BY DE-ALUMINIFICATION

FIG. 1(b)—DETERIORATION OF SEA-WATER VALVE
BY DE-ALUMINIFICATION

The appearance is typified by the 5-inch isolating valve shown in FIGS. 1(a) and (b), the condition being attained in some ten weeks of service only.

Components which found their way into service, handling flowing sea water, and manufactured from aluminium bronzes containing nil or only up to some 1 per cent nickel, and aluminium content in excess of 9.5 per cent have been found to suffer deterioration amounting to almost complete de-naturing of the material. The effects are characterized by the removal of the aluminium, leaving re-deposited copper in a rough spongy mass, and hence the term 'de-aluminification' that has been applied to the phenomenon.

The mechanism is considered to be the selective leaching-out of the aluminium via the poor corrosion-resistant continuous gamma 2 phase (formed by

differential cooling following imposition of heat in processes associated with manufacture and repairs by welding) when subjected to flowing sea-water. Where, of course, an alloy with discontinuous gamma 2 can be guaranteed, this action does not occur, but it is exceedingly difficult to ensure this wholly in practice.

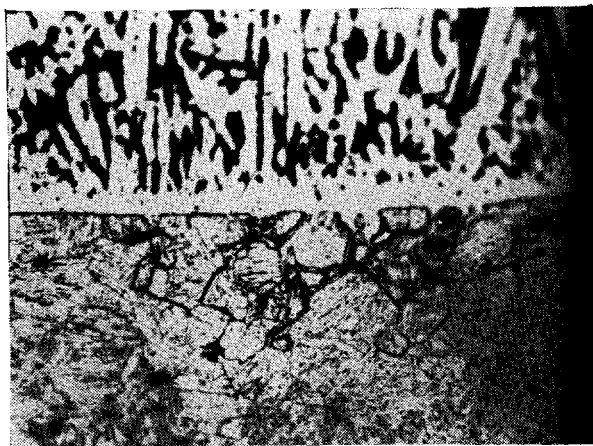
FIG. 9—COPPER INFUSION DOWN GRAIN BOUNDARIES OF STEEL BASE MATERIAL WITH CUPRO-NI DEPOSITED DIRECTLY

Thoughts then turned to the adaptation of the new-found technology developed for nuclear applications where it was necessary to utilize metallic cladding processes on an extensive scale. Taking advantage of the existence of machines at Messrs Babcock and Wilcox Ltd. for weld-deposition of stainless steel on plates, and internally on pipes, trials were initiated using reels of 70/30 Cupro-Ni (+ Fe) filler wire instead, and suitably adjusted welding parameters, feed characteristics, etc. to achieve a satisfactory heat input. The base material was a 2 ft square, 6 in. thick rigid carbon steel plate and the filler, 1/16 in. dia. wire of nominal composition 69 per cent Cu, 30 per cent Ni, 1 per cent Fe. This was deposited *directly* on the steel using a Metal-arc Inert Gas (MIG) welding head.
