FIG. 1.—PART OF STARBOARD CRANKSHAFT OF H.M. PADDLE TUG "FIRM" SHOWING POSITION OF FRACTURE IN L.P. CRANK PIN

AN INTERESTING CRANKSHAFT REPAIR

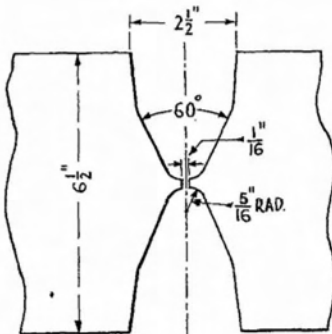
FIG. 4. DETAILS OF PREPARATION.

The new portion of the web was rough machined $\frac{3}{8}$ in. larger on all dimensions to form a finishing face and $\frac{3}{8}$ in. plates were tacked on the face of the old web to conform to the section of the welding groove as shown in Fig. 3. The webs were then aligned to allow a $\frac{1}{16}$ in. gap between the throat faces (Fig. 4) and angle iron stiffeners were tacked in position. The joint was then tack welded, the gap being maintained by fox wedges and four stay bars of $1\frac{1}{2}$ in. square section were tack welded in position as shown in Fig. 3. These operations were carried out while the two components were fixed to the aligning slab, the whole unit was then lifted so that the shaft was in the vertical position to enable gravity welding to be carried out. This is shown in the upper illustration on page 76.
