# **A Collaborative Approach to the Removal, Overhaul and Replacement of the Port and Starboard Electric Propulsion Motors on a T23 Duke Class Frigate**

*Babcock International Group*

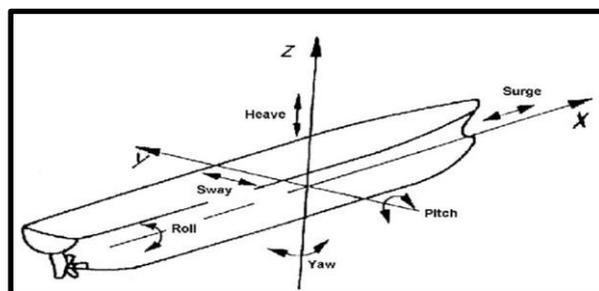
Figure 13 – Diagram of X, Y and Z Planes

To mitigate the alignment risk, additional arrangements were put in place to monitor the motor bedplate movement. Prior to removing the motors, three datum plates were welded on to each rail of the bedplate, to monitor the X, Y and Z plane movement Figure 13. There were six datum plates per motor, see Figure 14, which enabled alignment readings to be recorded. Readings were taken with theodolites in the X, Y and Z co-ordinates, Figure 15.
