INVESTIGATIONS AND SOLUTIONS FOR SUPERSTRUCTURE FATIGUE CRACKING IN UK ROYAL NAVAL VESSELS

CATRIONA SAVAGE BEng MSc CEng MRINA
JEREMY ATKINS MEng
BMT DEFENCE SERVICES LTD, UK

This paper seeks to review and consolidate the work undertaken to date, including reporting on the survey of the forgings fitted to HMS ST ALBANS.

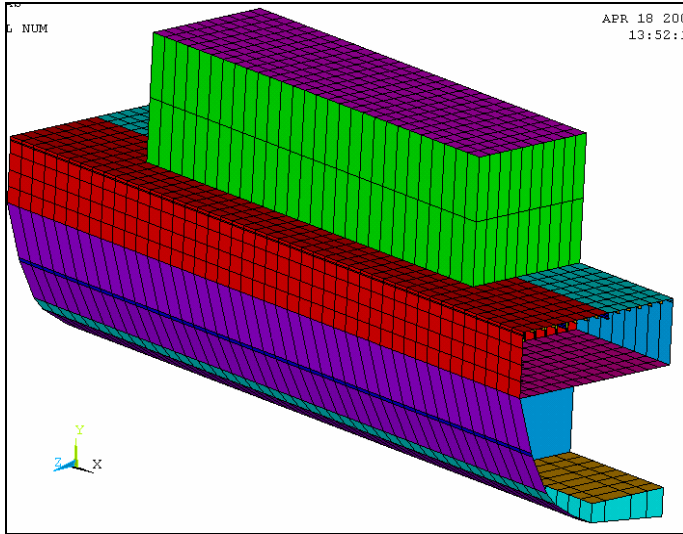
FIG.1 - GLOBAL MODEL (AREA PLOT)

The study found that the forged insert piece would virtually eliminate fatigue cracking in this area. The use of a deck insert or doubler plate was not found to be sufficiently effective to consider progressing further.

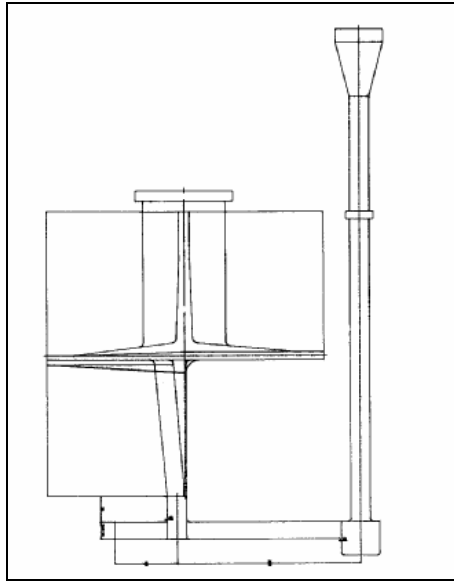
FIG.4 - CAST INSERT

Earlier work had identified that whilst the gusset plate had reduced the incidence of fatigue cracking it had not been a completely successful solution. The fatigue life of the gusset plate itself was found to be reasonably short and thus required regular repair or replacement. Thus a more effective solution was still required. It was thought that a node corner casting might be particularly effective as it should ensure precise alignment of the structure above and below deck due to its shape. In addition it would improve the fatigue classification of the joint by offsetting the weld detail away from the corner stress concentration.

The report concludes that the initial investigation was successful and that further development should be carried out. It recommended that further work should include:
