RECENT RN GEARING EXPERIENCES

Peter HOPKINS

(Defence Logistics Organization, Marine Propulsion Systems IPT)

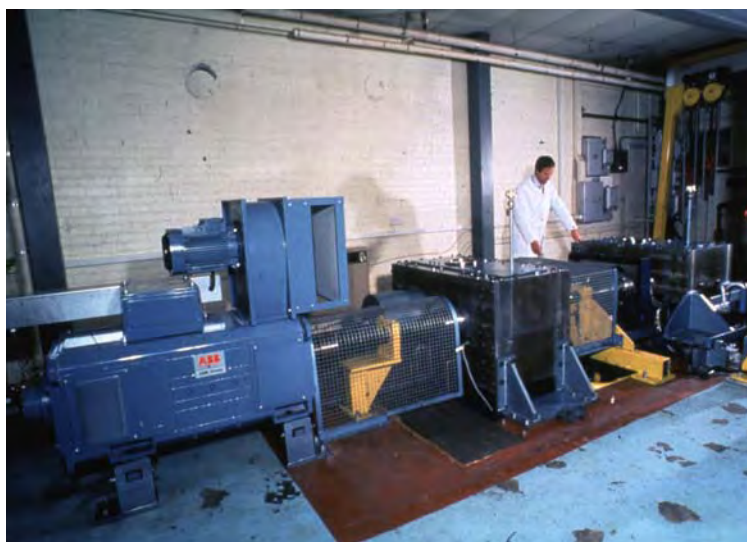
FIG.5 – MARINE GEAR RESEARCH RIG

- Developing robust techniques for measuring in-service gear stressing and gear mesh misalignment (strain gauging).
- Developing an accurate, comprehensive gear stress analysis and gear noise prediction technique – Design Unit Gear Analysis for Transmission Error and Stress (DU-GATES).
- Experimentally validating DU-GATES and proving the correlation between calculated Transmission Error (TE) and gear noise using the 8MW Marine Gear Research Rig (FIG.5).

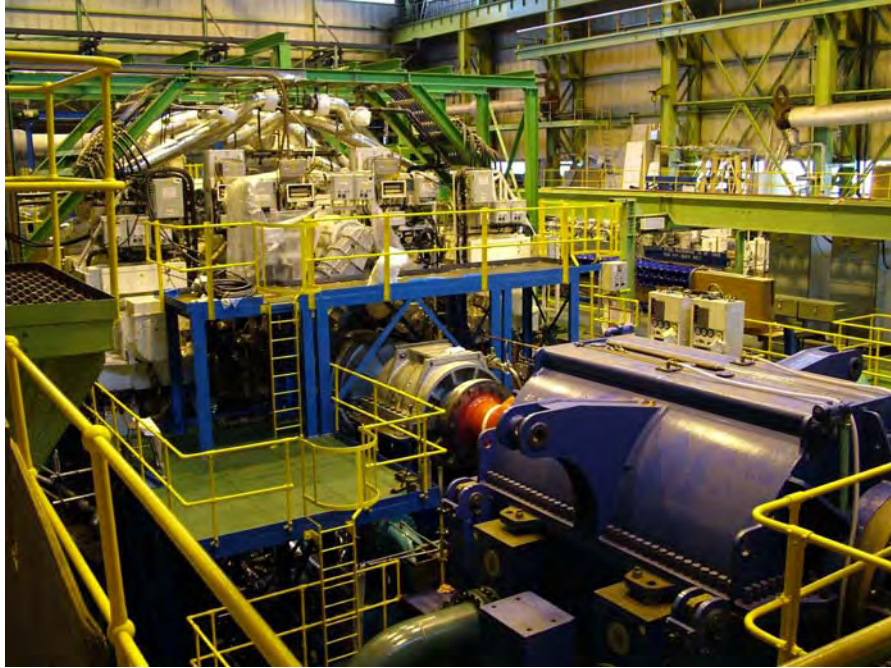
FIG.14 – SMITE

Shore trials in SMITE (FIG.14) culminated in a 6 hour run at full load in June 2004. The trial ran very smoothly and gearbox was the quietest ever tested at Barrow.

These achievements were partly overshadowed by a scuffing incident that occurred on the secondary gear elements part way through the full power trial (FIG.15). The damage was remarkably similar to that experienced in *Vanguard* (1989). In addition during the dismantling of the gearbox damage was discovered on the secondary gear thrust cones.
