FIRE IN THE FORWARD GEAR ROOM

THE 'ILLUSTRIOUS' GEARBOX EXPLOSION

COMMANDER R. A. ROWLEY, O.B.E., B.Sc., R.N.
(*Marine Engineer Officer, H.M.S. Illustrious*)

LIEUTENANT T. M. GAUGHT, M.Sc., C.ENG., M.I.MAR.E., R.N.
(*lately Propulsion Engineer Officer, H.M.S. Illustrious,
now in Sea Systems Controllerate*)

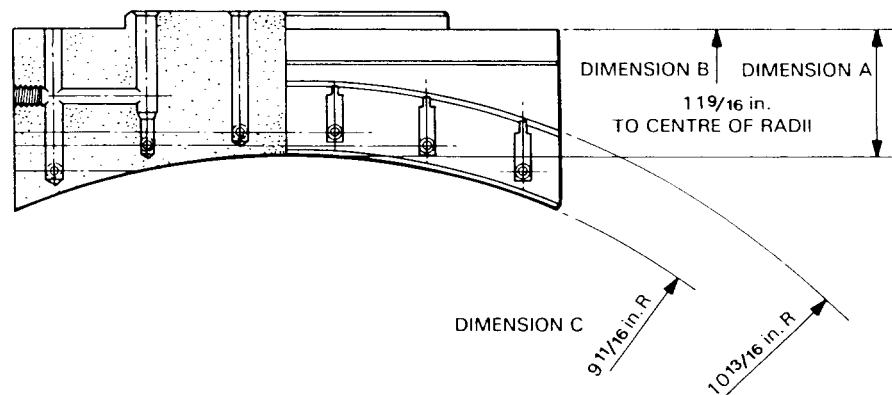
FIG. 9—SECTION THROUGH ACTUATING SHOE

Thus the evidence indicated that the critical clearance had always been marginal on the starboard outer and, further, that a frighteningly small clearance existed at the port inner clutch. The question then posed therefore was why had the incident occurred on 3rd April, shortly after *Illustrious* had sailed, and not earlier. FIG. 9 shows an extract from the shoe manufacturing drawing. The critical dimension is from the inner radius to the mounting face (FIG. 9 dimension A). This is the difference between two dimensions (B and C) both toleranced at ± 0.010 inches and thus it may vary by ± 0.020 inches from its nominal value. Examination of the available shoes showed that this range of dimensions could exist and thus it is conceivable that, at worst, the replacement shoe fitted to the starboard outer was 0.040 inches larger than its predecessor.
