# MARINE GEARBOX EXPLOSIONS

## A REVIEW

COMMANDER M. D. COOPER, C.ENG., F.I.MAR.E., R.N.  
(*Ship Department*)

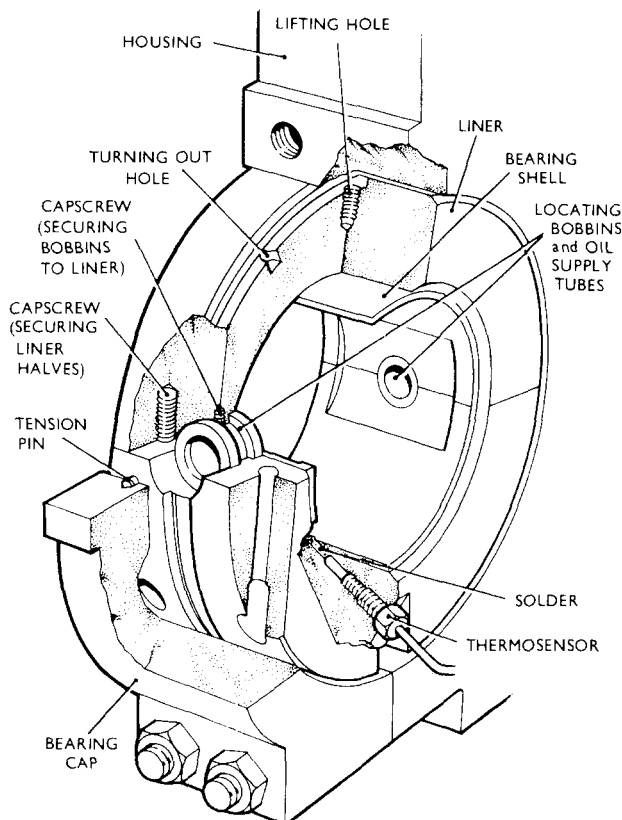
FIG. 4—TYPICAL THERMOSENSOR ARRANGEMENT

the investigations that poor contact on the back of the bearing has given rise to spurious low-temperature readings. In the 1970s, the R.N. changed, in some installations, to resistance thermometers with the thermosensor spring loaded to the back of the bearing shell by an arrangement that was dimensionally interchangeable with that of earlier ships. FIG. 4 illustrates a typical thermosensor arrangement.
