MAIN PROPULSION PRIMARY GEAR WHEEL FAILURES IN TYPE 42 AND TYPE 21 SHIPS

LIEUTENANT D. I. BOGGUST, M.Sc., C.ENG., M.I.MECH.E., R.N.
(Formerly R.N.E.C., Manadon)

AND LIEUTENANT-COMMANDER R. A. BOTTEN, B.Sc., Ph.D.,
C.ENG., M.I.M., R.N.
(R.N.E.C., Manadon)

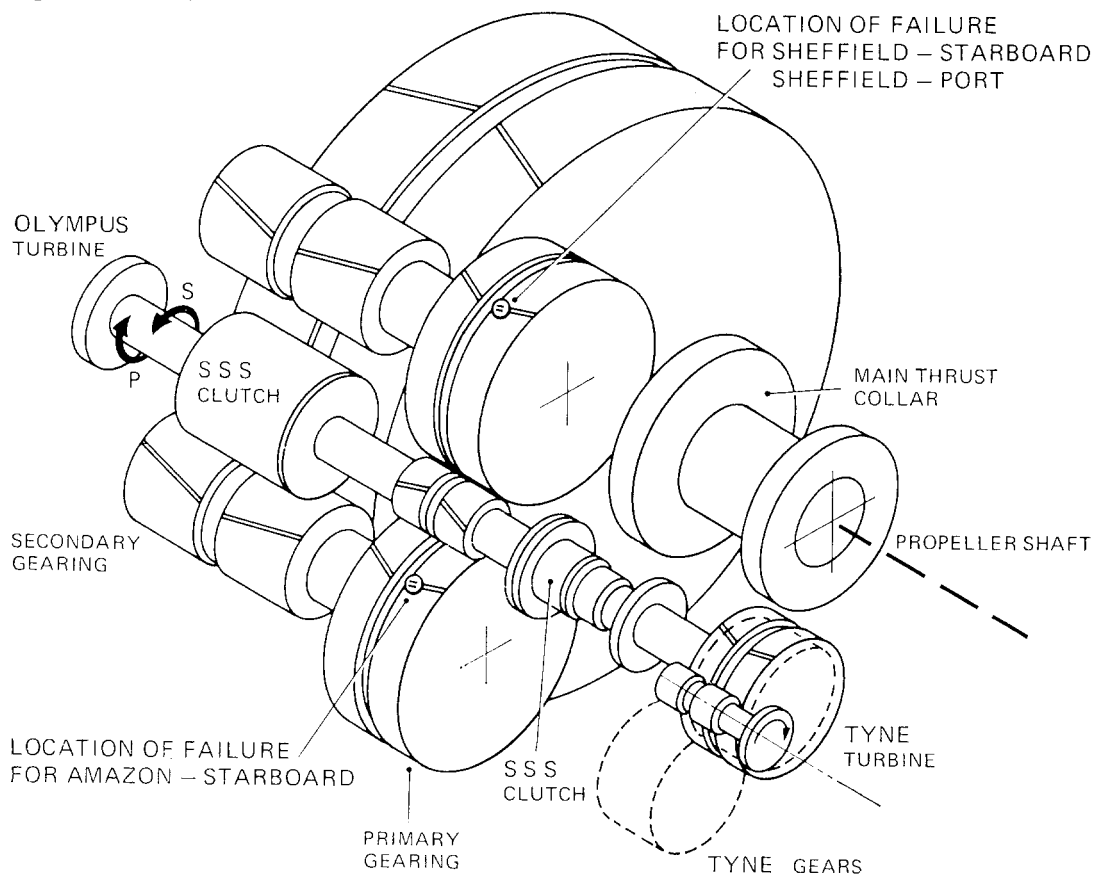
FIG. 1—SCHEMATIC DIAGRAM OF TYPE 42 DESTROYER STARBOARD GEARING. PORT GEARING ARRANGED OPPOSITE HAND, WITH IDLER WHEEL FITTED IN TYNE GEARS SHOWN DOTTED

Early in 1977, failures of teeth by breakage or cracking were discovered on the after helix of the primary gear wheels of H.M.S. *Sheffield* and of H.M.S. *Amazon*, Type 42 and 21 respectively. The location of the failures is given in FIG. 1.
