# SEA-WATER VALVES IN THE ROYAL AUSTRALIAN NAVY

B. W. TURNBULL

*(Dockyard Laboratory, H.M.A. Naval Dockyard, Garden Island, Sydney)*

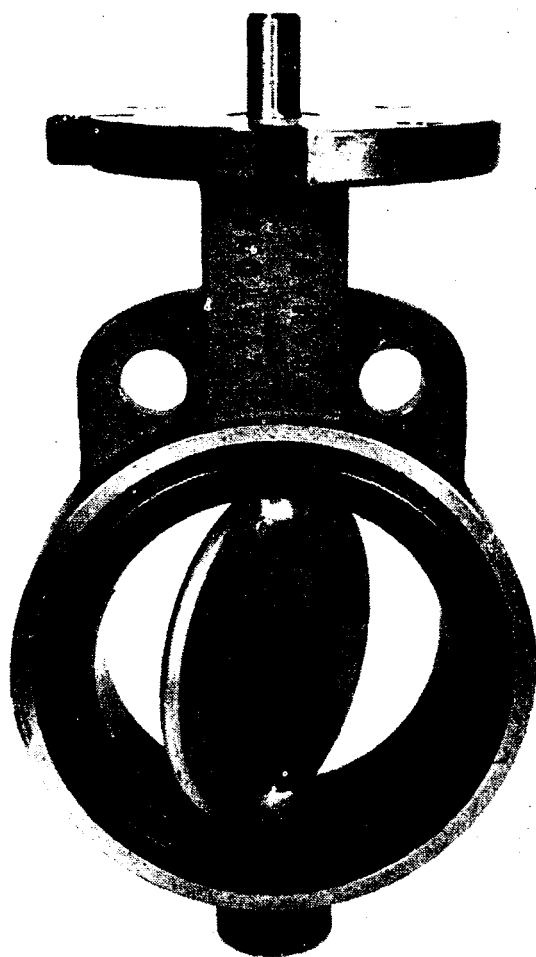
FIG. 4—A 5 IN. DIAMETER BUTTERFLY VALVE OF THE TYPE ADOPTED IN THE R.A.N.

The particular valve chosen had a solid integrated concentric disc and spindle and a split body. This design avoids the risk present in butterfly valves, with separate spindles and discs secured by screws or pins, of the spindle being ejected if the securing screws are sheared due to debris trapped across the seat. The valves gave negligible turbulence or pressure drop and weighed approximately one-eighth the weight of gate valves. Drip tight, maintenance free service over a period of five years has been obtained (see FIG. 4).

Butterfly valves used initially in D.D.G.s had cast iron bodies and some failures were experienced due to water leakage under the rubber seats. The cause was traced to faulty fittings which displaced the rubber liner, but subsequent modifications to the liner have reduced this risk. All valves used in new construction have gunmetal bodies as an additional safeguard.

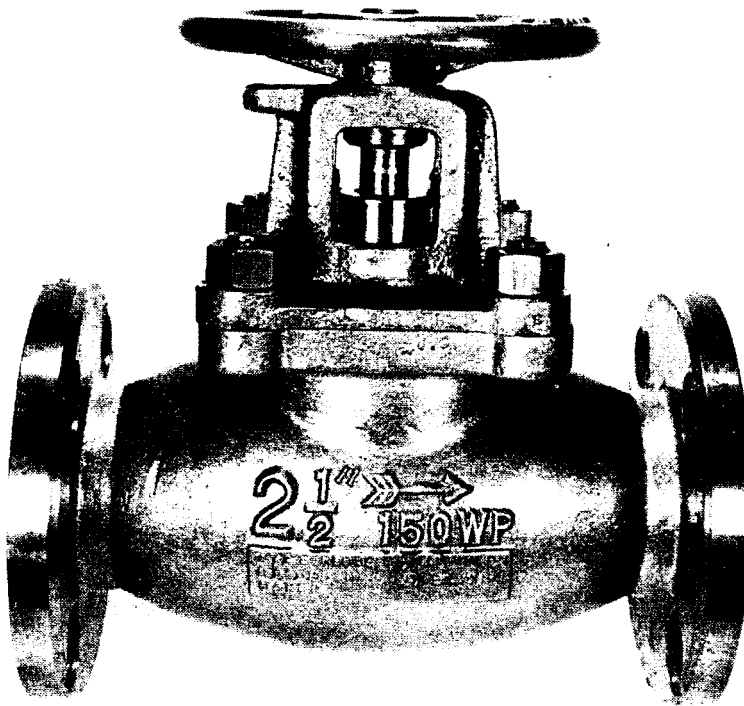
FIG. 5—A 2½ IN. DIAMETER VALVE OF R.A.N. DESIGN

- (a) *The body* is of conventional shape (see FIG. 5), but is modified internally to give improved flow characteristics and to accept an inserted seat. It has machined bores at each end to match the size of piping used.

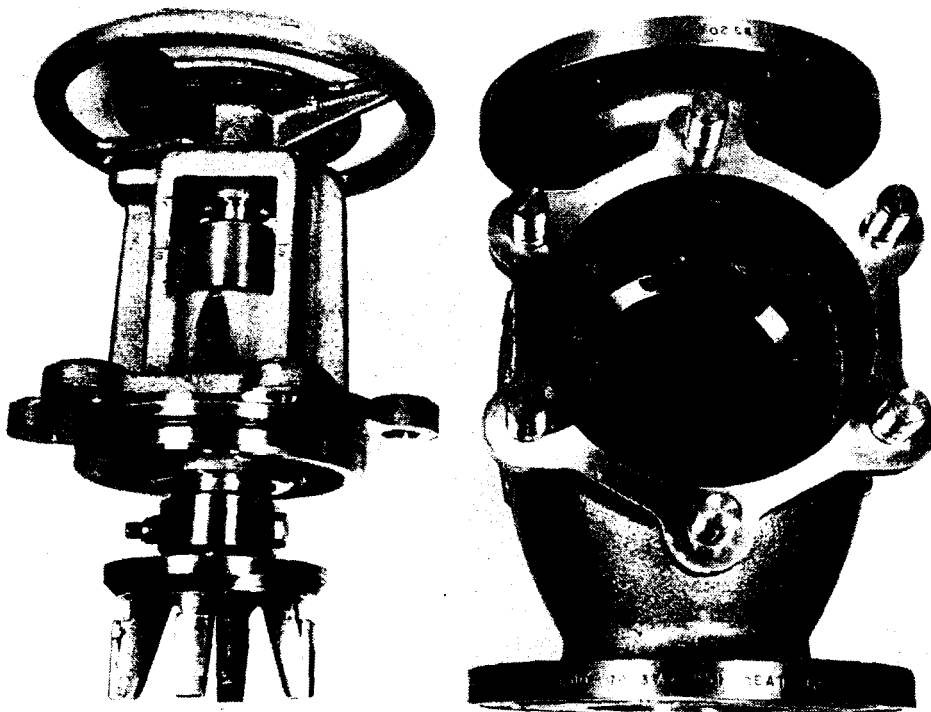
- (b) *The bonnet* is of unconventional design and uses one integral casting in lieu of the usual three, i.e., bridge, cover-plate and gland (see FIGS. 6 and 7). The standard packed gland has been replaced by 'O' ring seals (Viton A) which are also used for the bonnet seal and for back seating. The screw threads of the spindle are not exposed to dirt, paint or sea water and the same spindle is used when the valve is remotely operated by rod gearing. In the smaller valves (under 3½ in.) one bonnet assembly is common to two sizes. Sealed lubrication is provided by a grease-filled groove between the 'O' ring seals in the rising nut.

FIG. 6—INTERNAL CONSTRUCTION OF A 3½ IN. R.A.N. VALVE SHOWING THE MONEL SEAT AND MONEL-FACED VALVE DISC. THE VALVE DISC AND SECURING BOLT ARE MOUNTED IN SYNTHETIC RUBBER

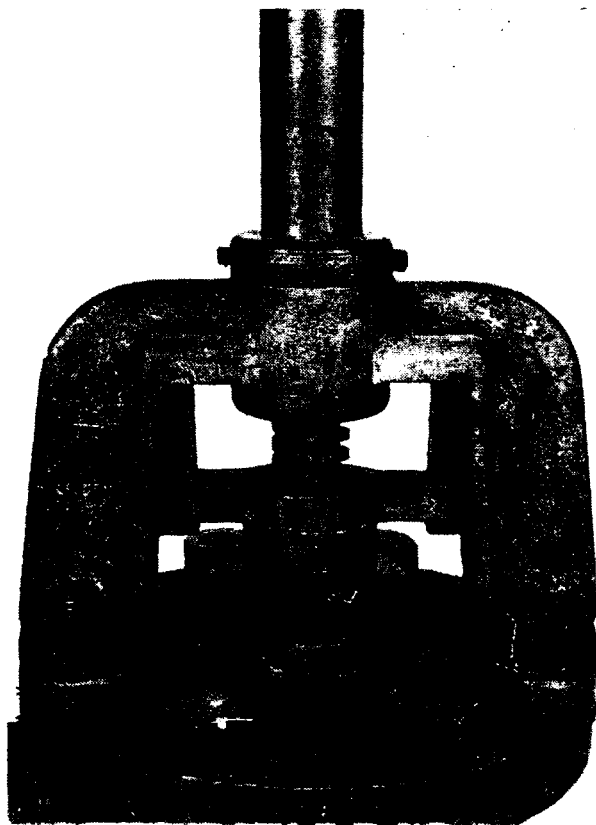
FIG. 7—BONNET OF ADMIRALTY TYPE VALVE SHOWING BRIDGE COVER PLATE AND GLAND WITH EXPOSED SPINDLE THREADS. COMPARE WITH SINGLE INTEGRAL CASTING OF R.A.N. VALVE IN FIG. 5
