PLAIN BEARING FAILURES

GEORGE R. FURMAN

The following article is reproduced by courtesy of Texaco Incorporated of New York. It was first published in July, 1964, in the Company's magazine Lubrication, a technical publication devoted to the selection and use of lubricants.

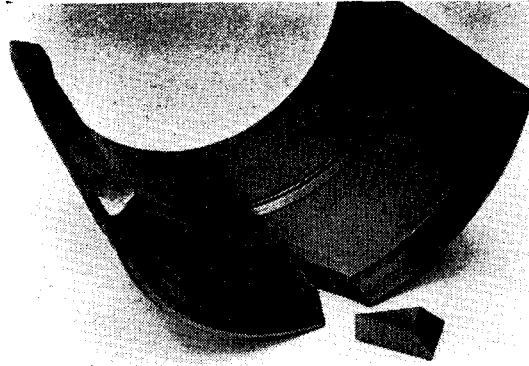
FIG. 1—A PRECISION TYPE PLAIN BEARING OR SLEEVE ENGINE BEARING WITH CROSS-SECTIONAL SAMPLE REMOVED IN PREPARATION FOR ROUGH GRINDING, MOUNTING, POLISHING, ETCHING AND MICROSCOPIC EXAMINATION

For example, to prepare a cross-section of a heavy-duty Diesel connecting rod bearing for microscopic examination, the desired portion is cut out as indicated in FIG. 1 with a saw or cutting wheel. Selection of the proper area is of paramount importance; defects are seldom evenly distributed over a bearing and, when a particular kind is in question—for instance, shallow fatigue cracks—several sections from different locations may have to be examined to find views suitable for diagnosis.

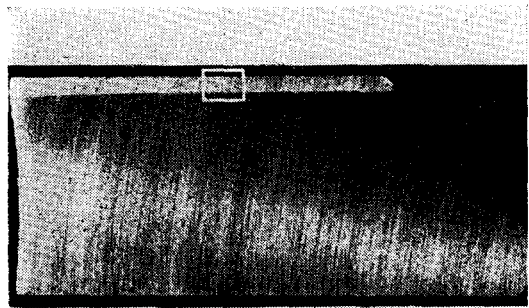
FIG. 2—SAMPLE SAWED FROM FIG. 1 AND ROUGH GROUND. NOTE 0.047 IN. LAYER OF BEARING ALLOY AT TOP BONDED TO A STEEL BACKING 0.5 IN. THICK ($\times 2\frac{1}{2}$)

FIG. 2 shows a specimen cross-section which has been lightly ground to reveal the bearing alloy layer 0.047 in. thick on a steel backing 0.5 in. thick. The specimen was then trimmed and moulded or cast into a round plastic mount. FIG. 3 shows a

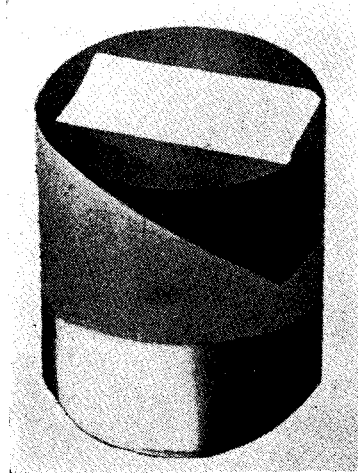
FIG. 3—SPECIMEN MOUNTED IN PLASTIC, POLISHED AND READY FOR FINAL ETCHING (APPROX. FULL SIZE)

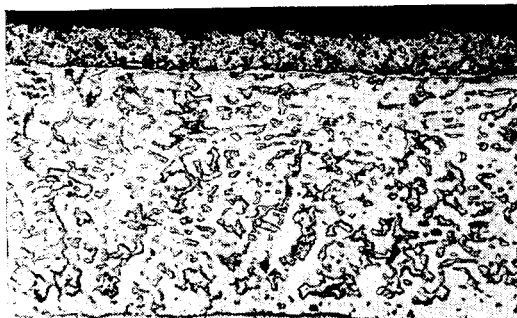
FIG. 4—PHOTOMICROGRAPH OF CROSS-SECTION OF BEARING SHOWN IN FIGS. 1, 2 AND 3. FROM TOP TO BOTTOM: (i) THE GREY-COLOURED LEAD-TIN BEARING SURFACE LAYER OR FLASHING, ABOUT 0.001 IN. THICK; (ii) THE NARROW WHITE-COLOURED NICKEL 'DAM'; (iii) THE WHITE-COLOURED COPPER MATRIX WITH ITS INTERSTICES FILLED WITH GREY-COLOURED LEAD; (iv) A SMALL PORTION OF THE STEEL BACKING ($\times 200$)

until a scratch-free mirror finish is obtained. This surface is then chemically etched by reagents specifically compounded to selectively attack one phase or grain type differently from the others and, in so doing, to create an optical differentiation between grains or microconstituents. FIG. 4 is a photomicrograph of a portion of the etched specimen ready for microscopic examination. The area shown represents the rectangle in FIG. 2, which includes the lead-tin bearing surface (10 per cent tin) approximately 0.001 in. thick, several thousandths of an inch of copper-lead substructure and a portion of the steel shell. Note the narrow, irregular white line between the copper-lead and lead-tin: this is electro-deposited nickel which serves as a diffusion barrier. It prevents the migration of tin from the surface layer into the underlying copper and thereby maintains the corrosion resistance of the surface layer. A structure such as this is frequently used in heavy duty Diesel bearings.

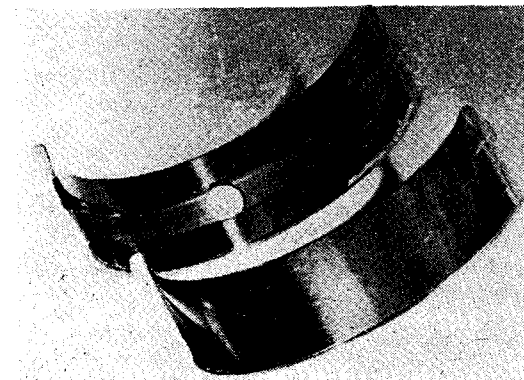
FIG. 16—A MATED SET OF MAIN BEARING INSERTS, ONLY THE UPPER LIGHTLY-LOADED HALF BEING PROVIDED WITH A CENTRAL OIL GROOVE

Abrasive shaft wear occurring at a slow rate can be offset by corresponding bearing wear so that no gross misfit occurs, even though the journal may wear to a barrel or hour-glass profile. For example, a shaft riding on a bearing shell having a central oil groove can become worn on the load-bearing areas so that the shaft develops a 'non-wear' ridge or band corresponding to the oil groove. If the groove is contained in only one half-shell of a full bearing as in FIG. 16, a ridge can still form on the shaft; however, the non-grooved half-shell will wear at the same time along a band matching the ridge, so that an even distribution of load continues. Such a bearing shell will show a narrow circumferential
