PLAIN BEARING FAILURES

GEORGE R. FURMAN

The following article is reproduced by courtesy of Texaco Incorporated of New York. It was first published in July, 1964, in the Company's magazine Lubrication, a technical publication devoted to the selection and use of lubricants.

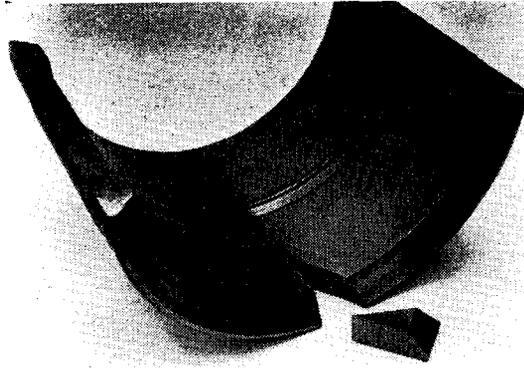
FIG. 1—A PRECISION TYPE PLAIN BEARING OR SLEEVE ENGINE BEARING WITH CROSS-SECTIONAL SAMPLE REMOVED IN PREPARATION FOR ROUGH GRINDING, MOUNTING, POLISHING, ETCHING AND MICROSCOPIC EXAMINATION

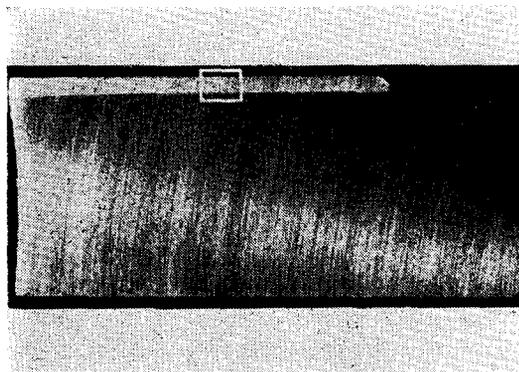
FIG. 2—SAMPLE SAWED FROM FIG. 1 AND ROUGH GROUND. NOTE 0.047 IN. LAYER OF BEARING ALLOY AT TOP BONDED TO A STEEL BACKING 0.5 IN. THICK ($\times 2\frac{1}{2}$)

FIG. 2 shows a specimen cross-section which has been lightly ground to reveal the bearing alloy layer 0.047 in. thick on a steel backing 0.5 in. thick. The specimen was then trimmed and moulded or cast into a round plastic mount. FIG. 3 shows a

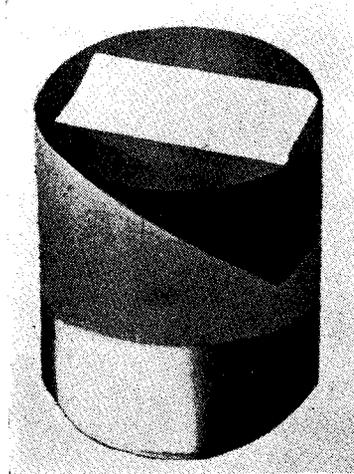
FIG. 3—SPECIMEN MOUNTED IN PLASTIC, POLISHED AND READY FOR FINAL ETCHING (APPROX. FULL SIZE)

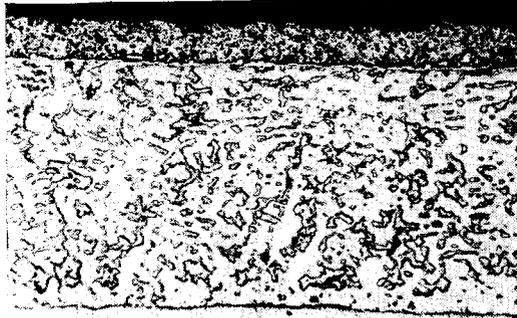
FIG. 4—PHOTOMICROGRAPH OF CROSS-SECTION OF BEARING SHOWN IN FIGS. 1, 2 AND 3. FROM TOP TO BOTTOM: (i) THE GREY-COLOURED LEAD-TIN BEARING SURFACE LAYER OR FLASHING, ABOUT 0.001 IN. THICK; (ii) THE NARROW WHITE-COLOURED NICKEL 'DAM'; (iii) THE WHITE-COLOURED COPPER MATRIX WITH ITS INTERSTICES FILLED WITH GREY-COLOURED LEAD; (iv) A SMALL PORTION OF THE STEEL BACKING ($\times 200$)

until a scratch-free mirror finish is obtained. This surface is then chemically etched by reagents specifically compounded to selectively attack one phase or grain type differently from the others and, in so doing, to create an optical differentiation between grains or microconstituents. FIG. 4 is a photomicrograph of a portion of the etched specimen ready for microscopic examination. The area shown represents the rectangle in FIG. 2, which includes the lead-tin bearing surface (10 per cent tin) approximately 0.001 in. thick, several thousandths of an inch of copper-lead substructure and a portion of the steel shell. Note the narrow, irregular white line between the copper-lead and lead-tin: this is electro-deposited nickel which serves as a diffusion barrier. It prevents the migration of tin from the surface layer into the underlying copper and thereby maintains the corrosion resistance of the surface layer. A structure such as this is frequently used in heavy duty Diesel bearings.

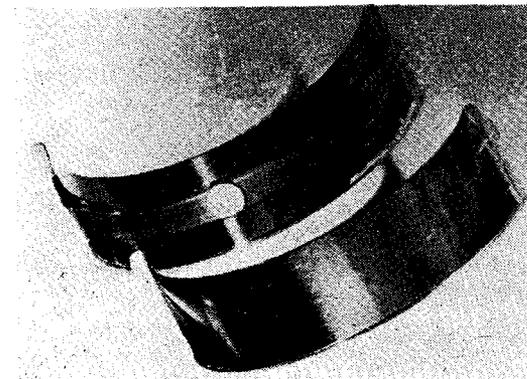
FIG. 16—A MATED SET OF MAIN BEARING INSERTS, ONLY THE UPPER LIGHTLY-LOADED HALF BEING PROVIDED WITH A CENTRAL OIL GROOVE

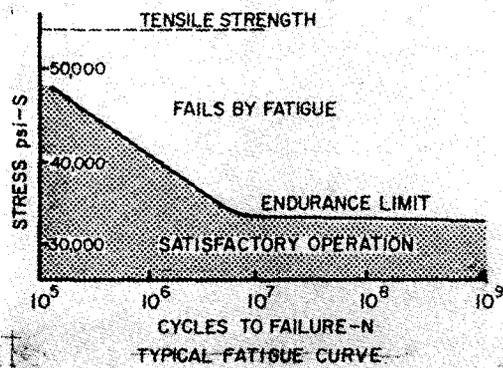
FIG. 21—A TYPICAL FATIGUE LIFE OR S/N CURVE. NOTE THAT THE FAILURES OCCUR WELL BELOW THE MATERIAL'S TENSILE STRENGTH AND ESPECIALLY SO AS THE NUMBER OF LOADING CYCLES IS INCREASED

Forces which tend to compress, flex, pound or overheat a bearing are conducive to fatigue; however, to initiate damage the intensity of these forces must exceed a certain tolerance, called the endurance limit. The greater the stress, mechanical or calorific, the sooner damage occurs as in FIG. 21. Bearing fatigue is first visible as fine surface cracks like those in FIG. 22 which are hair-line cracks in the lead-alloy overlay on a bronze marine bearing. Repeated stressing deepens the cracks, usually more or less perpendicular to the surface, and sometimes almost to the backing of the bearing. Continued stress extends
