REPAIRS.

(i) REPAIR TO FIRE AND BILGE PUMP CYLINDER COVER.

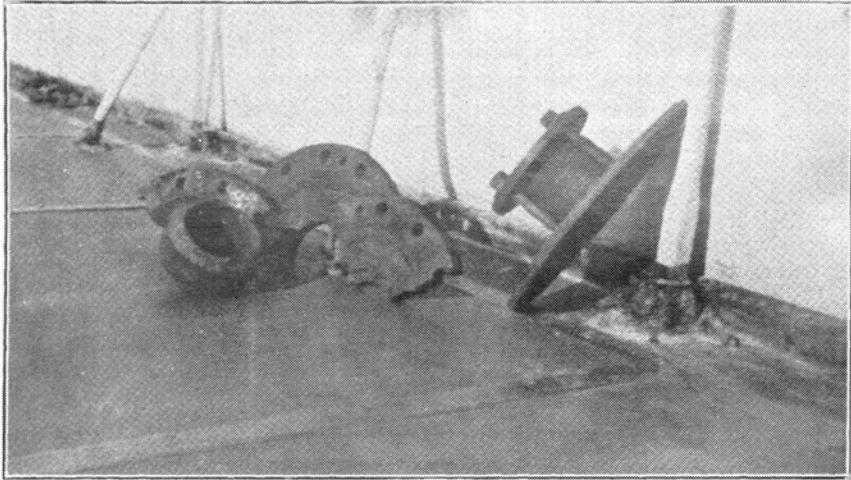
The breakdown was due to the excessive wear between the valve steam cap and the end of the main shuttle valve. This caused the main shuttle valve to stick in its steam cap, thus allowing the piston to travel beyond its normal stroke and come in contact with the cover, the result being that the cover was badly smashed into four pieces.

The repair was effected by improvising a new cover composed of a piece of steel plate for the flange and an old Weir's Pump Shuttle Valve Cap, with the slot cut off, as the dome—this method being adopted to overcome the difficulty of having a casting made.

The flange was 15 inches diameter and $\frac{3}{16}$ inch thick and had a $4\frac{3}{8}$ inch diameter hole cut in the centre. The dome of the Weir's Shuttle Valve Cap was fitted on to the flange with a serrated joint of permanite and was held in place by four $\frac{7}{8}$ inch steel studs which passed through a circular plate of $\frac{1}{2}$ inch steel, placed on top of the valve cap to form a strongback; the studs screwed into the flange of the cover, and the nuts when tightened up on the strong back, clamped the valve cap securely on to the flange.

The repair was satisfactory in every respect and was used for several months afterwards.
