# Service Performance of Boiler Brickwork—The Causes and Extent of Wastage

BRYAN TAYLOR, B.Sc.(Eng.) (Member) and H. BOOTH

The investigation described in this paper was undertaken by the British Shipbuilding Research Association and the British Ceramic Research Association with the following objects: to determine the extent of deterioration of refractory materials in watertube boilers in the merchant service; to formulate the main causes of wastage; to consider ways of improving the life of furnace brickwork; and to provide a background for any experimental work that may be desirable.

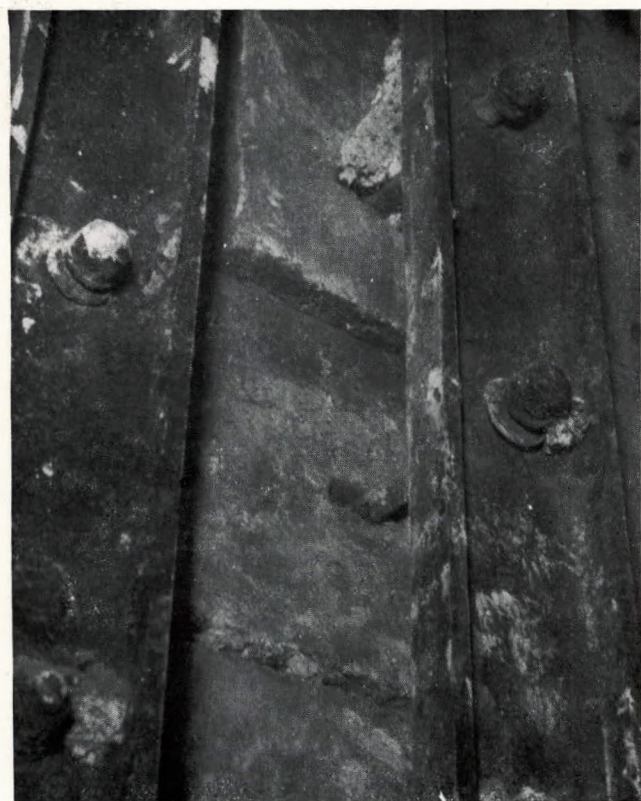
FIG. 24 (top left)—Damage due to failure of brick bolts: end wall of side-fired Yarrow boiler

FIG. 25 (top right)—Cracking of bolted blocks and failure of brick bolts: twin furnace controlled superheat boiler
