Some Interesting Ship and Machinery Defects, Their Investigation and Cure

A SYMPOSIUM OF SHORT PAPERS

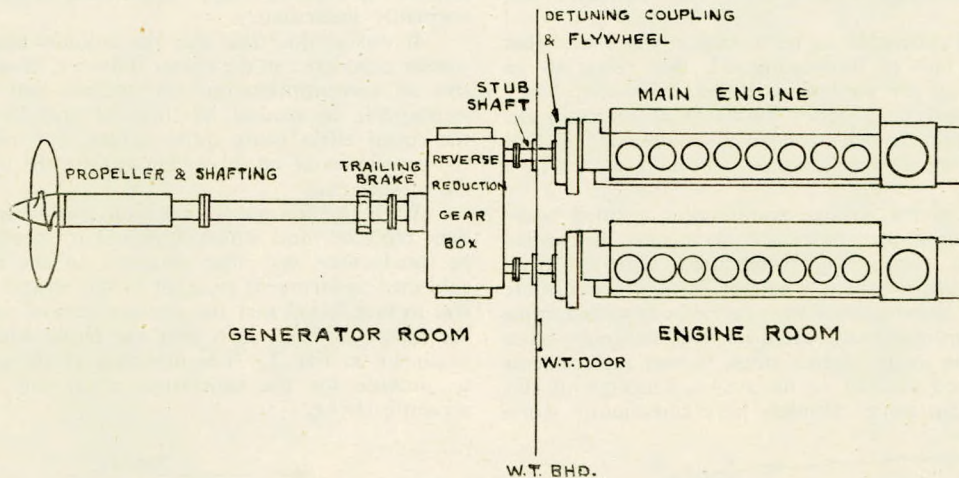
FIG. 3—Diagrammatic arrangement of geared Diesel installation

The arrangement in Fig. 3 shows a geared Diesel installation in which two engines, either independently or jointly, drive a single screw through a reverse-reduction gearbox. Each uni-directional main engine has eight cylinders, is of the two-stroke single-acting type and is capable of developing 1,400 b.h.p. at 300 r.p.m. At the forward end of each crankshaft, a hydraulic damper of the pumping-chamber type is arranged and at the aft end there is attached to each engine flywheel a detuning coupling. Separating engine room from generator room is a watertight bulkhead through which two stub shafts pass, each connecting an engine to the reverse-reduction gearbox, in which are fitted the oil-operated manœuvring clutches and constant mesh gearing. In the ahead gear train, the reduction ratio is 1:82:1 and the propeller speed at full power just under 165 r.p.m. The reduction ratio in the astern gearing is 2:62:1

The gearbox was then dismantled for examination. The starboard astern inner clutch members were found to be cracked and were replaced. The state of all other clutch members necessitated remedial attention. Inspection of the teeth of the gearing showed these to be in first rate condition.

There is little doubt that the condition of the engine dampers, particularly the starboard unit, deteriorated during the early service of the vessel. Their main duty was to damp the 3-node eighth order critical vibration which peaked at 212 r.p.m. in single engine operation and at 209 r.p.m. with twin engines. Reduced damping effect imposed increased vibratory torque in the gearbox clutches. The makers stated that the drive through the gearing could be treated as solid, as the clutches would not slip unless an overload of 50 per cent were applied. The transmission torque in single engine operation up to 175 r.p.m. was well within the capacity of the clutches but it was found in practice that deterioration took place and adversely affected their capacity for overload. To this feature these four causes contributed: (a) the shock effect of frequent

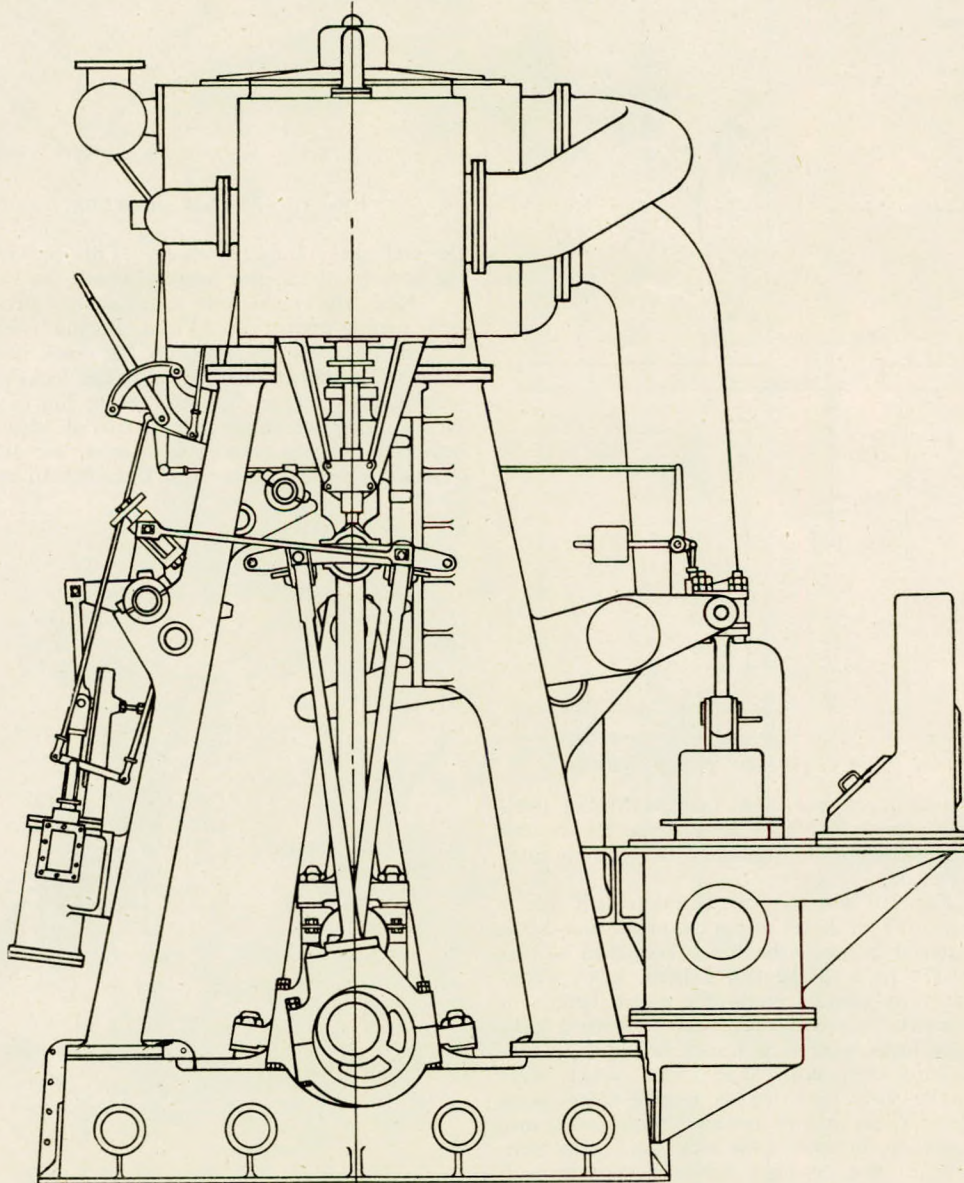
FIG. 8—Arrangement of steam reciprocating engine showing beam air pump

In this case a valve guard stud had broken off and cracked the air pump cylinder wall in several places and a triangular-shaped section, about $3\frac{1}{2}$ inches \times 5 inches, was broken out completely. Because of the age of the engine, no replacement cylinder was available and inquiry disclosed that a new casting could not be obtained until after the close of the season so it

was decided to attempt to carry out a repair by the use of a method known as "Metallock".

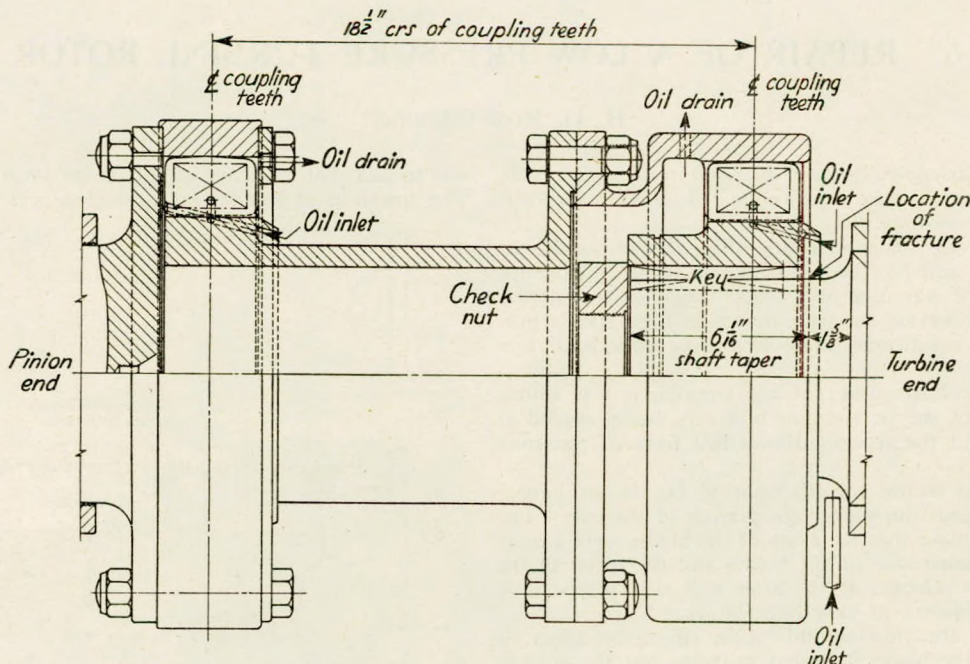
FIG. 17—Original arrangement of flexible coupling to low pressure turbine

This vessel is a twin screw, transatlantic passenger liner built in 1939, which saw very arduous duties as a troop transport during the war. It was stated that when the vessel was leaving the dock at Southampton, on opening steam to the starboard unit the turbines would not operate. Examination revealed that the stub portion of the low pressure turbine rotor shaft aft of the after bearing, to which the male claw of the flexible coupling is secured, had completely fractured in such a manner as to cause a jamming between the rotor thrust and the after end of the flexible coupling (Figs. 14, 15 and 16, Plate 2).

It would be noted that in Fig. 17 there were the words "Check nut". He himself had sent in a contribution which, Mr. Sampson said, would ultimately be published, referring to these check nuts, and to their slackening off. Why they should slack off was a complete mystery, but they did slack off and they rotated sufficiently to jack the turbine shaft forward and to ruin the thrust which was, he thought, unusual. While the cure was relatively simple—to put in adequate pins to stop it—the cause was still uncertain.

Several methods of procedure were considered but since they involved either a long delay in returning the ship to service or a considerable reduction in power and speed, it was finally decided to attempt a temporary repair (Fig. 17).

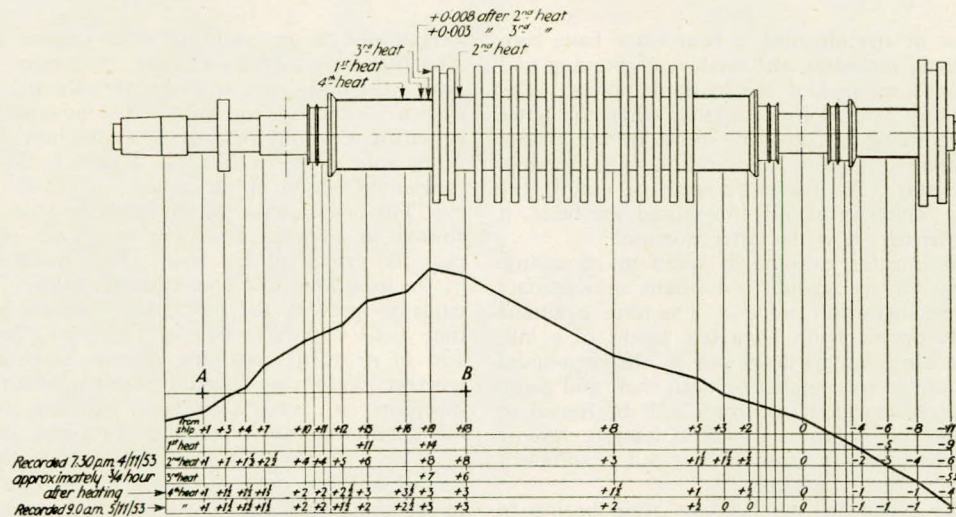
drawing of the rotor to a suitable scale, as shown typically in Fig. 20. It will be found in nine cases out of ten that the bend is near the neck of the main gland, and is concentrated into a few inches' length of shaft; the bend is usually in one plane, as shown by the fact that all the largest readings occur at one angular setting of the rotor, though small departures from this may arise near the points of support due to some initial eccentricity. Check that the axial readings are compatible with the bow as deduced from the radial readings, and take care not to get confused by mis-reading of a 0-50-0 micrometer scale (on one occasion in the author's experience this nearly happened).

FIG. 20—Graph of clock gauge readings taken in lathe. After fourth heat, high spot at A was 90 degrees from original plane of bend. Between A and B the plane of maximum bend gradually returned to the original position

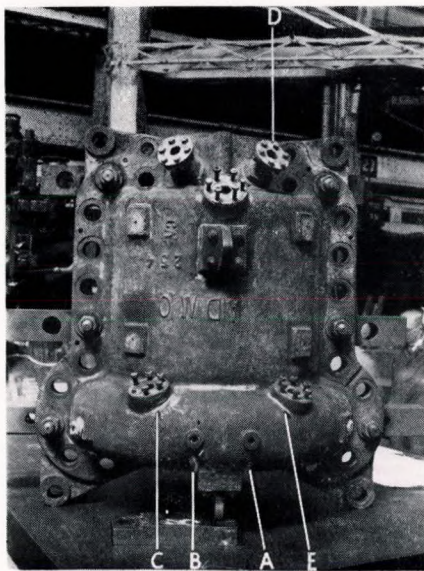
joint were the result of, and ran along, the boundary of previous welding operations and their removal has resulted in three large cavities, as shown in Fig. 24 (Plate 3), between the bolt holes and the bore of the cylinder. During the machining out, one or two blow holes were exposed at a depth of $1\frac{1}{2}$ inches from the surface of the joint. They showed clearly that slag inclusions were the cause of the cavities. A small exploratory cavity (Fig. 26, Plate 3), and three small cavities (Figs. 24 and 25, Plate 3), due to the removal of contraction cracks on the edge of the joint face and bore, complete the record of repairs required on this face. All the external radii were ground and polished, thus revealing five contraction cavities, four of which required attention, viz., one alongside the inlet gland casing and three on the surface on the exhaust steam belt. (Figs. 26 and 27, Plate 3, and Figs. 28 and 29, Plate 4.)

FIG. 26 (left)—Top half of h.p. cylinder

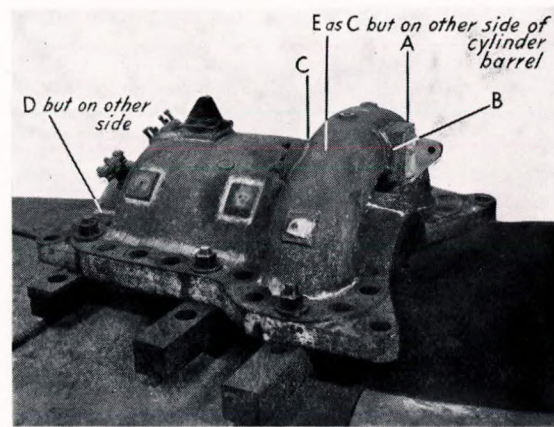
FIG. 27 (right)—Top half of h.p. cylinder

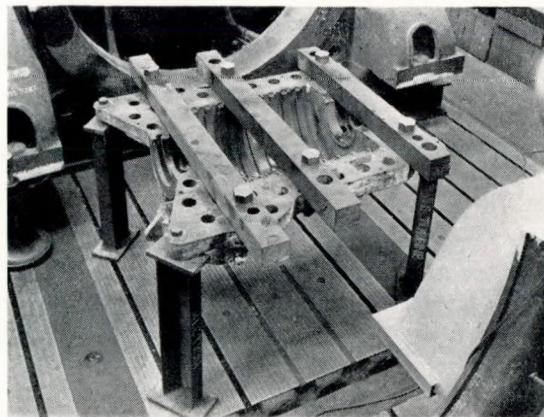
FIG. 30—View of top half of h.p. cylinder strapped
for welding

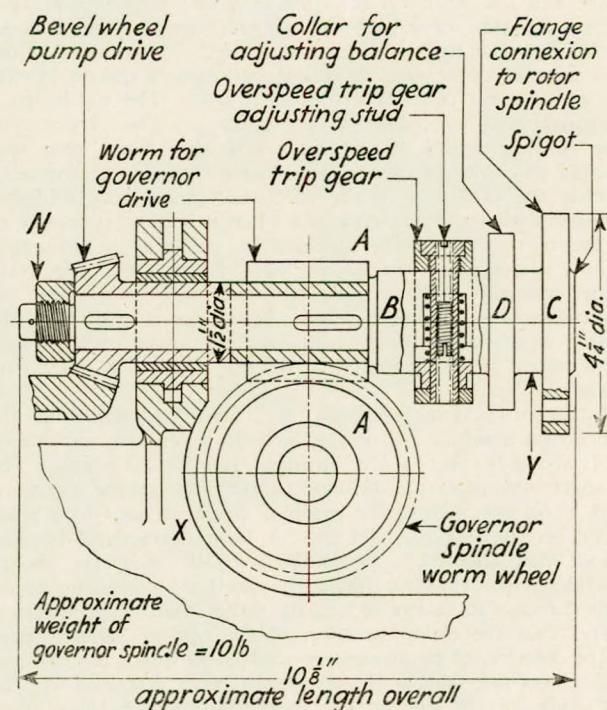
The machine concerned in the defect to be described was a 500 kW. turbo generator with a spigoted flanged joint at the end of the rotor spindle to secure a stub shaft for the purpose of driving the governor gear and water pump assembly and carrying the overspeed trip gear. This stub shaft is shown in the accompanying sketch (Fig. 37).

FIG. 37—Arrangement of stub shaft

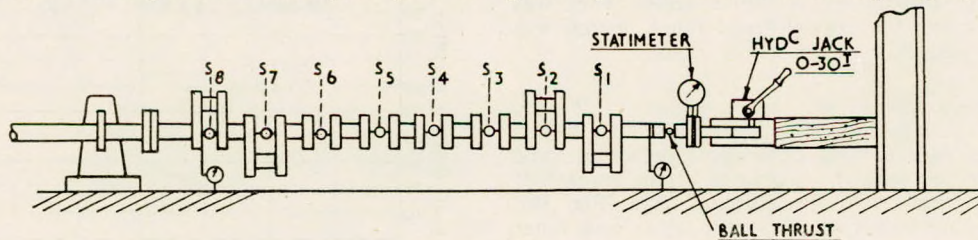
FIG. 38(a)

The records of the axial vibratory movements gave values of 0.200 inch at the free end of the crankshaft and approximately 0.100 inch at the thrust at 103 r.p.m. at a frequency of 412 c.p.m., i.e. 4th order. At this critical the noise emitted from the crankcase was suggestive of the sides of the crankwebs hammering against the bearing cheeks. A crankcase examination revealed that the coupling bolt points had in fact heavily gouged out the ribs and flanges of the adjacent transverse bearing girder. A static compression test was then made on the crankshaft, as shaft in Fig. 38, to obtain a reliable value for the axial stiffness. Electric resistance strain gauges were affixed to Nos. 7 and 8 crankpins and deflexion gauges placed in position in each of the crank throws and at the forward and after ends of the crankshaft. It was remarkable to observe the accuracy with which readings could be repeated for various loadings and the return to zero of all gauges when the load was removed.

Recommendations were made for cropping of the propeller tips with a view to raising slightly the service r.p.m.

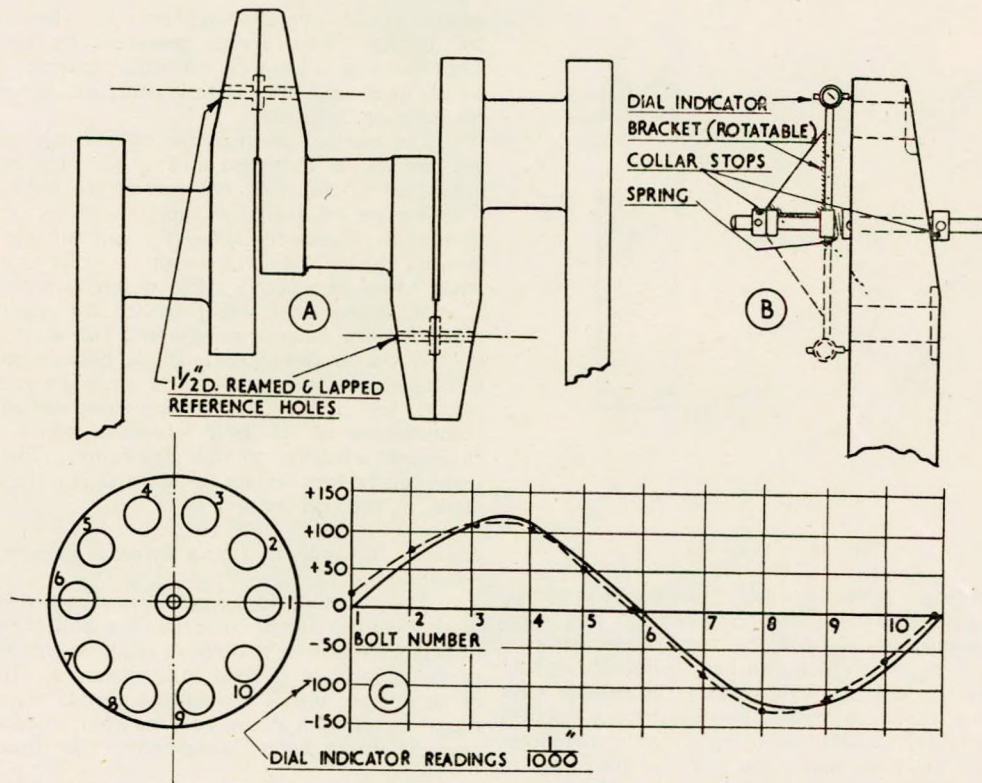
FIG. 41

and round. The bobbin piece was then withdrawn and machined. A ground bar size and size was inserted in one of the reference holes in the bobbin piece (Fig. 41(a)). The radius arm with two bearing bushes having a good fit on the bar and carrying a dial indicator at the other extremity (Fig. 41(b)) was threaded on to the bar and located by spring pressure against a registering collar secured to the bar. The arm was then run round the outermost plane surface of the coupling face and the indicator readings at each of the numbered bolt holes were noted. These are shown plotted in Fig. 41(c) as the full line. The bar was then inserted into the reference hole in the corresponding mating crankshaft coupling. The results obtained are shown dotted in Fig. 41(c). Small reference patches filed in way of the corresponding numbered holes in the crankshaft coupling would give a datum plane true to the machined surface of the bobbin piece coupling. It should be remembered that in this case directions are reversed, i.e. a high spot shown on the bobbin piece coupling would

mate with a low spot of the same amount on the crankshaft coupling because the dial indicator on the radius arm would be on the opposite side of the plane representing the abutment of the two mating couplings. The dotted curve shown has been plotted with signs reversed.

by merely dismantling the adjacent connecting rods, would be resurfaced in the lathe while the abutting crankshaft coupling faces would require hand work to be carried out *in situ*. The problem was how to ensure that when the four coupling faces were put up to each other there would not be excessive misalignment between the faces. The following arrangement was adopted and is shown in Fig. 41.

Recommendations were also made that the abutment of both coupling faces should be limited to an annular fitting strip of $4\frac{1}{2}$ inches on either side of the pitch circle, and that the very hard fit previously employed for the coupling bolts should be reduced as it was felt that the effective elasticity of the bolts had been seriously reduced.

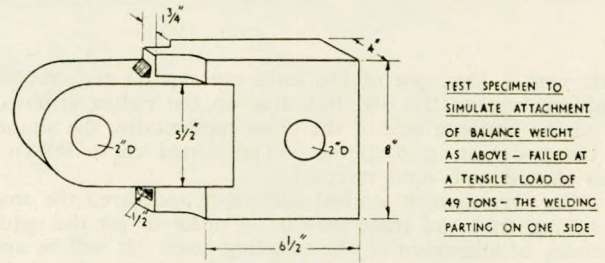
FIG. 44(b)

A problem was recently presented to the department where quite strong vibratory forces were generated in some compressor units intended for shipboard, and it was rightly considered by the makers that there was a possibility of trouble with the joints of attached piping and other ancillary equipment when installed in the vessel. Calculations showed that it was possible to reduce the offending primary couple in the compressor to negligible proportions by fitting balance weights of a size which could be accommodated within the totally enclosed crankcase. The difficulty arose when consideration was given to the attachment of these weights to crankwebs. Welding was the
