# The Significance of Apparently Minor Factors in Corrosion Problems Affecting Condenser and Cooler Tubes\*

C. BRECKON, B.Sc. (Member)† and J. R. T. BAINES (Associate)‡

\* Presented at a meeting of the Kingston upon Hull and East Midlands Section of the Institute, on 17th February 1955.

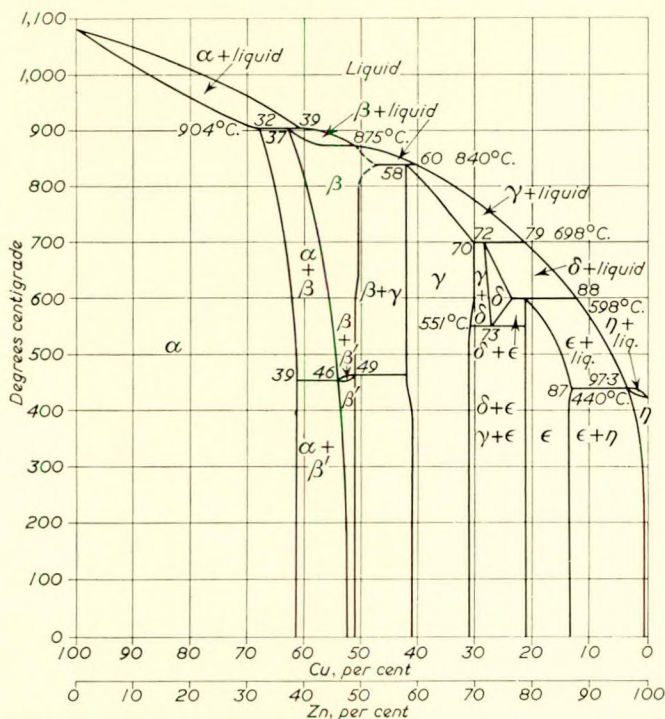
FIG. 3—Equilibrium diagram of the copper-zinc system

The freezing points for the complete range of alloys of copper and zinc are shown, together with any changes taking place after the alloys have reached the solid state. Alloys of copper and zinc containing less than 38 per cent zinc consist entirely of the alpha phase, but with increasing zinc content a proportion of the beta phase is present so that a 60/40 alloy at room temperature contains both alpha and beta phases.

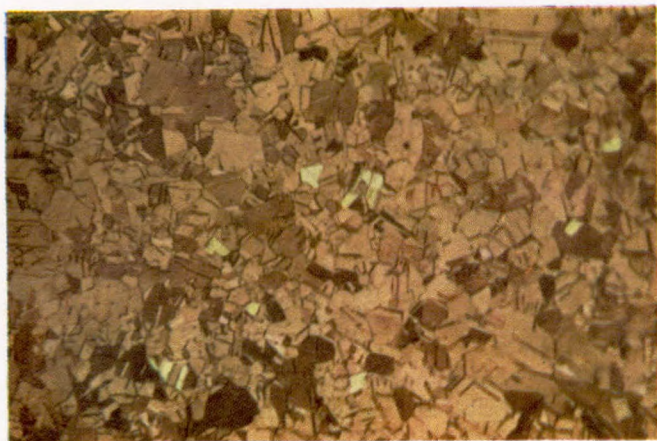
FIG. 4—Photomicrograph showing the structure of alpha brass

A specimen of wrought 70/30 brass polished and etched to show the crystal structure. The material exists as a homogeneous alpha brass. Colour differences between groups of crystals are due to the different orientation of the crystals of the alloy.

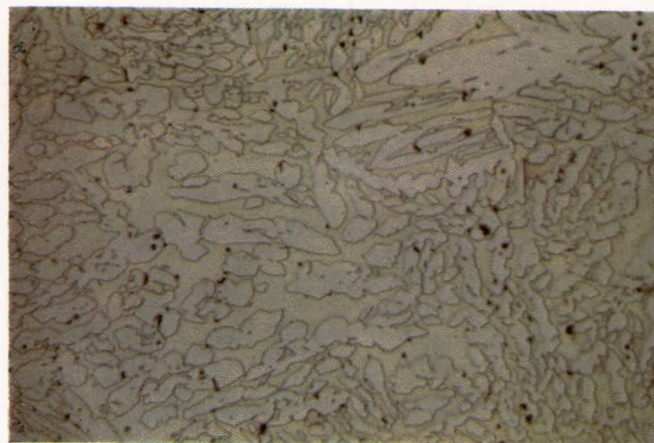
FIG. 5—Photomicrograph showing structure of a duplex brass

Specimens of wrought leaded 60/40 brass polished and etched to show the crystal structure. The two phases (alpha and beta) existing in this alloy can be distinguished on the photograph, the darker background showing the beta phase with islands of lighter coloured alpha phase embedded in it.

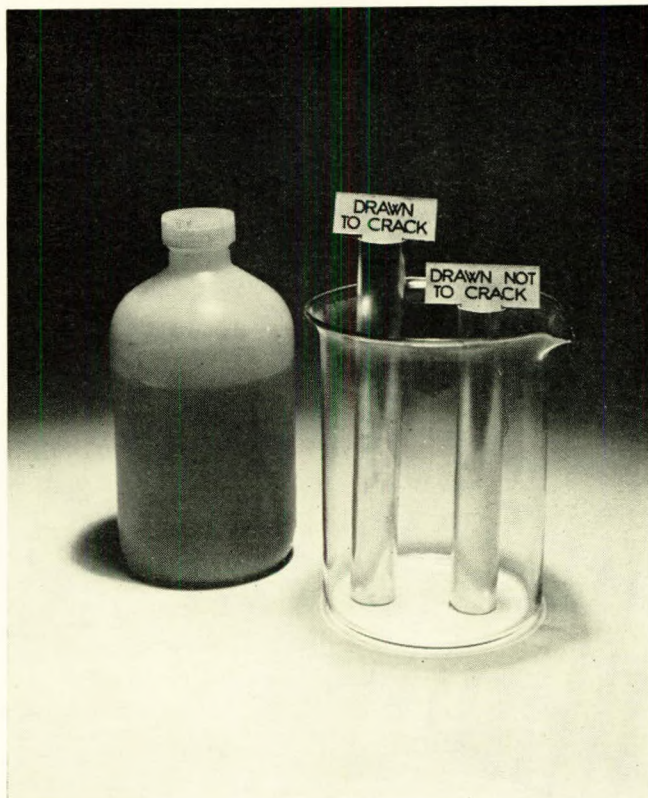
FIG. 14—Season cracking test (a) before immersion of specimens  
Two portions of the same, original tube, drawn by different drawing methods, are ready for immersion in 10 per cent mercurous nitrate solution.

There is a very good test which illustrates when a tube is liable to fail by season cracking, in which the tube is immersed in a dilute solution of mercurous nitrate. The mercury liberated by chemical interchange on the surface of the brass tube acts as a very rapid stress corrosion agent and a tube which is liable to fail after a prolonged period in service can be cracked by a period of only a few minutes in this solution. Figs. 14 and 15 show tubes before testing and again after a period of only fifteen minutes in this solution. The correctly drawn tube has developed no cracks, but the one containing unbalanced stresses is very badly cracked and has been distorted by the stress.

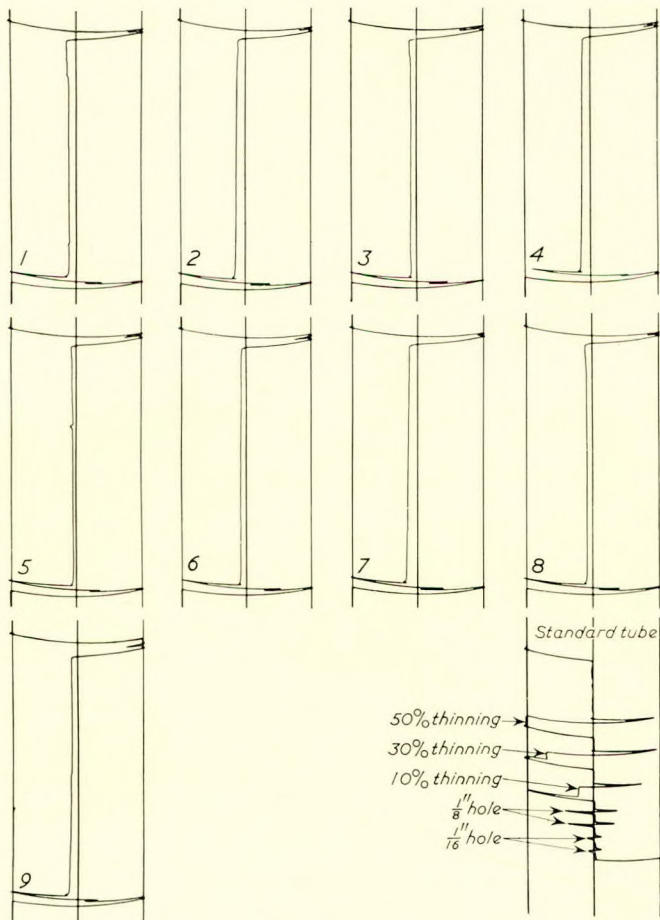
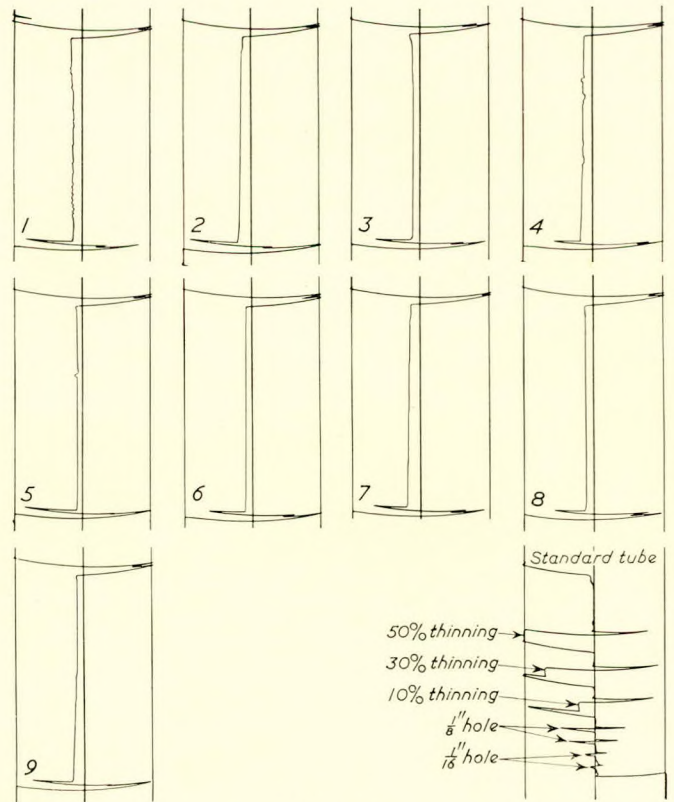
FIGS. 16 (original) and 17 (after service)—Probolog charts of aluminium brass tubes drawn in the normal manner

The traces obtained for the nine tubes are shown prior to going into service, and after six months' service. It will be seen that there is little difference in the two sets of traces and that after six months' service these tubes are free from attack by corrosion.

After the tests had been running for approximately six months the tubes were again examined by the Probolog. Fig. 17 shows the Probolog charts of the nine tubes made in a normal manner at the end of the test run. It will be seen that the traces are still essentially straight lines on the same standard setting of the instrument.

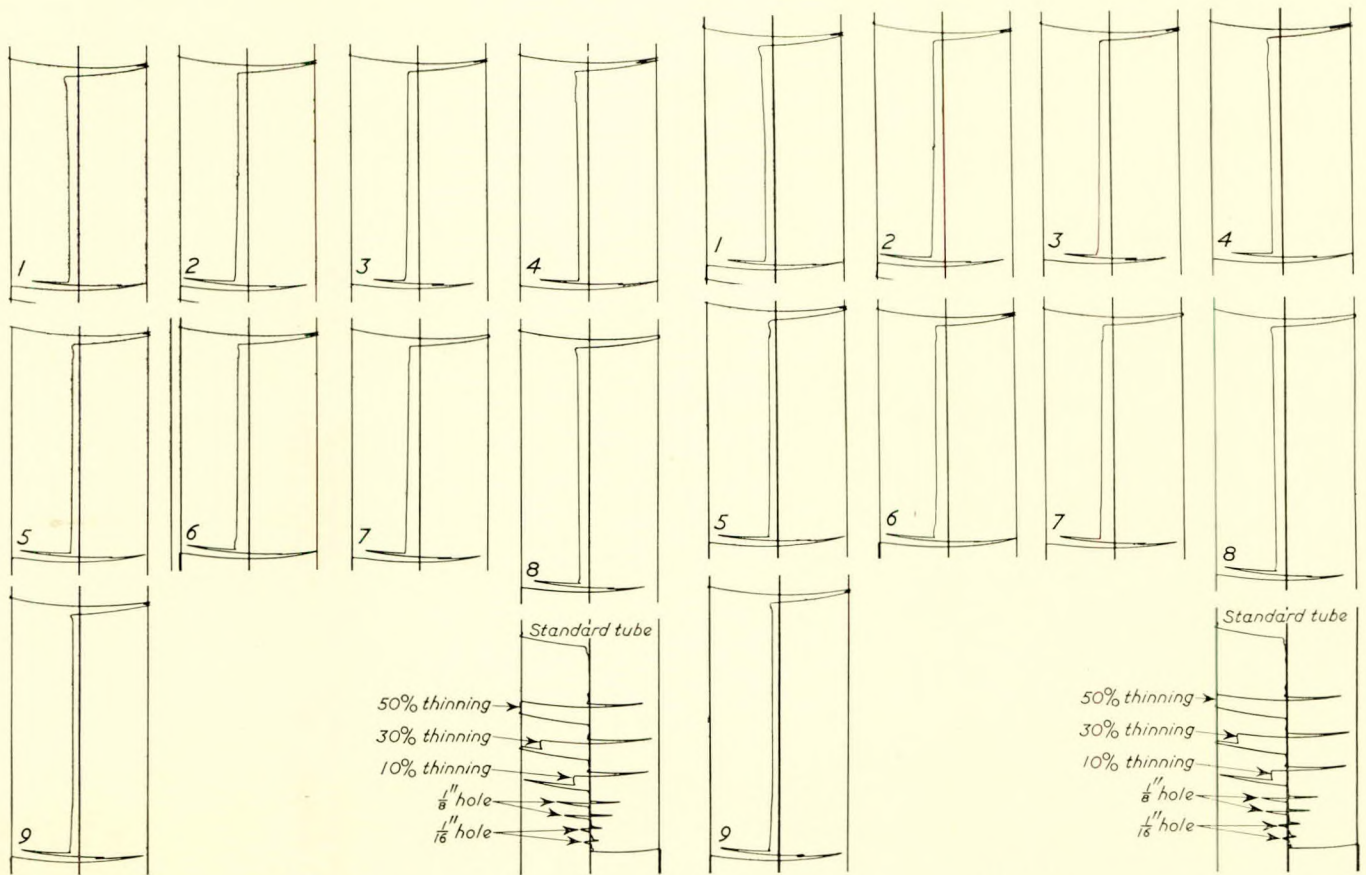
FIGS. 18 (original) and 19 (after service)—Probolog charts of aluminium brass tubes with a very fine grain structure

The particularly fine grain size tubes, before the test, are shown in Fig. 18, and after the test run in Fig. 19. Again, no corrosion of any consequence has taken place.

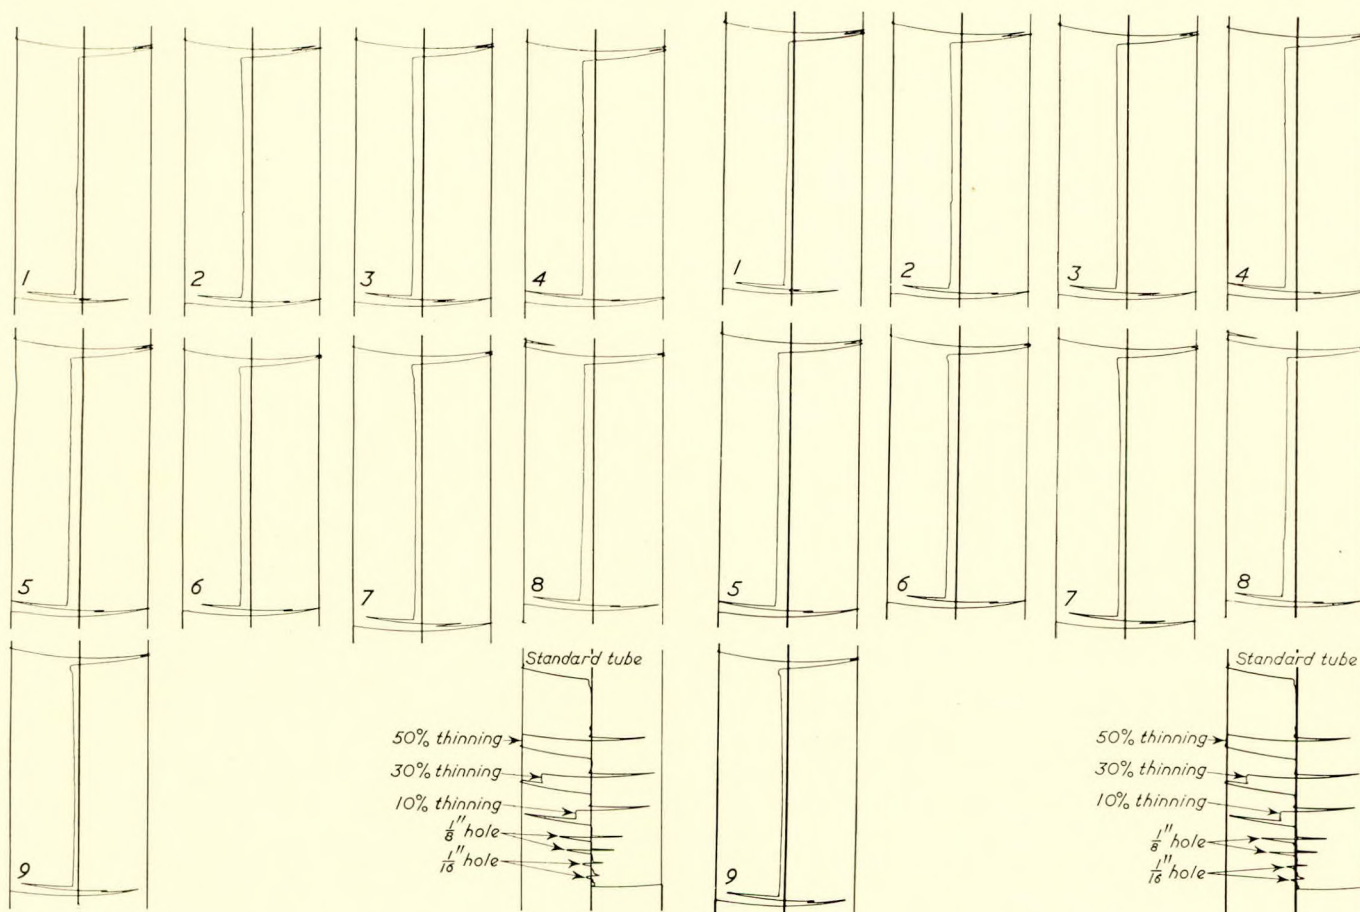
Fig. 20 shows the heterogeneous grain size tubes before the test, and Fig. 21 shows the traces given by the tubes after test, and again there has not been any corrosion.

FIGS. 20 and 21—Probolog charts of aluminium brass tubes drawn with heterogeneous grain structure
