THE INSTITUTE OF MARINE ENGINEERS

Some Operating Experience at 950 Degrees F.

L. BAKER, D.S.C. (Vice-President)* and W. H. FALCONER (Associate)†

The paper gives an account of the two years' experience of the operation of s.s. *Nestor* and s.s. *Neleus*, which were the first two British ships to operate at 950 degrees F.

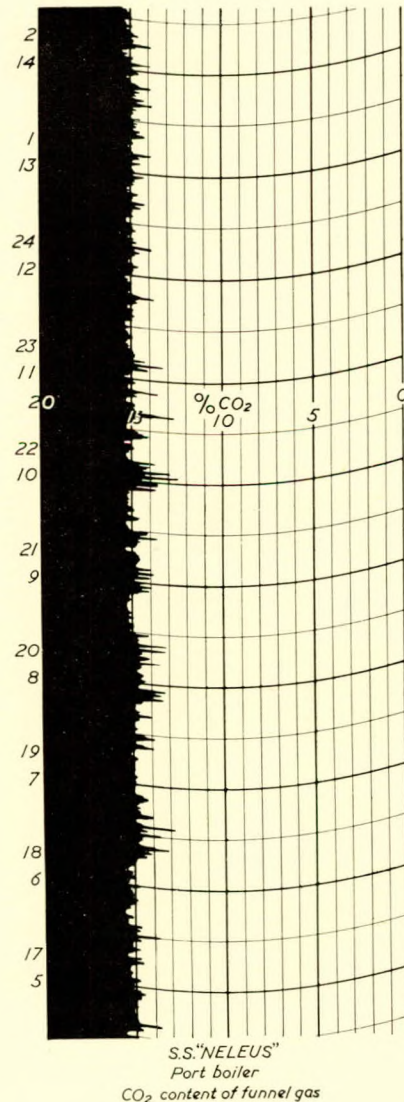
FIG. 13—Extract from the CO₂ chart

typical of the whole voyage (Fig. 13), 14.5-15 per cent being usual with fuels of viscosities from 90 seconds Redwood No. 1 to 4,500 seconds Redwood No. 1.

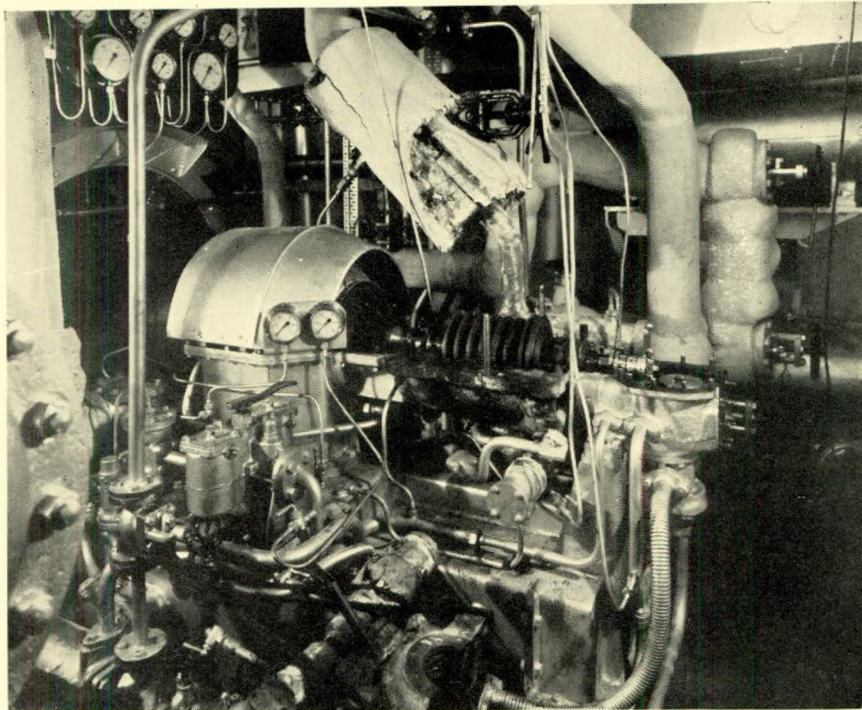
FIG. 14—Turbo generator in s.s. *Neleus*: view of gearbox and turbine casing removed

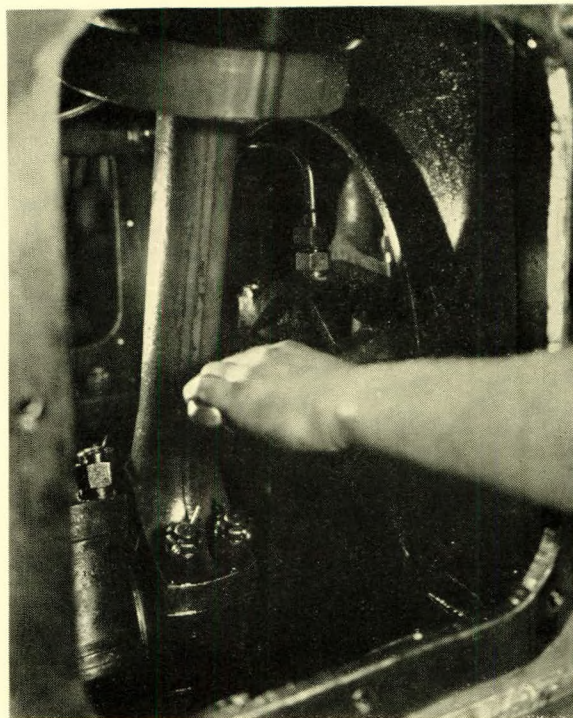
FIG. 17—Diesel generator in s.s. Neleus: view through No. 1 crankcase showing accessibility of main bearing

The accessibility of the engine received particular attention at the design stage and the usual disadvantage of the Vee engine has been most successfully overcome (Figs. 16, 17, 18, 19 and 20).

Service experience has been excellent and the wear rate of the liners is 1.29 thousandths per 1,000 hours using ordinary cast iron liners.

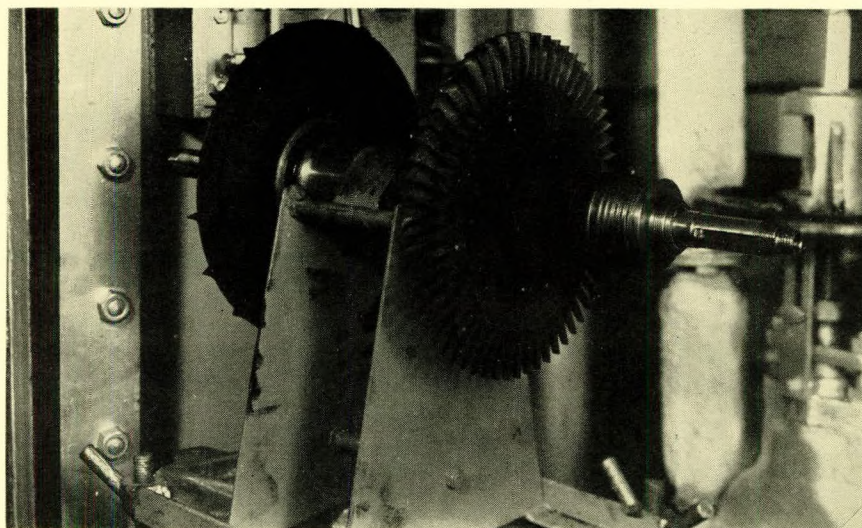
FIG. 16—Napier turbocharger in s.s. Nestor: general view of turbine wheel—admission side

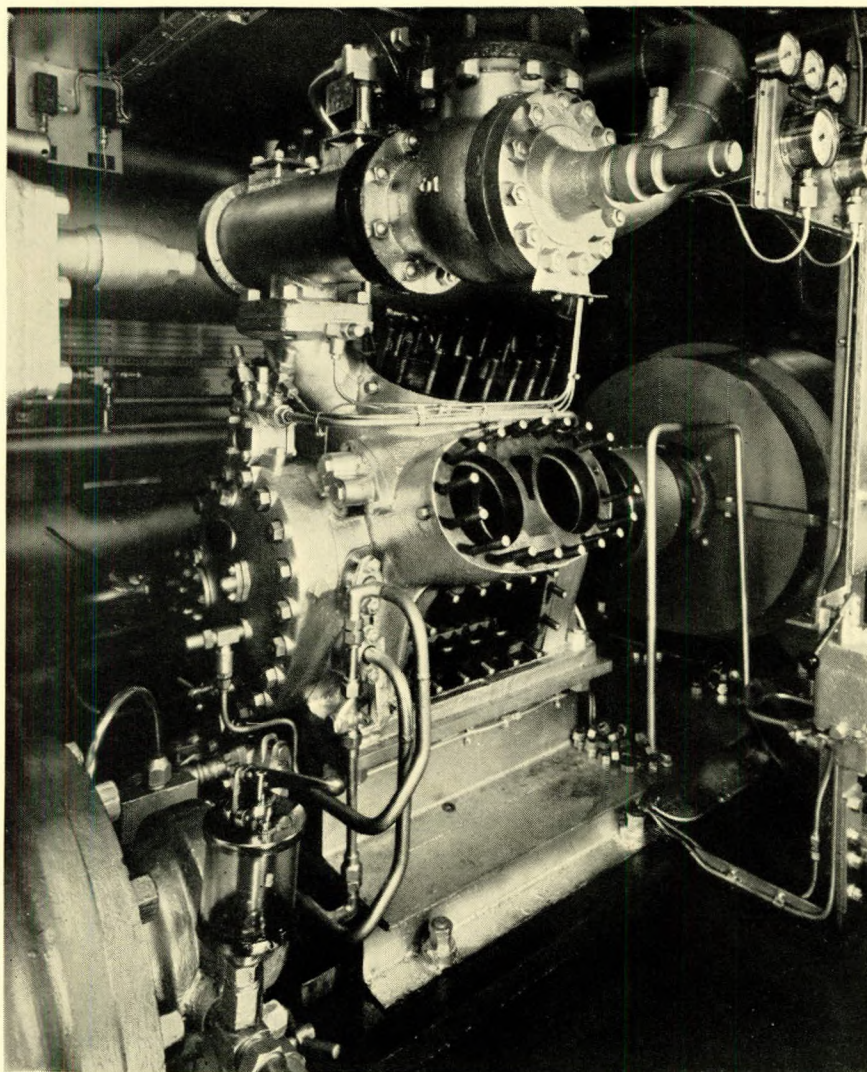
FIG. 21—Vee-block refrigerating compressor in s.s. *Neleus*: general view of dismantled compressor with suction valve chest and magnetic filter overhead

This high-speed Freon compressor has behaved very satisfactorily and has proved to have only one drawback from the point of view of the ship's staff, viz. that its capacity is so large that it requires no assistance from the other compressors fitted! It is obvious from Figs. 21, 22 and 23 that mechanically the condition is perfect.

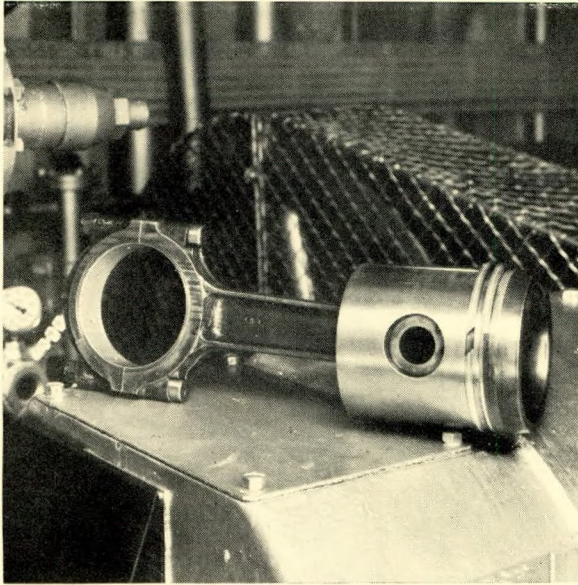
FIG. 22—Vee-block refrigerating compressor: piston and connecting rod assembly as removed from machine

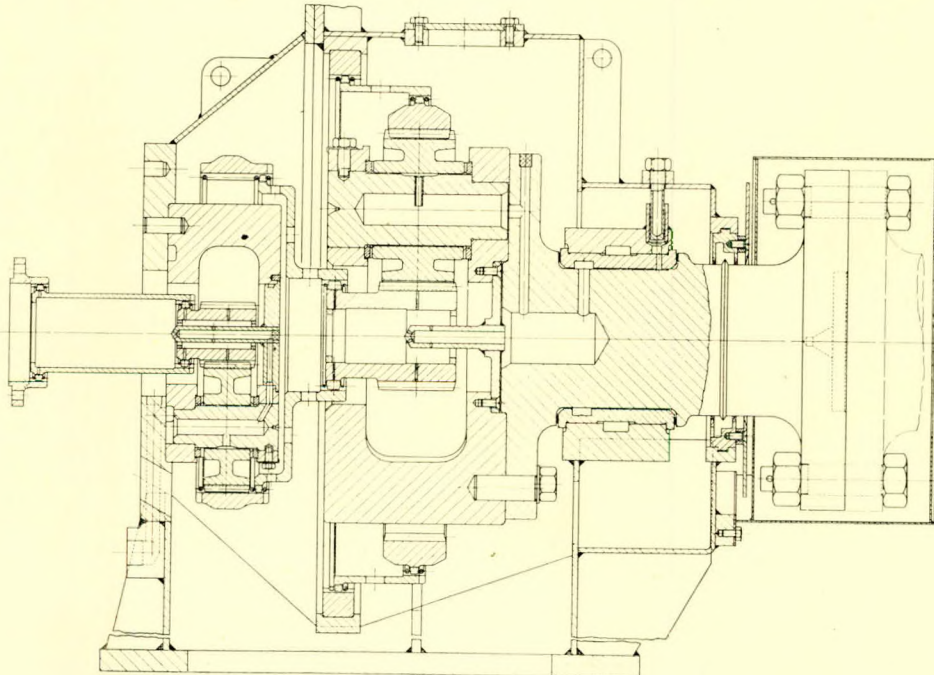
FIG. 24—Double reduction epicyclic gear with straight spur teeth (780 h.p., 16,500/600 r.p.m.)

Fig. 24 showed a sectional arrangement of the gear. On the extreme left-hand side was the flexible coupling which was driven from the turbine shaft. The coupling drove the floating sun wheel or sun pinion of an epicyclic gear with stationary planet wheel axes. (This type of gear train was sometimes called a "star gear".) The annulus engaging the planet wheels was connected by a flexible coupling to another floating sun wheel which drove a planetary epicyclic gear train, which in turn drove the dynamo shaft. The whole assembly comprised, therefore, a double-reduction, straight-spur, epicyclic gear. The teeth of the sun and planet wheels were hardened and ground.

In 1951, when the first set was ordered, the art of high precision epicyclic gear manufacture embraced only single helical and straight-spur gears, and it was hoped that straight-spur teeth would be adequate for both the boiler feed pump and the turbo-generator gears. In the case of the boiler feed pump gear this hope was entirely justified, but it was only partly justified for the turbo-generator. At the end of 1952, when the *Nestor* and *Neleus* gears had both been made and tested and had both been found to produce a somewhat objectional noise, it had become possible to design and manufacture a double helical epicyclic gear to fit into exactly the same gear-box; which gear was illustrated by Fig. 25. Such a gear had now been made and tested. Under the same conditions as those in which 103 db had been recorded for the two other gears, it gave a noise level of 92 db, 11 db lower than before, and was regarded as an entirely satisfactory gear.

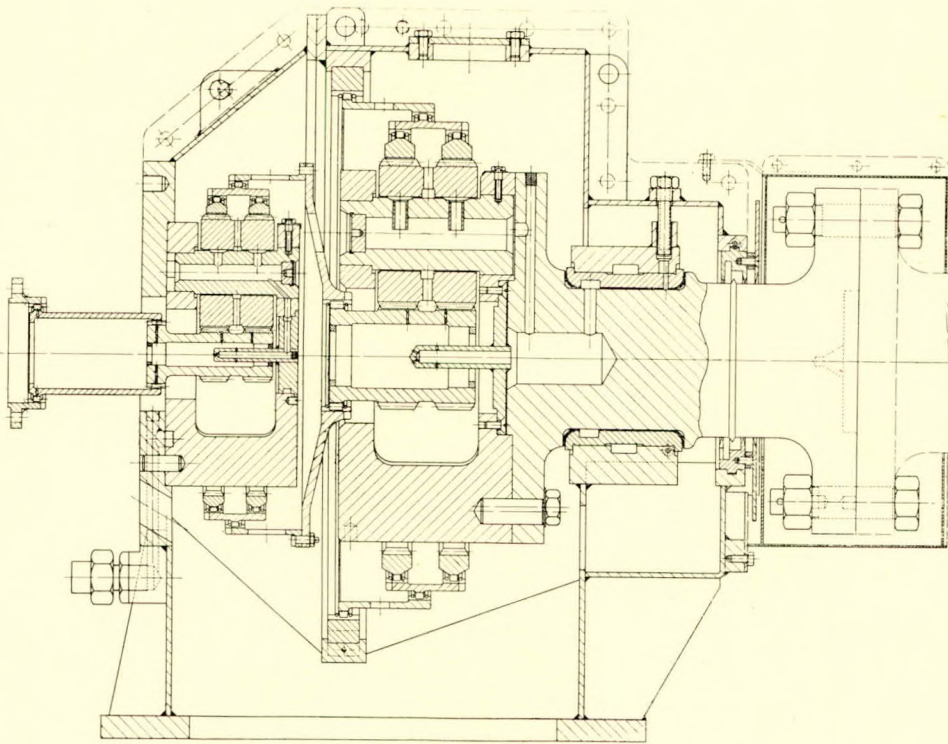
FIG. 25—Double-reduction epicyclic gear with double-helical teeth (780 h.p., 16,500/600 r.p.m.)

spur gears. There were, however, considerable differences in details of construction, as indicated in Fig. 25, notably in the use in each train of a pair of annulus rings coupled together by an internally toothed coupling ring.

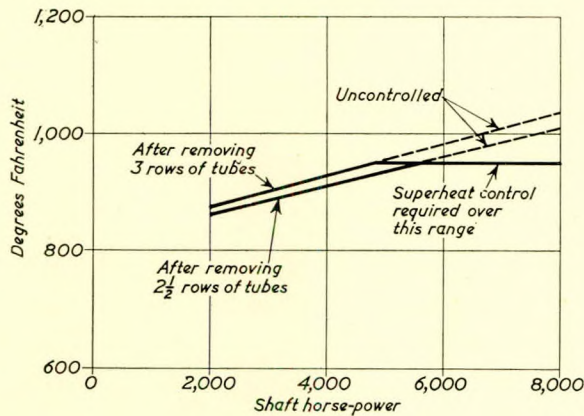
FIG. 29—S.S. Neleus: final steam temperature

During manoeuvring the steam temperature was limited to 750 deg. F. and after "full away" had been ordered, the temperature of the steam was allowed to rise at the rate of about 250 deg. F. per hour to 950 deg. F. Fig. 29 showed the potential steam temperature curve for the boilers, outlining the portion controlled by the desuperheaters.

Replying to Mr. Culver, the authors stated that the potential superheat with the final arrangement of four-and-a-half rows of tubes and the range of steam temperature control were both shown in Fig. 29. The safety devices for boiler water level were always in use and had only rarely operated due to adverse conditions. In the early days the swing of water level, due to manoeuvring, was sufficient to cause tripping but this had now been stabilized.
