Some Considerations of Wear in Marine Gearing

W. H. DARLINGTON, M.B.E., Ph.D., M.Sc.(Eng.), A.M.I.Mech.E.*

The paper deals with the design, manufacture and operation of three sets of marine double reduction gears, having a tooth loading indicated throughout by a Lloyd's K value of 120. They were also the first set of marine gears to be shaved throughout by the author's company. The first two sets of gears had a transient wear problem associated with the dedenda of the second reduction pinions and wheel which cured itself on continued operation and has now ceased. The third set was fitted with hardened and ground pinions but soft main wheel. This had no wear problem.

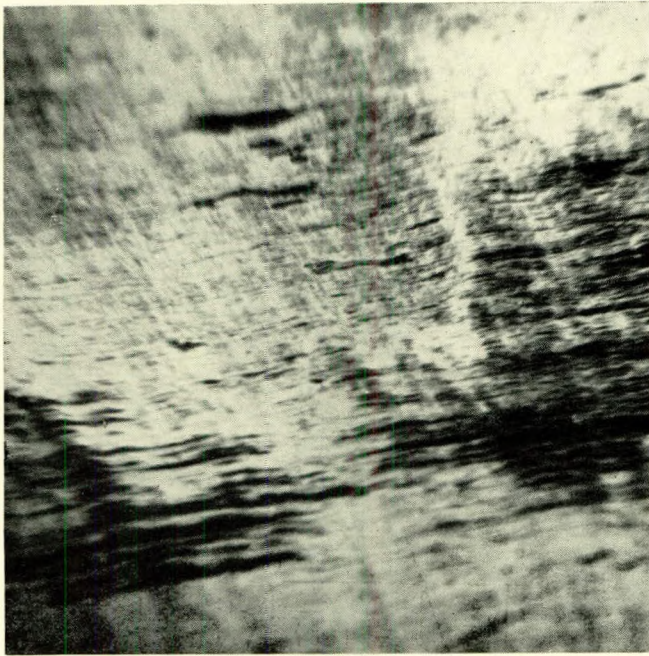
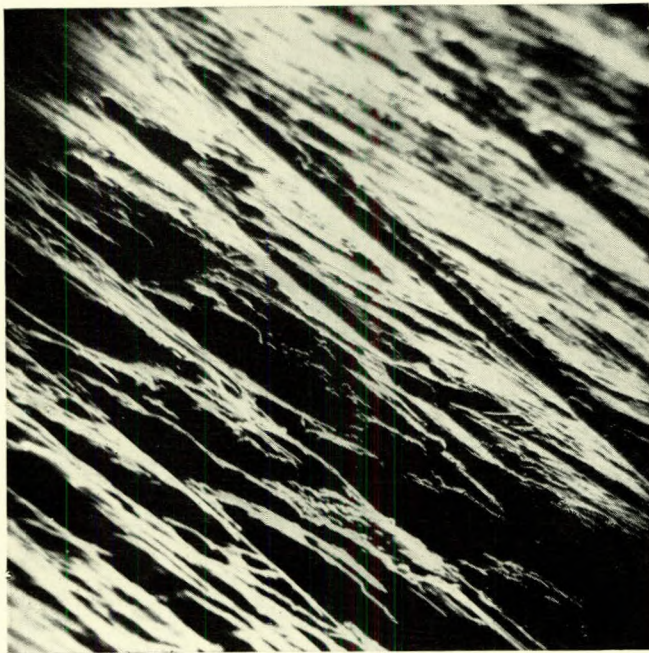
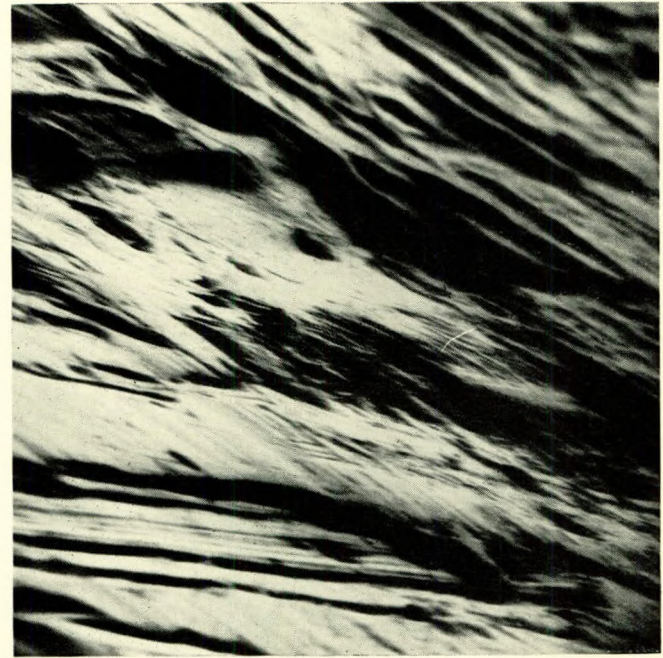
FIG. 5(a)—Reflection electron micrograph: hobbed gear

FIG. 5(c)—Reflection electron micrograph: heavily shaved gear

FIG. 5(b)—Reflection electron micrograph: lightly shaved gear

remaining elements to be shaved. Some idea of hobbled and shaved surfaces viewed, using methods described by Haliday⁽³⁾, are shown in Fig. 5. These only view a very small area and are not necessarily representative of the whole surface.

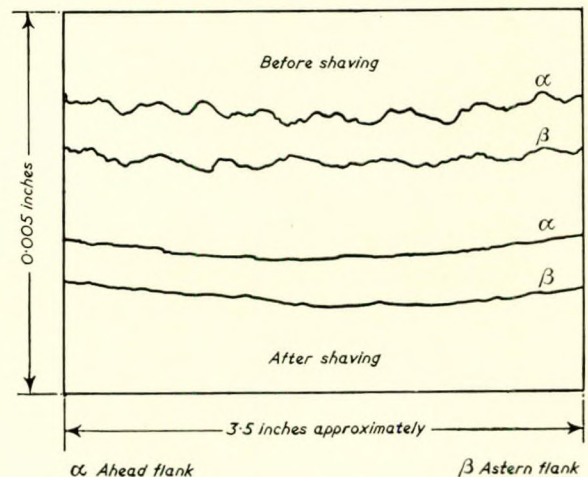
FIG. 6—Typical undulation records of Nestor *i.p.* second reduction pinion

removing undulations, and correcting profile, but was also excellent on sets 2 and 3 for matching the beds of wheels and pinions. Some final inspection records are given in Fig. 6 and Table V.

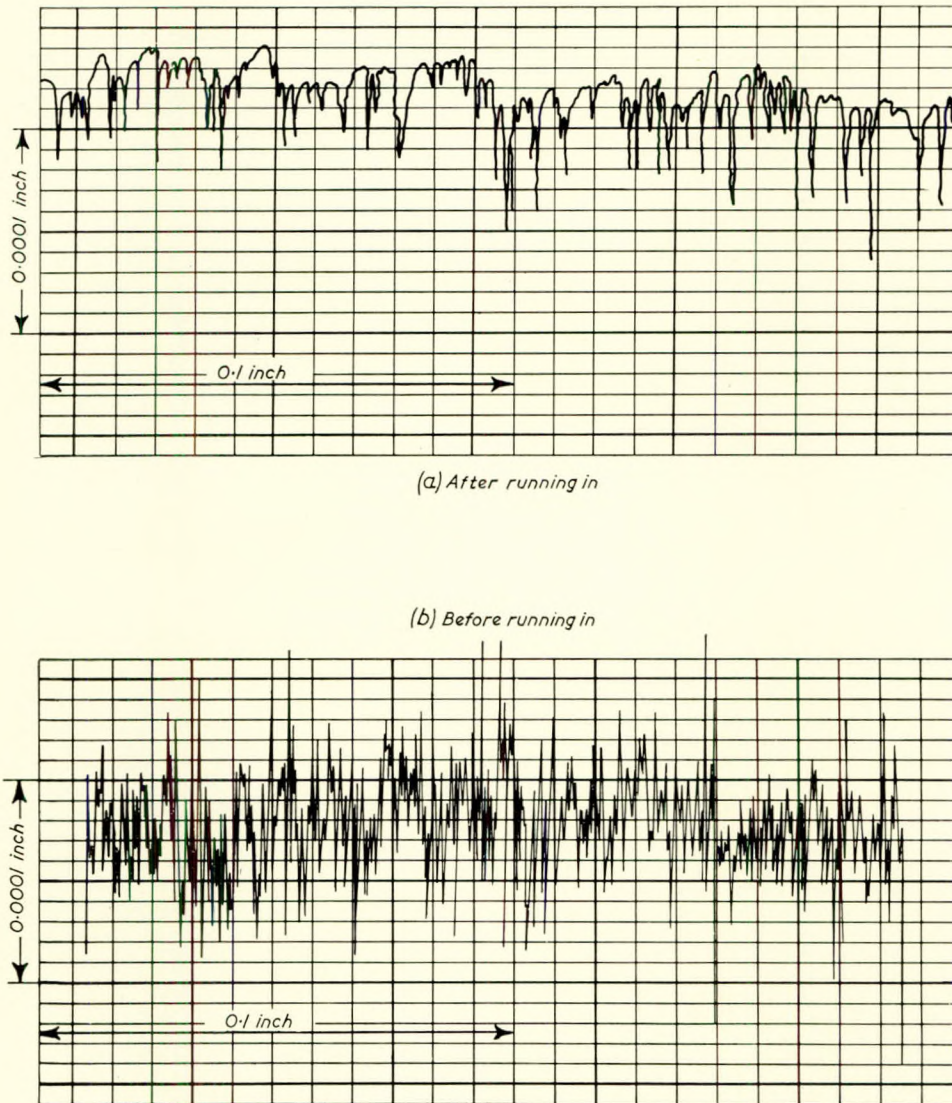
The tests show a definite connexion between permissible loading and surface finish, since, given care with the "running in", it was possible to operate the discs without scuffing up to the highest loading, with the worst combination of materials. This seems at first sight to indicate that there is no unique scuffing load attributable to any pair of materials. It may be that different materials fail because of different surface conditions produced by the same manufacturing process. Surface finish measurements on the discs which had been run-in show a profile with most of the asperities worn away (see Fig. 18). It is suggested that the altered surface conditions probably allow a thinner oil film to operate satisfactorily since the

FIG. 18—Surface finish records of discs on a 6-in. machine

It is suggested that odd asperities make initial contact and heat up the disc and hence the residual oil film on the surface; this allows more asperities to touch and so on. According to the shape of surface finish as well as its value, this may result in a well run-in surface with good lubrication when all the major asperities have gone, as in Fig. 18, or a progressively increasing metal-to-metal contact culminating in scuffing.

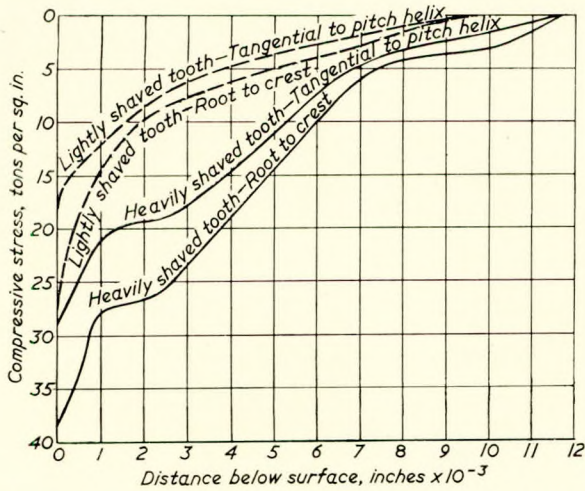
A recent examination of surface stresses due to grinding and milling had been carried out with small square plate specimens, and this was extended to cover thin, approximately flat, plate sections, cut from the tooth surfaces on the above slabs. For details of the method used see Appendix III. The results are given in Fig. 20.

FIG. 20—Residual stress measurement, experimental pinion: all stresses measured at centre of tooth surface

The values obtained, corrected as described above for distortion of the test piece during cutting-out and polishing, are plotted on Fig. 20 against distance from the surface. No claim can be made for their absolute accuracy because the method of calculation applies strictly only to specimens of constant thickness. From the comparative point of view, however, the results should be useful since the dimensions of all test pieces used were almost identical.

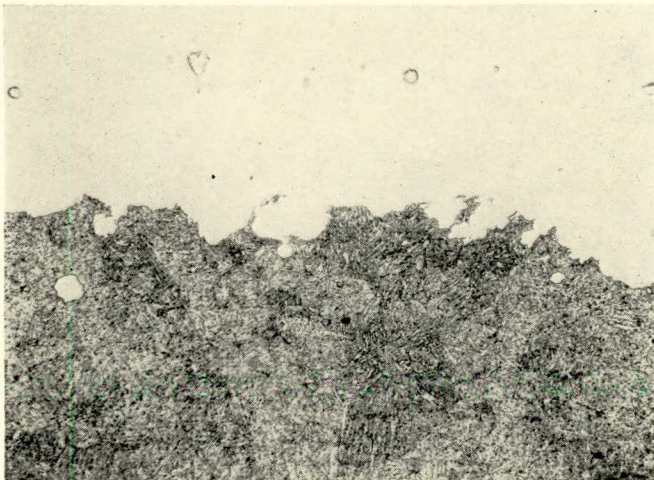
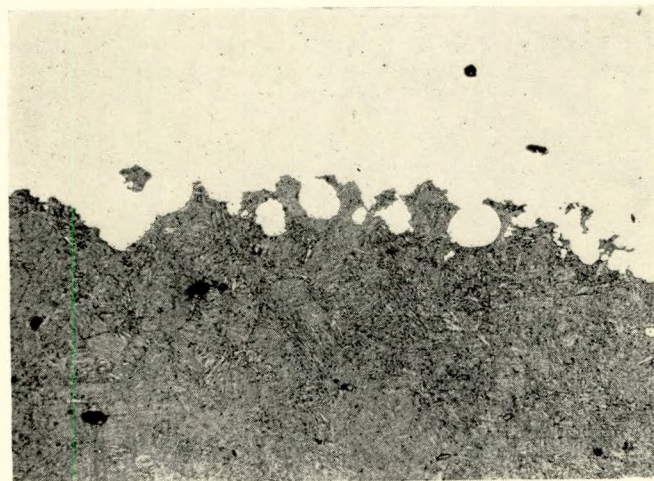
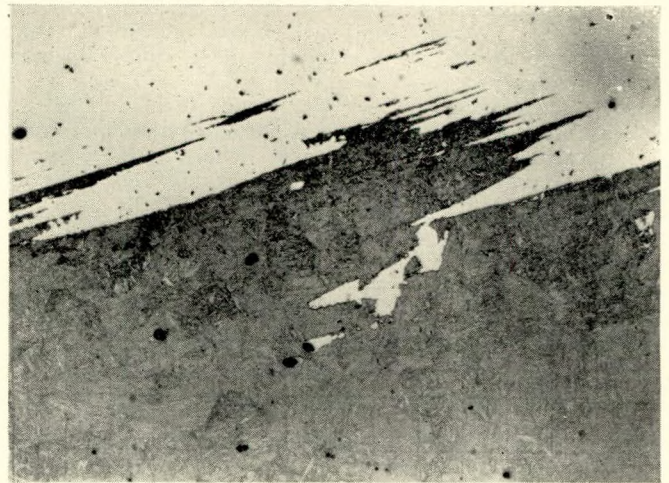
Transverse magnification 3,000 Lateral $\times 150$
FIG. 21(c)—1:20 taper section of heavily-shaved gear tooth

Transverse magnification 3,000 Lateral $\times 150$
FIG. 21(a)—1:20 taper section of as-hobbed gear tooth

Transverse magnification 3,000 Lateral $\times 150$
FIG. 21(b)—1:20 taper section of lightly-shaved gear tooth

Taper sections were also made of the surface layers to examine the microstructure for grain flow along the surface as reported in other machining processes (Chisholm)⁽¹³⁾, since Cameron⁽¹⁴⁾ mentions cracks which started at the surface and followed grain flow. No serious alteration or deformation was found due to any of the three processes (see Fig. 21(a), (b) and (c)).

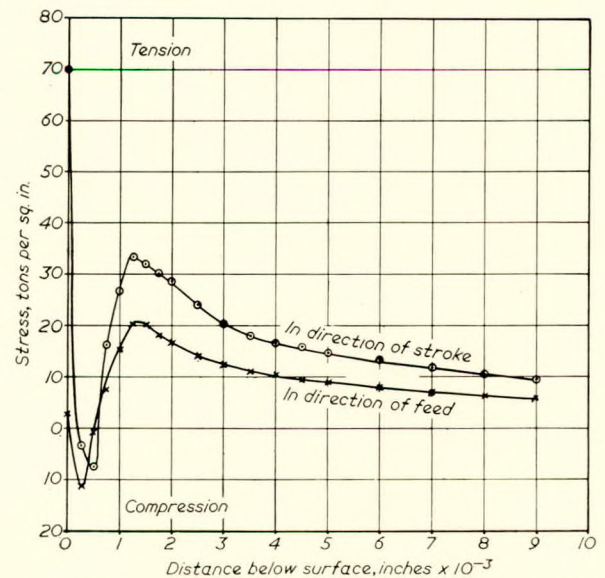
It has not yet been possible to examine a hardened and ground tooth for comparable stresses. The only evidence the author has on this process is that from the plate specimens mentioned earlier, in which the metal removed per pass by grinding was much greater than is normal in gear practice. The results are shown in Fig. 22, but they are not strictly comparable with the other curves, or necessarily indicative of the conditions of the *Theseus* pinions.

FIG. 22—Residual stress distribution after grinding

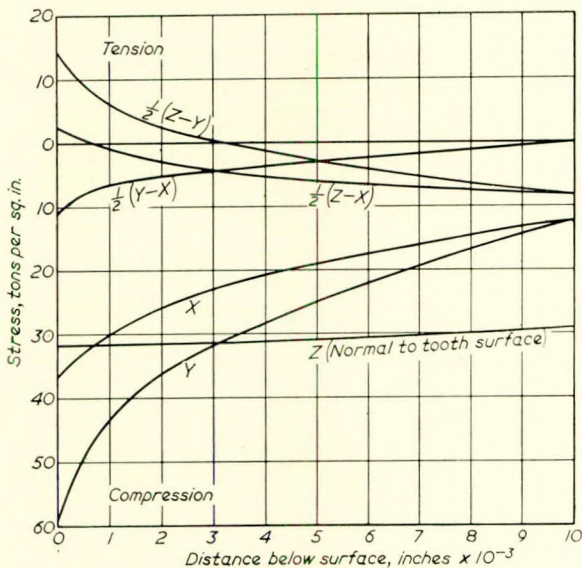
with the residual stresses due to (a) and allowing for the different principal axes, the resulting stresses are shown in Fig. 24.

FIG. 24—Components of combined residual and applied stress

In the region immediately below the centre of the contact area the three principal stresses are of the same order and the shear stresses are thus small. This condition is unlikely to produce plastic deformation. Any overloading due to torsional conditions will increase the contact stresses but not the residual stresses. This will alter the shear stresses somewhat but the change should not be serious in this case.

In the surface surrounding the contact zone there are only two principal stresses, since the normal stress is zero, and plastic surface deformation could occur if the combined stresses exceeded the mechanical limits of the material. This could account for the loss of tip relief during the first two voyages when metal may have been rolled along to fill up

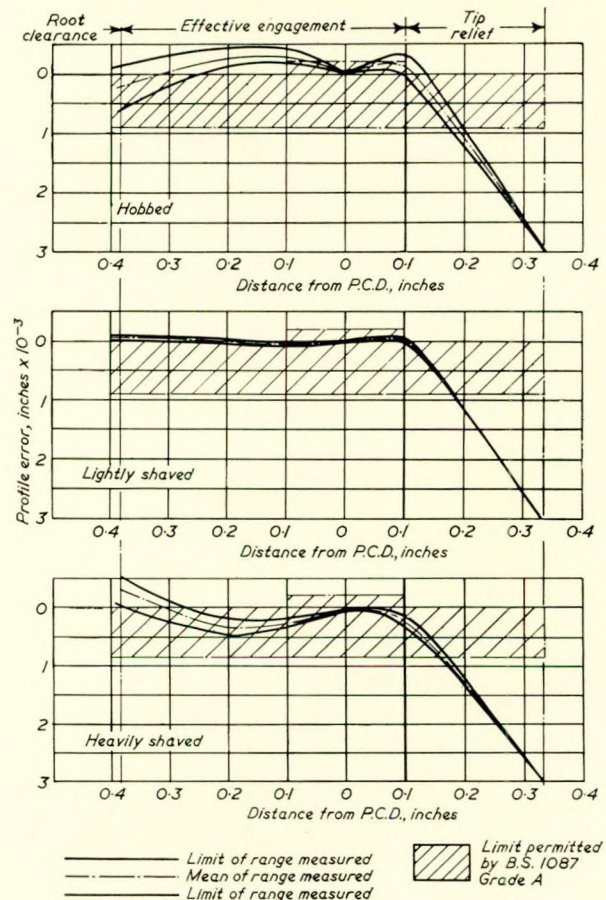
FIG. 25—Profile records from test pinion based on Maag P.H. 60 measurements

Since both the first reduction and second reduction pinions were too heavy for mounting on the P.H. 60 machine, no profile records were taken of the pinions or wheels during manufacture. When the three pairs of discs representing the second reduction pinion were made for stress analysis, opportunity was taken to measure the profile of the teeth produced by the three processes. The results are shown in Fig. 25, the mean profile and the range of profile variation being shown. The hobbled profile was as would be expected with small hob setting errors (see Merritt⁽¹⁶⁾). The shaved profile was good when shaved correctly but when heavily shaved tended to become hollow.

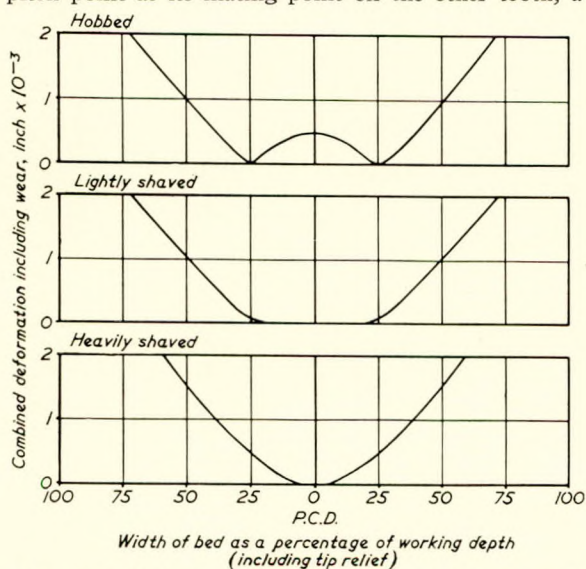
FIG. 26—Variation of bedding with deformation of surface

of corrected profiles can be obtained from which the bedding can be forecast by presenting them to each other, as in Fig. 26. The familiar two line hobbled bedding is shown. It can be seen that with this hobbled profile a combined deformation of the two surfaces under load, plus wear, if any, of 0.0005 inch, is required before a full bed is obtained over the centre of the flank. The lightly shaved gears were fully bedded without any appreciable deformation. This bedding forecast, of course, assumes parallel axes and identical angles of lead on mating helices. The initial bedding on the test bed (Figs. 7, 8 and 9) shows that the shaving of the actual gears was not as complete as that of the lightly shaved test pinion since some two line bedding is indicated on some helices.

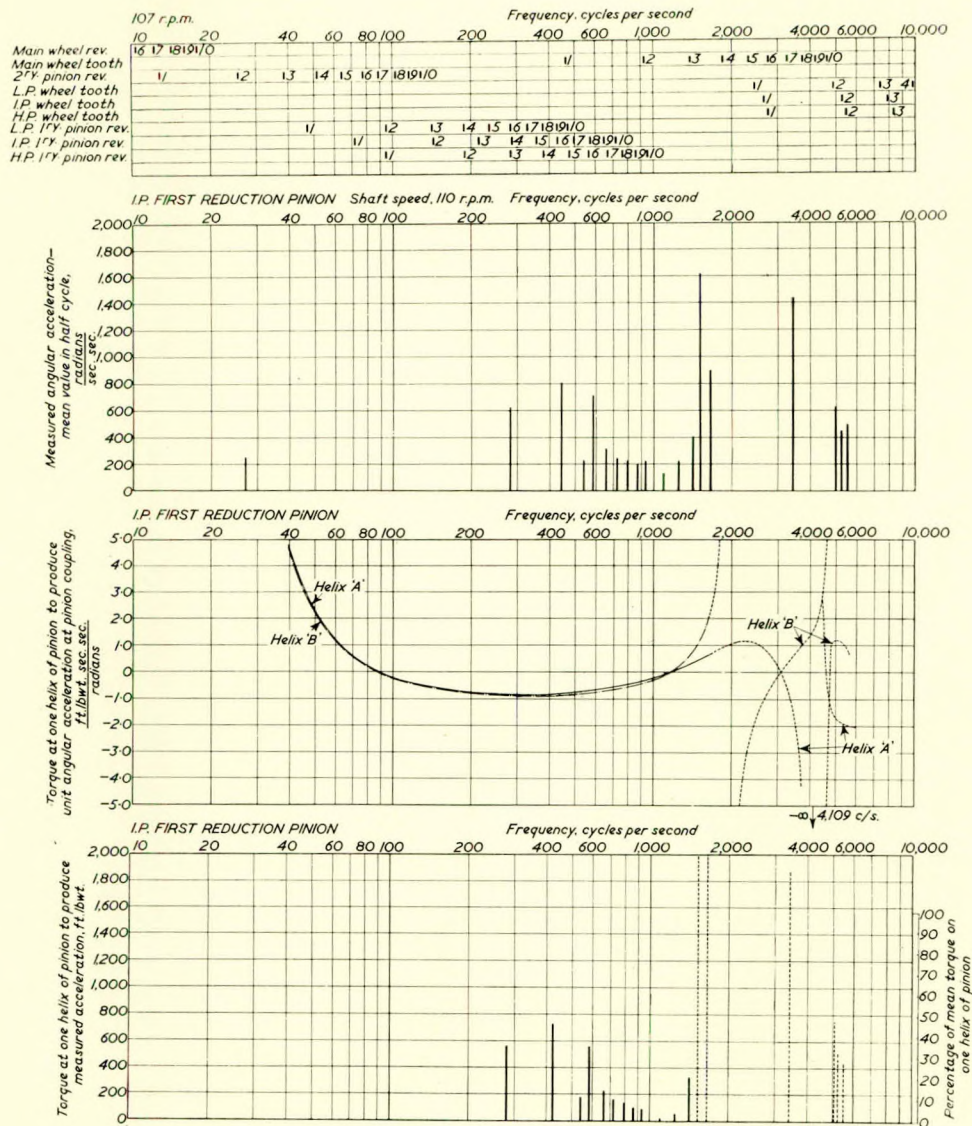
FIG. 27(b)—Torsional analysis of system associated with i.p. first reduction pinion

any single measured acceleration, expressed as a percentage of steady torque, is $2\frac{1}{2}$ per cent for the second reduction gears and 47 per cent for the first reduction gears based on "averaged" values of acceleration. The analyser gave an averaged reading of acceleration at any frequency, but since acceleration was a recurrent wave form of approximately sinusoidal shape with continuously varying peak values, it was difficult to convert an "averaged" acceleration to a "zero to peak" acceleration. Assuming a sinusoidal shape, the conversion is a simple multiplying factor of 1.4, but, in fact, due to the departure from sinusoidal, and the fluctuation of the peak values, it is probably more likely 2 or even greater. It can thus be seen that for the first-reduction tooth contact, the maximum loading at any one frequency due to torsional vibrations possibly induced by gear errors is about 100 per cent of the steady value, while for the second reduction the figure is 5 per cent.

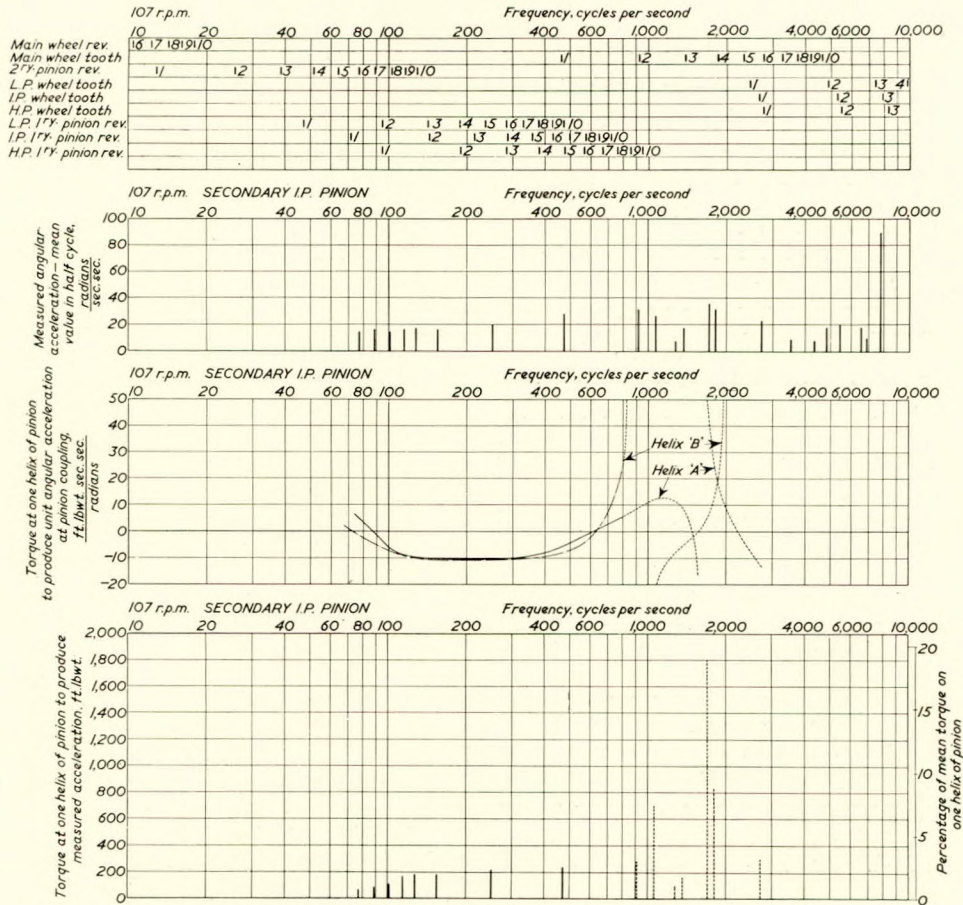
FIG. 28(b)—Torsional analysis of system associated with i.p. second reduction pinion
