OPERATING VLCC—WHAT HAVE WE LEARNT?

D. L. Saunders-Davies, M.A.(Cantab), C.Eng., M.I.Mar.E.*

and G. L. Cunningham, C.Eng., M.I.Mar.E., M.R.I.N.A.†

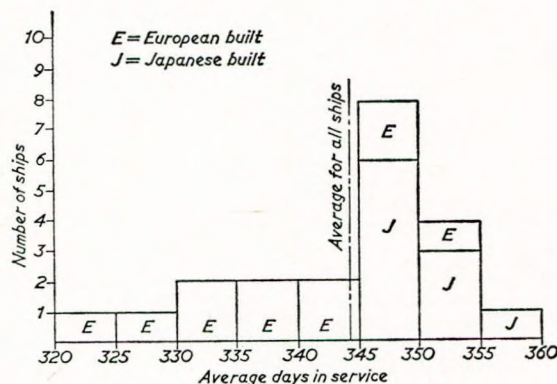
FIG. 21—Availability of "M" class ships

The "M" class showed an average availability up to the end of 1973 of 94.1 per cent, taking into account time for refits. The average for the Japanese ships was 95.8 per cent compared with 92.4 per cent for almost the same number of European ships. This is illustrated in Fig. 21 showing the average days in service.

He noticed in Fig. 21 that the authors produced a very interesting statistic which seemed to speak for itself. Mr. Cruikshank's experience was generally that the more detailed commissioning procedure and timing of trials in relation to scheduled delivery date carried out by the Japanese builders played a very large part in the subsequent successful operation of the vessel. To put it into greater perspective, could the authors indicate whether the M and R and spare gear costs for the European vessels relative to the Japanese built vessels showed an identifiable difference; sometimes increased availability was bought at the expense of greater repair costs.

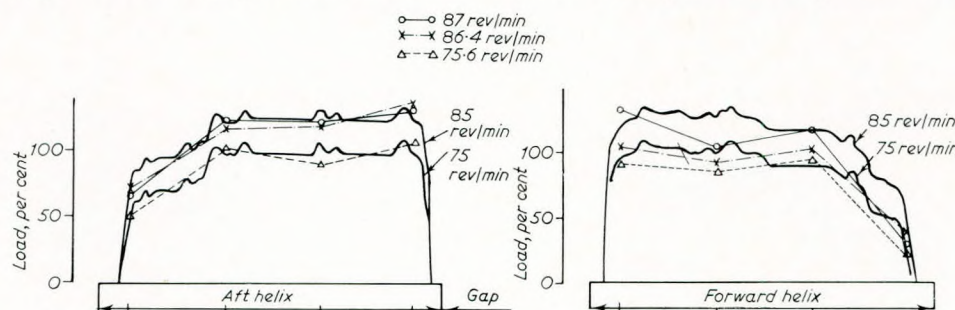
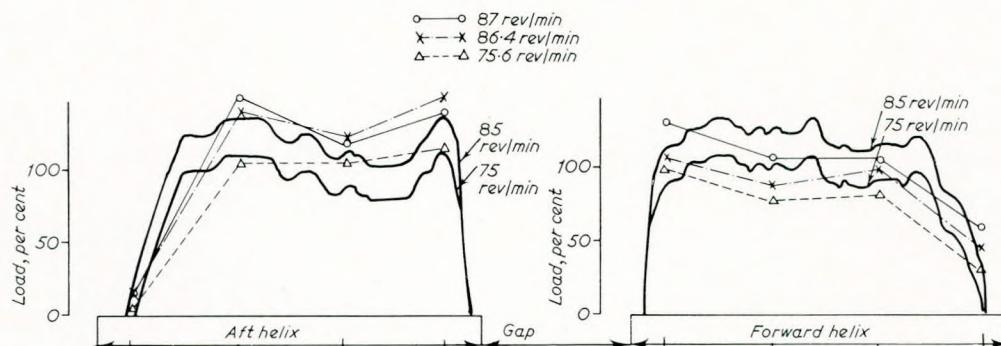
wheel. The measurements carried out by Det Norske Veritas verified that the gear contact was maintained from the installation through various service conditions. Fig. 25 (a) and (b) showed a sample of the readings; a calculated load

distribution based on the contact patterns and undulation readings obtained during the manufacturing was shown as solid curves. The measured values were used to set the absolute level of the calculated load distribution. It was then possible to compare the nominal bending stress with the measured stress level.

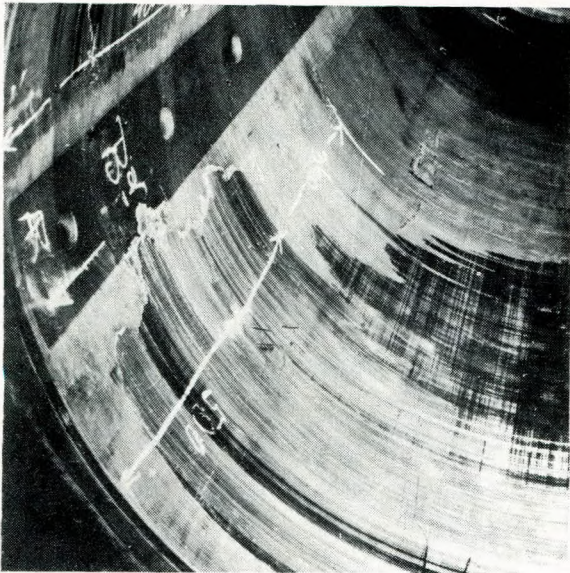
FIG. 26

The second part of the contribution concerned stern tube bearings. The authors had described the experience of their company in relation to the behaviour of whitemetal and Railko stern tube bushes. The Society had been consulted by a number of shipyards concerning whitemetal stern tube damage on VLCC, the ships in question being classed with other societies. In fact, and despite the execution of the slope boring of the stern bush and correct distribution of reaction values on line-shafting bearings, there had occurred on those VLCC some damage to whitemetal tube bearing. What was also interesting was that in most cases those damages occurred in ballast conditions, during manoeuvres and at rather low rev/min. Fig. 26 showed the damage to one of the bushes of a VLCC.

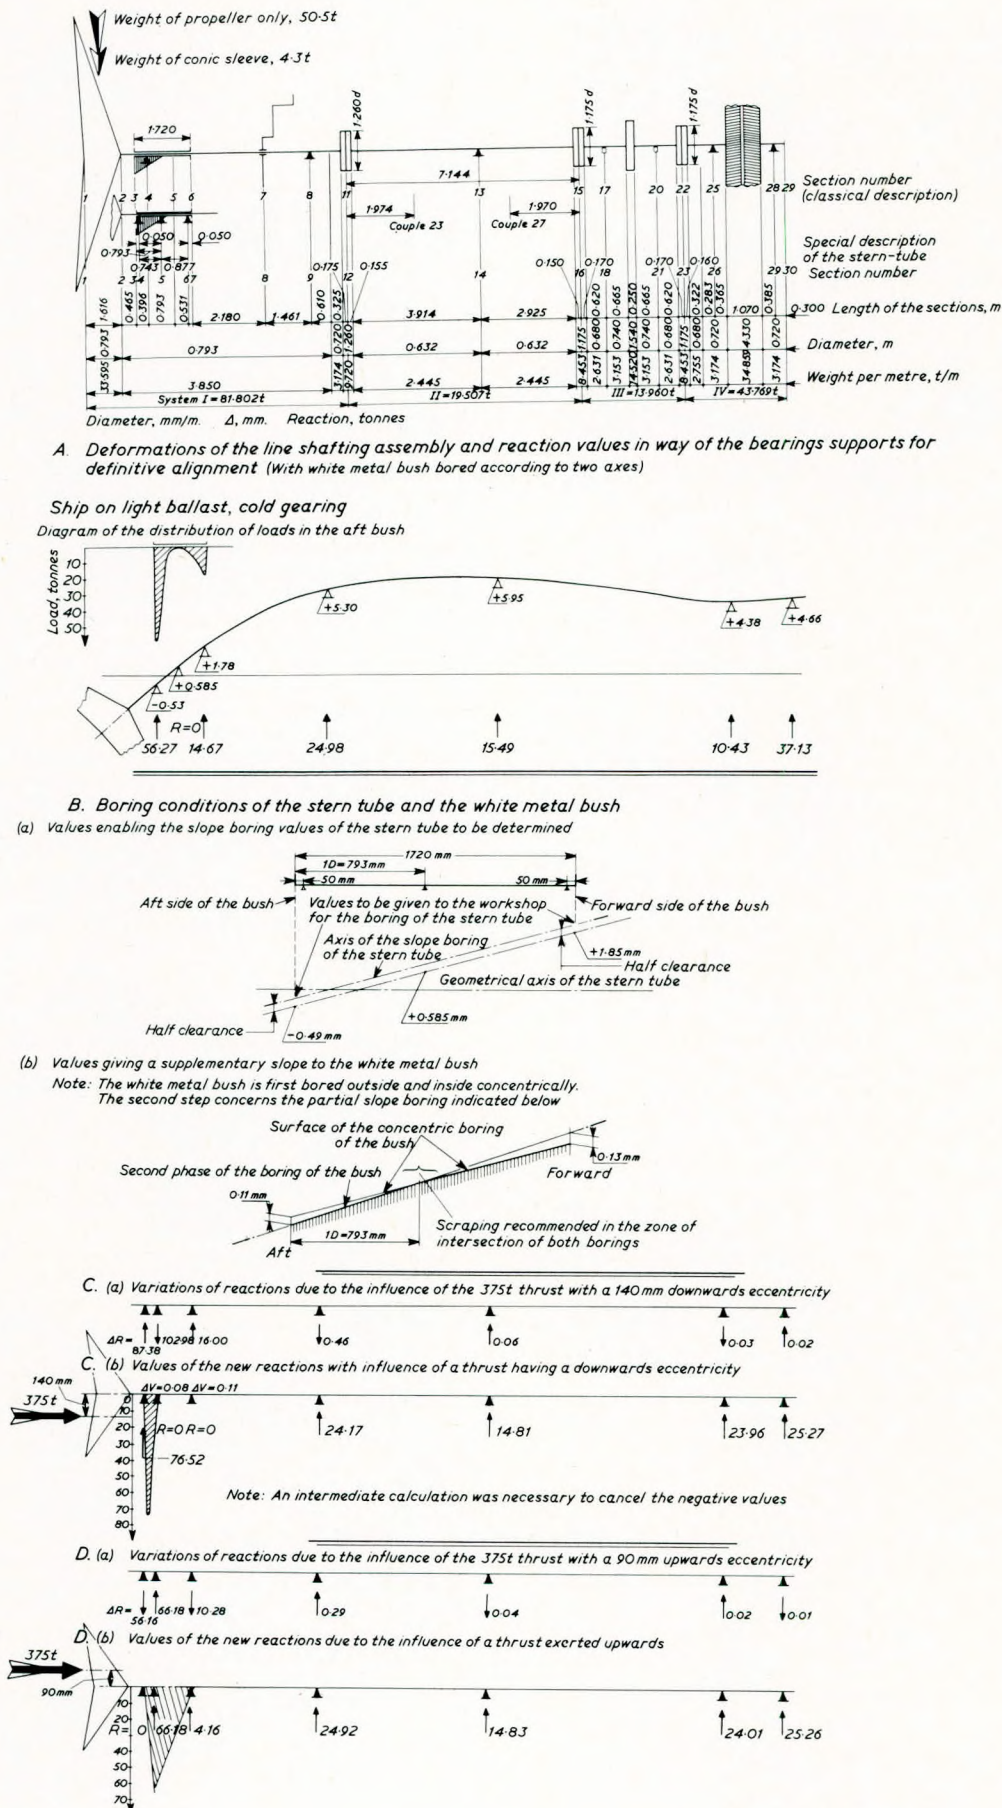
FIG. 27

Today for large tonnage ships, equipped with powerful propulsive plants, the importance of the six components of propeller forces acting on the tail shaft and disturbing the original alignment conditions was such that they should not be neglected during alignment calculations. In fact the presence of thrust eccentricities were detrimental mainly for ballast conditions. That was due to the fact that for ballast condition the thrust eccentricities were situated below the tail shaft axis, provoking a couple which increased the specific pressure in way of the aft extremity of the aft bush.

Such a case was shown on line C/b of Fig. 27. From the figure it could be seen also the loss of contact in way of the forward extremity of the aft bush, and the particularly high pressure in way of the aft extremity of the concerned bush. On line D/b was shown the influence of the thrust and its vertical eccentricity for the fully loaded ship. In that way the

applied couple was such that for full speed and a fully loaded ship, the aft extremity of the aft bush was unloaded.

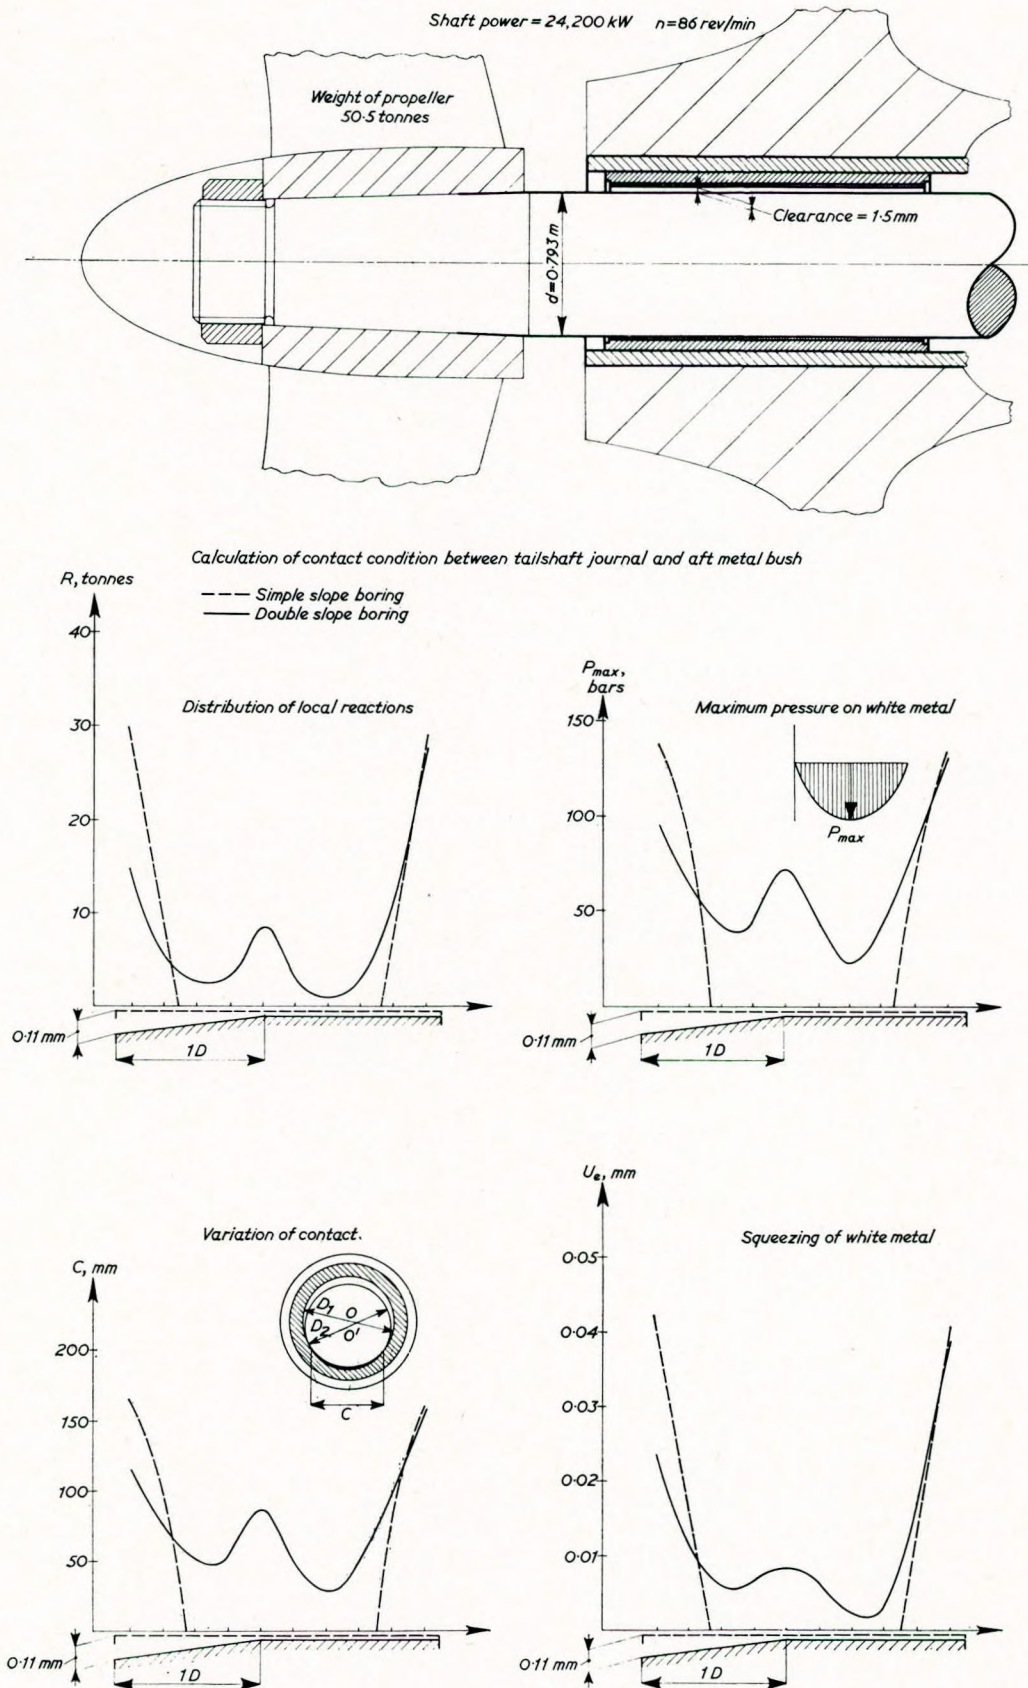
FIG. 28

Due to the above mentioned consideration, a question had been raised regarding the real contact pressure and contact surface in way of whitemetal. A corresponding theoretical investigation had been executed in the special study and research section of Bureau Veritas and in Fig. 28 were shown the results of that calculation executed for a turbine driven VLCC of 270 000 dwt.
