MEDIUM SPEED DIESEL ENGINES IN BULKCARRIERS

N. K. Bowers, C.Eng., F.I.Mar.E.*

By mid 1972, twin Ruston and Hornsby 'A.O.' medium speed diesel engines had been installed in each of 11 bulkcarriers in the 22/24 000 dwt class. During the period from May 1973 to August 1974 these engines were replaced by the Stork-Werkspoor TM 410. This paper examines the reasons that made the change unavoidable.

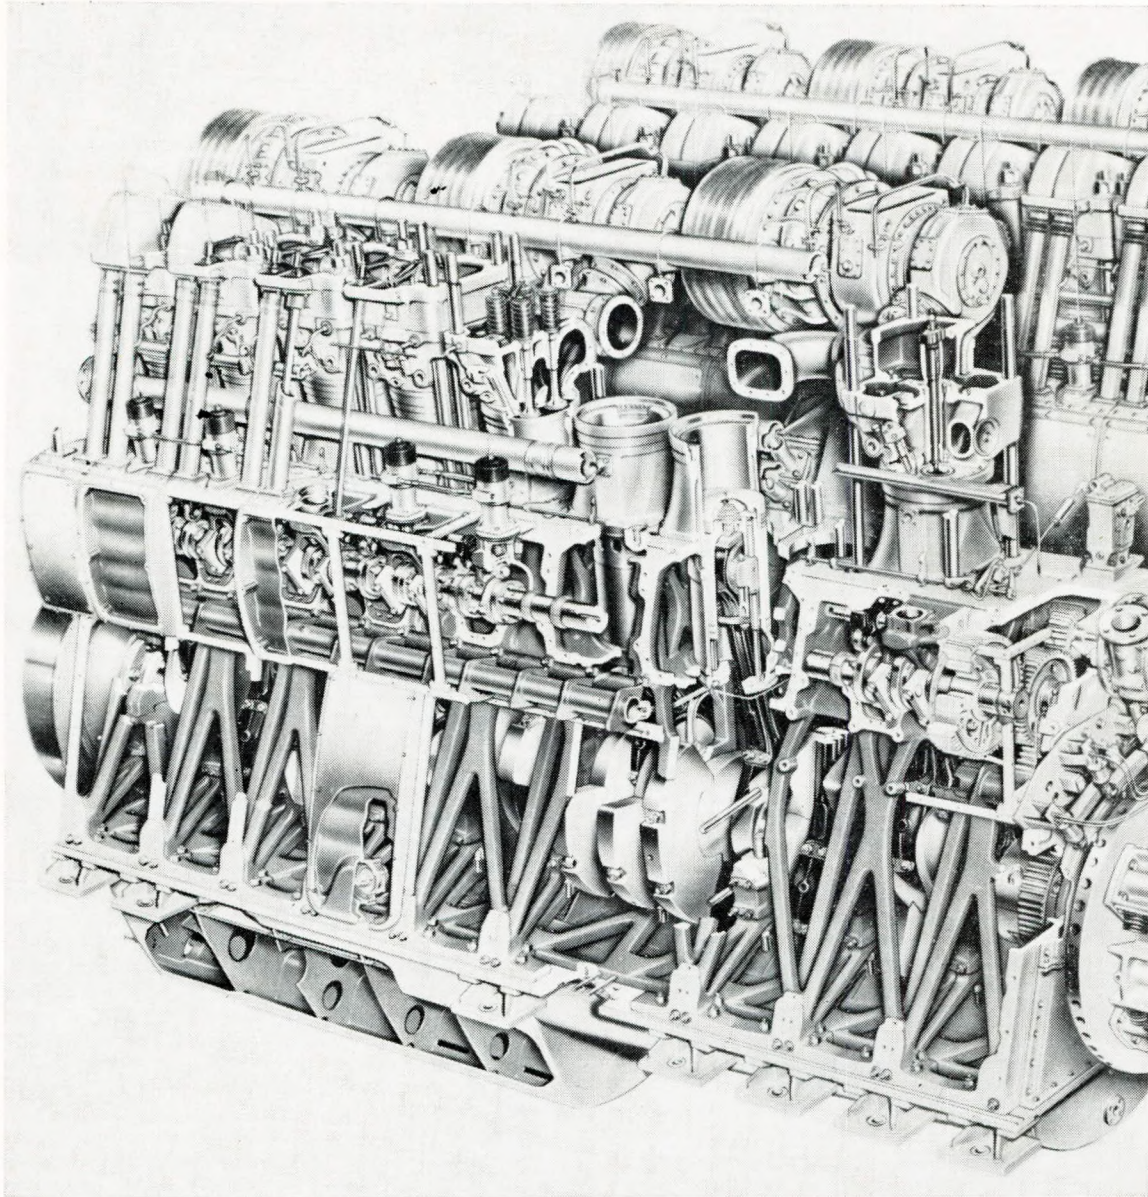
FIG. 1—Twin 9 cylinder A.O. engine installation showing fabricated steel "space frame" supporting cylinder liners.

This ship was the first A.O. engined vessel of the series. *Temple Arch* differed from the rest of the A.O. engined fleet in having two 9 cylinder in-line A.O. engines (Fig. 1) rather than the twin 12 cylinder vee engines fitted in later ships. The ship commenced her maiden voyage on 4 November, 1969, and on 4 December 1969 the first exhaust valve failure occurred. This was quickly followed by other failures and on that voyage approximately 70 valves burned through, in some cases after a service life of only 250 hours.

At this point it is worth comparing Figs 1 and 4. The TM 410 engine illustrated in Fig. 4 has a massive cast iron bedplate and an entablature that constrains the relative positions of the cylinder head, cylinder liner and main bearings to within very close limits. By virtue of its large surface area the cast iron structure suffers only a small change of stress when the engine fires. As long as the tie bolts are tightened so that their combined pull exceeds the firing load on the cylinder head by a generous margin, relative movement of any of the parts should be very small. By contrast, significant relative movements in the A.O. engine will occur very rapidly, probably at some harmonic of firing speed.

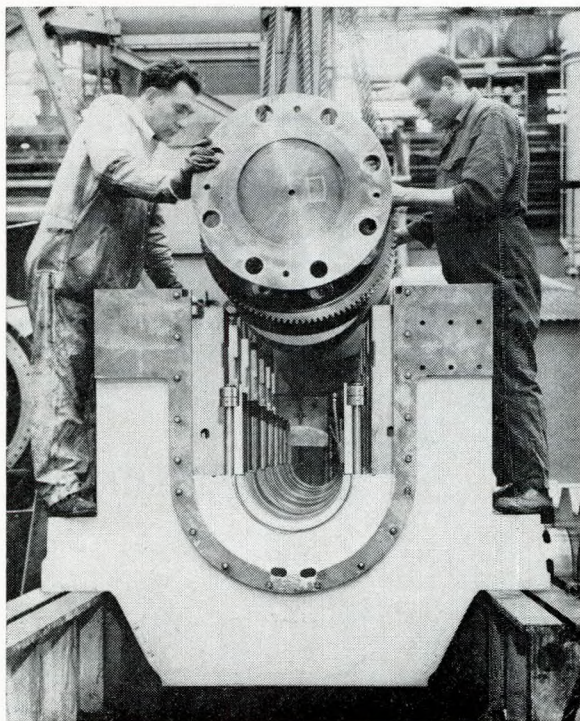
The design philosophy underlying the TM 410 is very different from that of the A.O. engine. In the case of the A.O. considerable ingenuity and skill had been exercised in making the whole assembly as light as possible (Fig. 1 and Ref. ⁽¹⁾). The designer of the TM 410 had not regarded weight-saving as an important feature but had placed the emphasis on rigidity, both torsionally, and laterally between the cylinder liners and the main bearings (Fig. 4).

FIG. 4—Cast iron bedplate of an In-line Stork-Werkspoor TM 410 engine

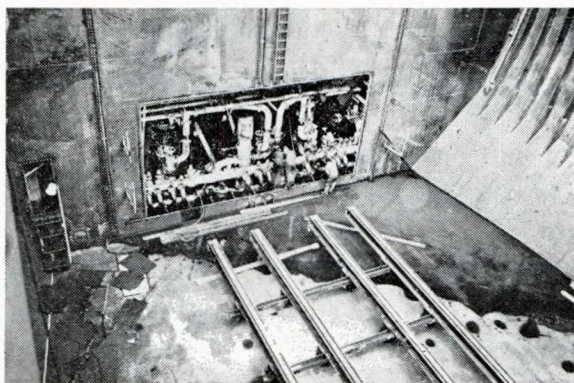
As the forward end of the engine room was also the after end of the aftermost hold, a section was cut out of this bulkhead to allow the A.O. engines to be pulled out into the hold and thence taken away by crane (Fig. 5). A smaller hole cut through the next bulkhead provided direct access to another hold and this was used as a store room for the items of equipment that were to be replaced. A door was cut in the ship's side at dockside level to allow easy access for the work force.

FIG. 5—Forward engine room bulkhead of Cape Horn showing a section removed prior to withdrawal of engines, and separate access door

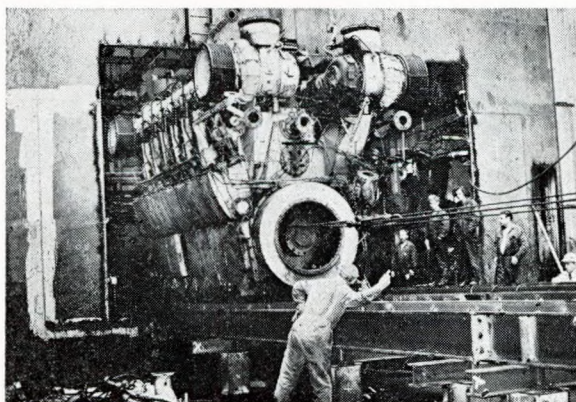
The engines were disconnected from their couplings, control gear and pipe work, and pulled along tracks built up from heavy steel girders into the aftermost hold and lifted out on to the dockside (Figs 6 and 7).

FIG. 6—12 cylinder A.O. engine being withdrawn through engine room forward bulkhead into aftermost hold

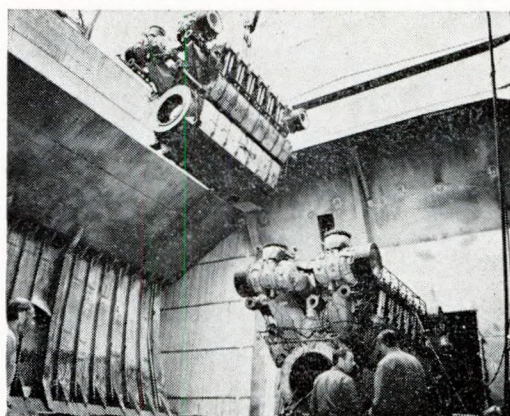
FIG. 7—Removal of A.O. engine indicating relative size of engine and hold access

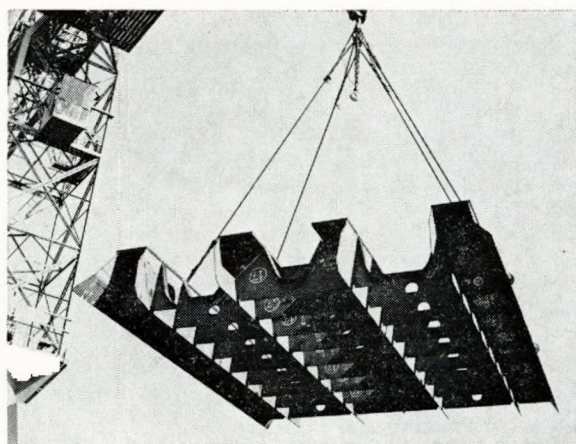
In several ships this proved to be more difficult than had been expected due to the distortion that occurred as the old bedplate was removed and the tank top cut. Correction of this distortion added four days and a substantial sum to the cost of re-engining. The main bedplate was prefabricated as a single unit, lowered into the aftermost hold and pulled into position on the tank top (Fig. 9).

FIG. 9—Seatings for TM 410 engines being lowered into the hold

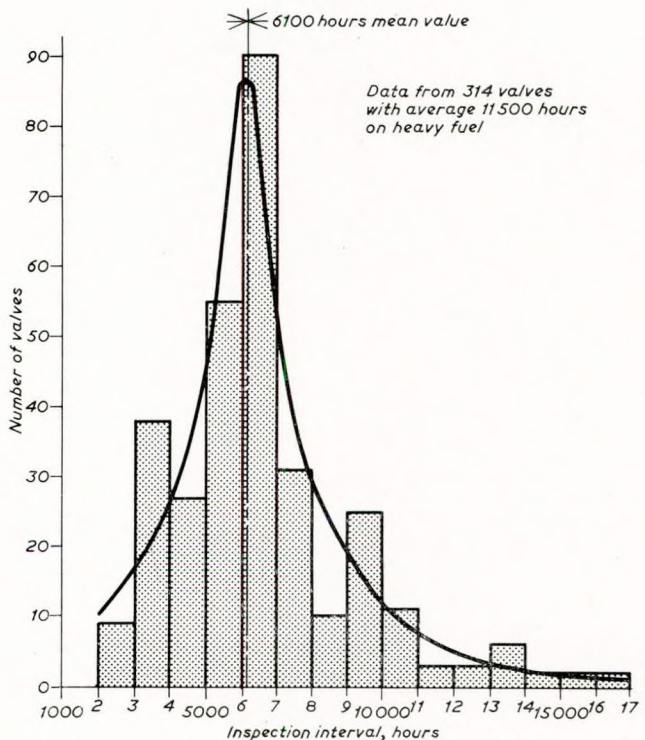
FIG. 16

Ir. Wesselo said that his Company would have to become accustomed to the idea that exhaust valves could burn. Up to a year and a half ago this had not been known with the TM 410 engine. The general situation over the fleet today was still favourable but, also, in some other ships burning of valves had occurred now and then: more than 200 from all TM 410 engines in service; about the same number of burned valves had been reported as from the ships mentioned in the paper alone. This meant that at about one per cent of all exhaust valve positions, a burned valve had occurred once.

For 99 per cent of the cases Fig. 16 illustrated the normal picture:

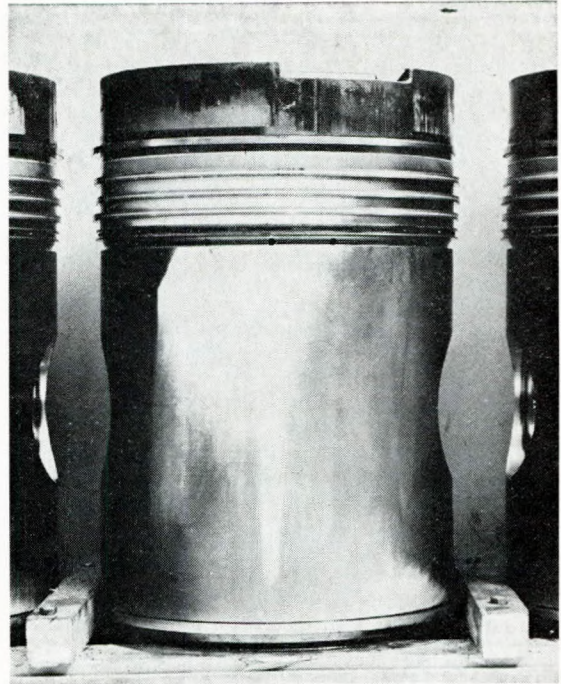
FIG. 18

Fig. 18 showed a piston inspected after 17 000 service hours in one of the first engines in the ocean-going tug *Rode Zee*, which used 0.85 g/bhph as an average over three years and this was still the normal figure for TM 410 engines. The ring pack consisted of a chrome plated spherical top ring; three cast iron compression rings with bronze insert; one conformable slotted scraper ring and one simple block-ring at the bottom. This normal figure was so reliable that a cause outside the engine could nearly always be found for a higher consumption. If piston rings had been spoilt running in would take longer, but the consumption would come down, otherwise the Company had a strong suspicion of other sources.
