THE INSTITUTE OF MARINE ENGINEERS

A REVIEW OF MARINE GEARBOX EXPLOSIONS

THE KOOTENAY GEARBOX EXPLOSION

ISSN 0309-3948
Trans I Mar E (TM)
Vol. 93 1981 Papers 10, 11.

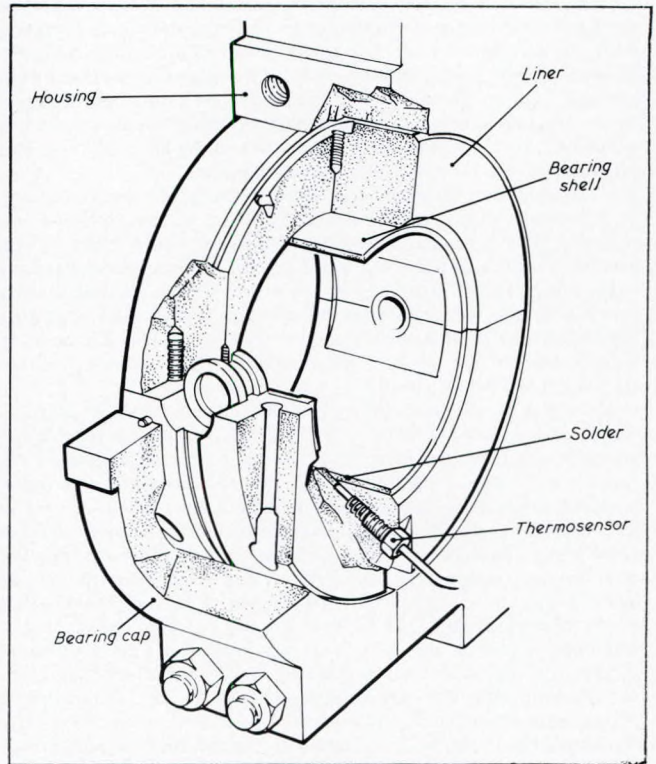
Fig. 5 Typical thermosensor arrangement

However, it is clear from some of the gearbox incidents investigated that there have been cases of low temperature readings due to poor contact on the back of the bearing shells. In the 1970s the Royal Navy changed in some installations to resistance thermometers with the thermosensor spring-loaded to the back of the bearing shell by an arrangement which was dimensionally interchangeable with that of the earlier ships. Fig. 5 illustrates a typical thermosensor arrangement.

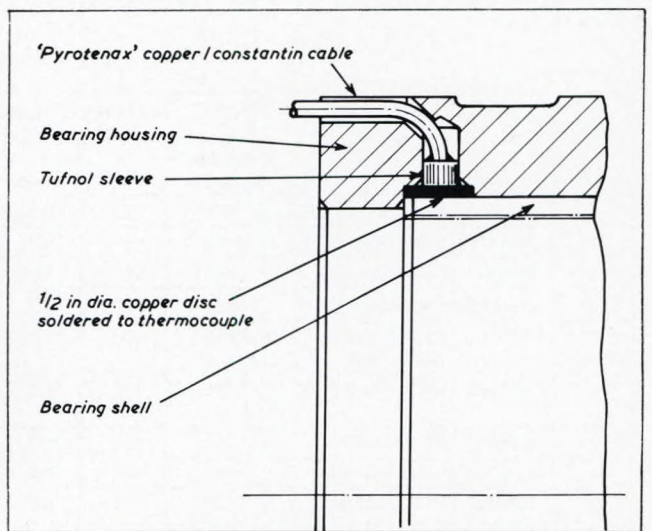
Fig. 6 Typical thermocouple arrangement

3.4 Royal Navy submarines have retained thermocouples in journal and thrust bearings for temperature monitoring. Where thin or medium thick shell bearings are used, the thermocouple junction is made into the form of a disc, illustrated in Fig. 6, rather than the more usual pencil-like probe, and press fitted into the housing so that there is a positive contact with the back of the bearing shell. In journal bearings of the thick-wall, conventional type, the bearing sleeve is drilled to within, or close to, the whitmetal, and a thermocouple having a small junction is secured by a screwed arrangement.

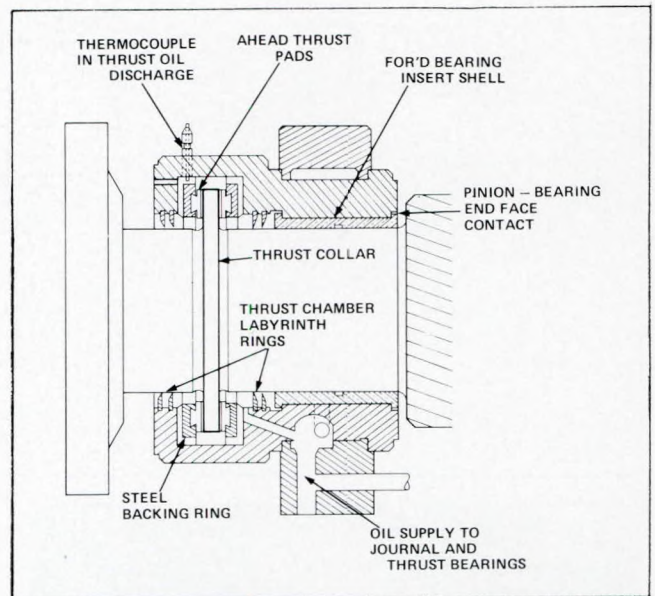
Fig. 6 Primary pinion for'd bearing and thrust

At full power the single-helical main primary pinion exerts a significant axial thrust (Table II), which is absorbed through an integral thrust collar, acting on a tilting pad thrust bearing. Fig. 6 shows the arrangement of the thrust bearing housed in a thrust chamber integral with the primary pinion's forward bearing shell.

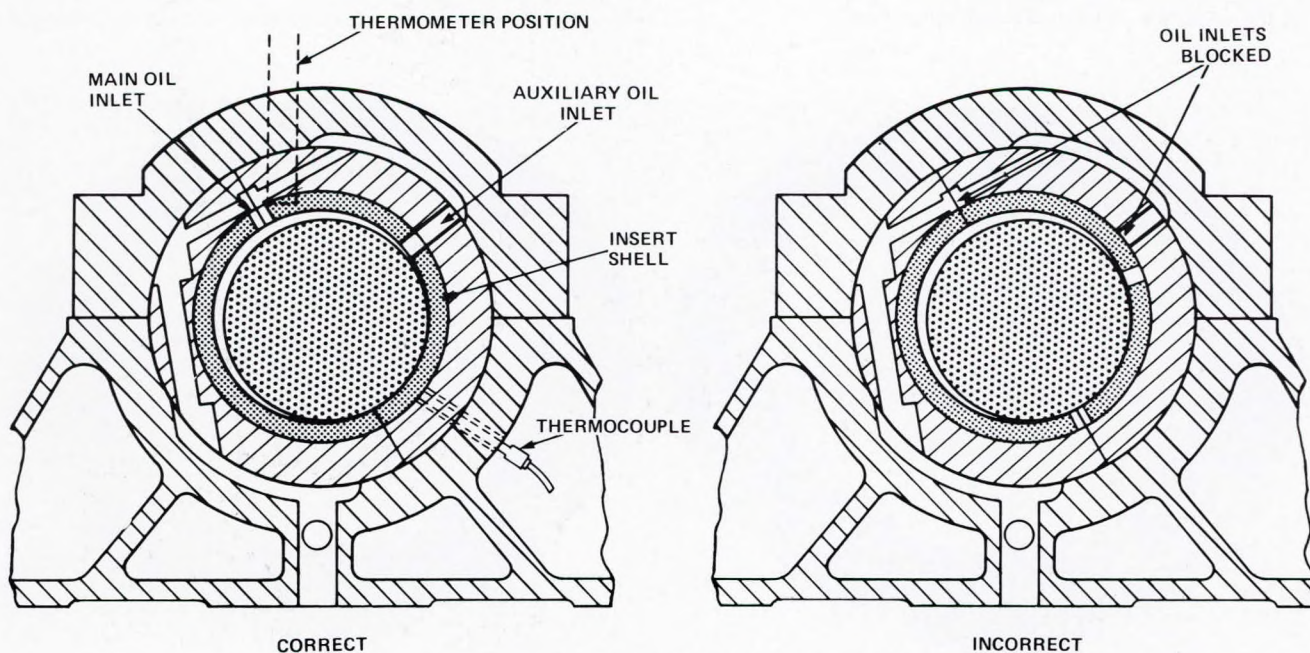
Fig. 9 Pinion bearing insert shell assembly.

The loaded top half insert has a full annulus with an auxiliary inlet hole located 80° from the bearing split. Extensive ship trials, with the single-inlet insert shells fitted in the primary pinion bearings, were successfully completed in May 1957 under main and cruising turbine drives. Thermocouples fitted in each bearing half, but not penetrating the insert shells, were sufficiently sensitive to register temperature changes due to major helm movements. The complete insert bearing assembly, shown in Fig. 5 was then fitted in all ships of the class.

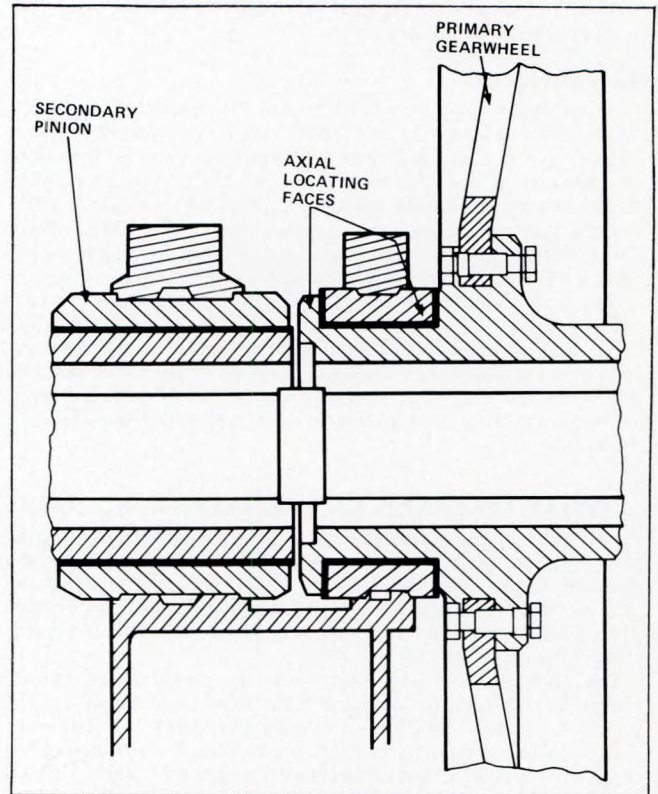
Fig. 15 Gearwheel axial locating bearing

The responsible heat source was a failed primary gearwheel aft bearing, which was not covered by the six point monitor. The cause of failure was incorrect installation which resulted in the complete blockage of the oil supply. This bearing axially locates the primary gearwheel/secondary pinion assembly and is positioned between thrust shoulders as shown in Fig.15. An undetected failure in this type of bearing can clearly generate a dangerously high temperature due to the galloping effect of heat causing the absorption of axial clearance which, in turn, increases the heat being generated.
