# SOME MEMORABLE BREAKDOWNS AND RESULTING IMPROVEMENTS

T. W. Bunyan

ISSN 0309-3948  
Trans IMarE(TM)  
Vol 93 1981 Paper 5

The author describes some of the more interesting hull and machinery problems in ships with which he has been personally involved during his career. He covers trouble shooting, redesign and improved construction with particular reference to vibration and bearings.

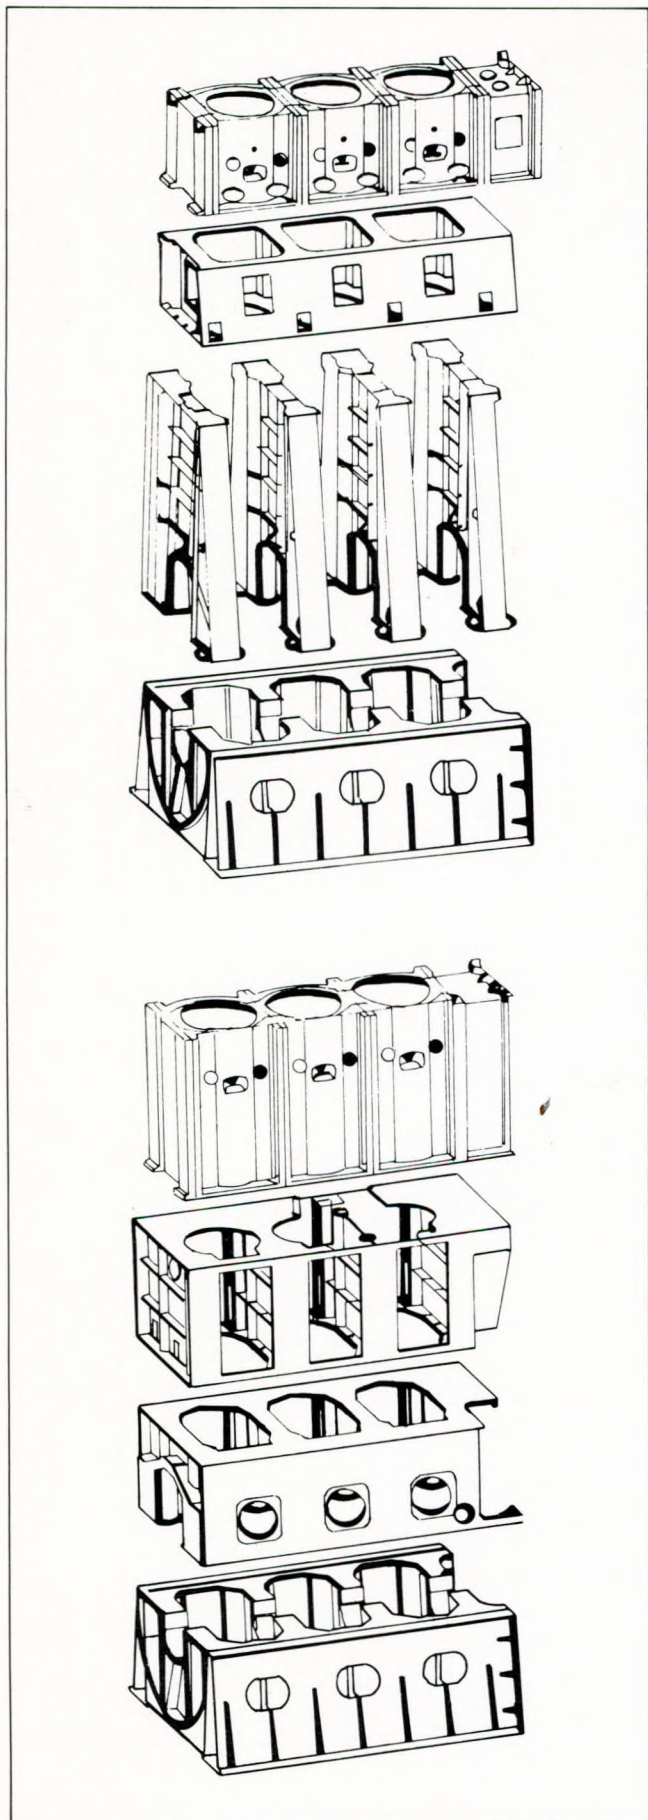
**FIG D4 Comparison of conventional column type and new box type engine girder**

engine from deformations of steel-work of double-bottom and hull, some diesel engine manufacturers have abandoned the old-fashioned column type engine (which does not present an homogenous girder) in favour of a stiffer solution. Fig D4 compares the old-fashioned column type with the new box-type engine girder<sup>7,8</sup>.

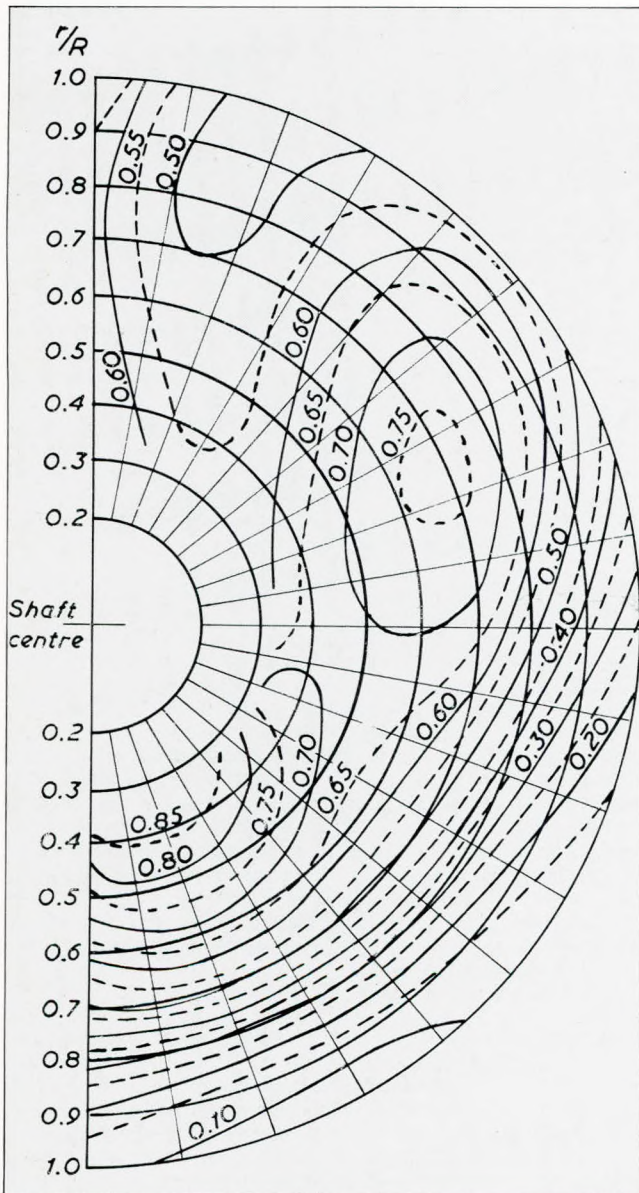
Swan Hunter Shipbuilders have been actively involved, over the last decade, in the shaping of aft ends to limit vibration from cavitation forces and the goal from the outset has been to get as near as possible to the circular wake. Two samples of Taylor Wake Contours derived from model tests for block coefficients of 0.817 and 0.839 are shown in Figs D5 and D6 respectively, which demonstrate what has been achieved by careful shaping of the hull forward of the propeller. As can be seen the wake flow over a major part of the propeller disc tends to be circular, whilst the flow is very good in the critical area at the top of the disc where cavitation problems normally develop. I am sure the author, with his wealth of experience, will give his nod of approval to these wakes as they will no doubt reduce the tendency for the tailshaft to run in the top of the stern bearing and also minimise the variation in propeller thrust.

**FIG D5** Contours of constant Taylor wake fraction for block coefficient 0.817

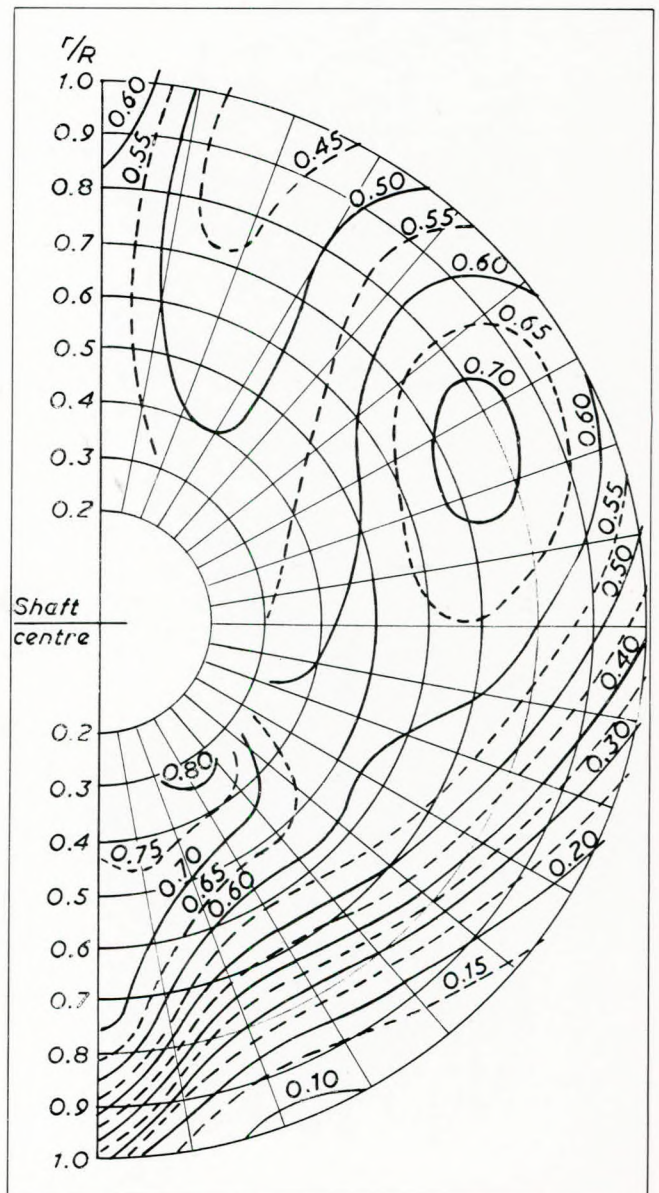
**FIG D6** Contours of constant Taylor wake fraction for block coefficient 0.839

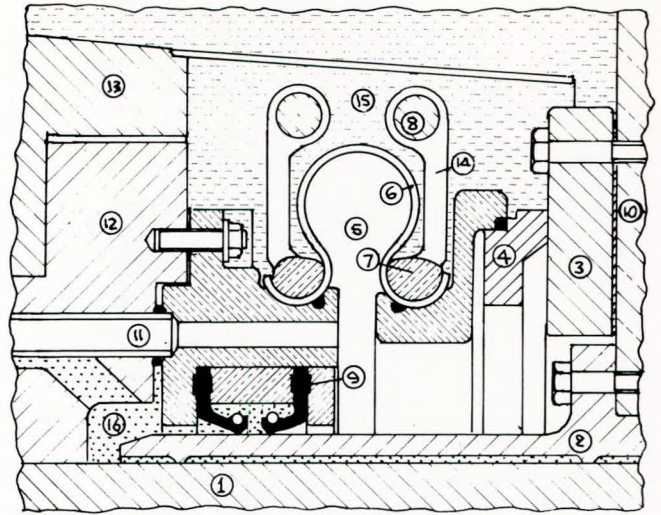
**FIG D7 'Coastguard' stern seal (section at 12 o'clock)**
