Some marine machinery failures And their causes

R. F. Munro and P. E. Haynes

Lloyd's Register of Shipping

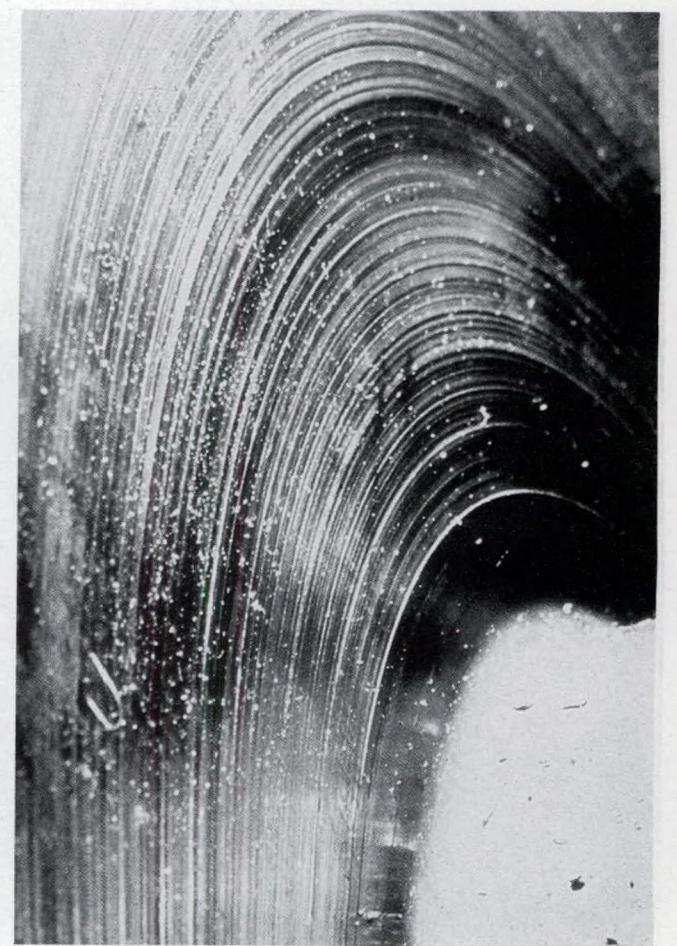
FIG. 9

This ship suffered two crankcase explosions. The first happened at 0300 hours and caused minor damage. After waiting for the engine to cool down, a crankcase inspection of the running gear was carried out and, because nothing unusual was found, the engine was restarted and the passage resumed. Shortly afterwards there was a violent explosion which resulted in serious fire and the death of four crew members.

Figure 9 shows the condition of the integral thrust collar, which had been overlooked by the engineers, and Fig. 10 the state of the ahead thrust pads from which the white metal had been completely melted out.

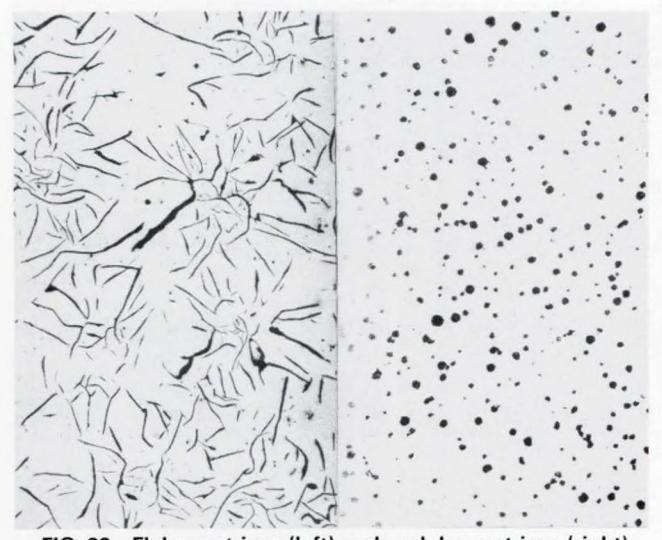
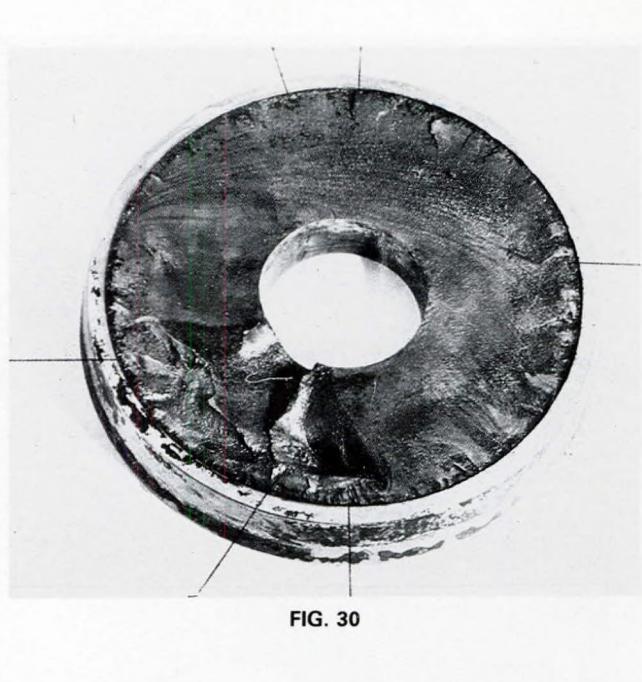
FIG. 28 Flake cast iron (left) and nodular cast iron (right)

The comparison in Fig. 28 shows the striking difference between the two forms of cast iron. Nodular graphite iron is also relatively cheap, easy to cast and can show ductilities comparable with structural steels.

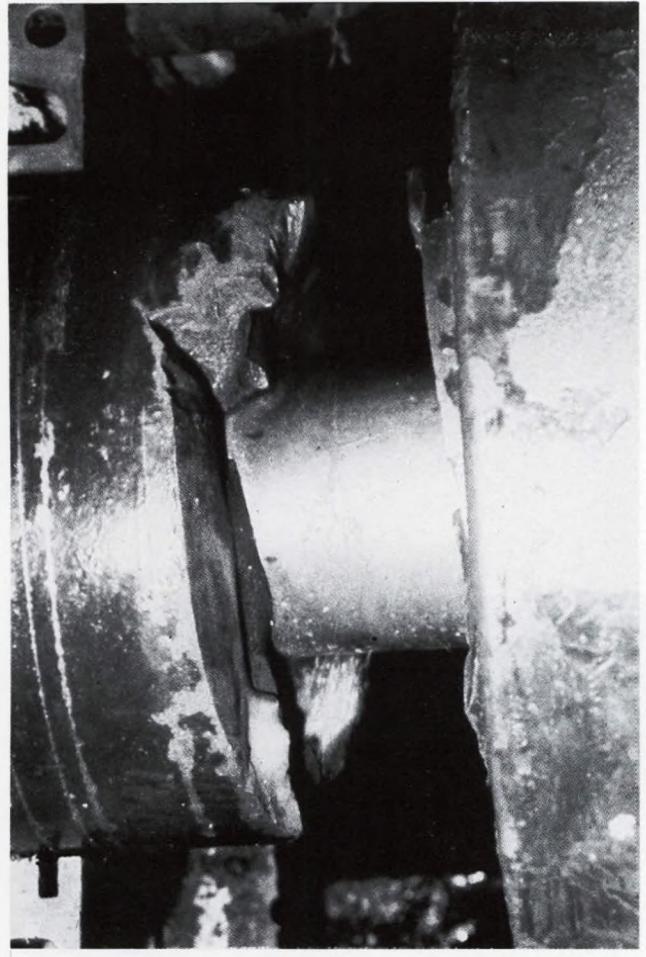
FIG. 32

Figure 32 shows a controllable-pitch propeller shaft which broke at the forward coupling. The stern tube is fitted with a lignum vitae bush and the ship operates in an extremely hostile environment due to sand bars. She has a history of extremely rapid wear-down of the stern bush, renewal of the lignum vitae having taken place at each annual drydocking.

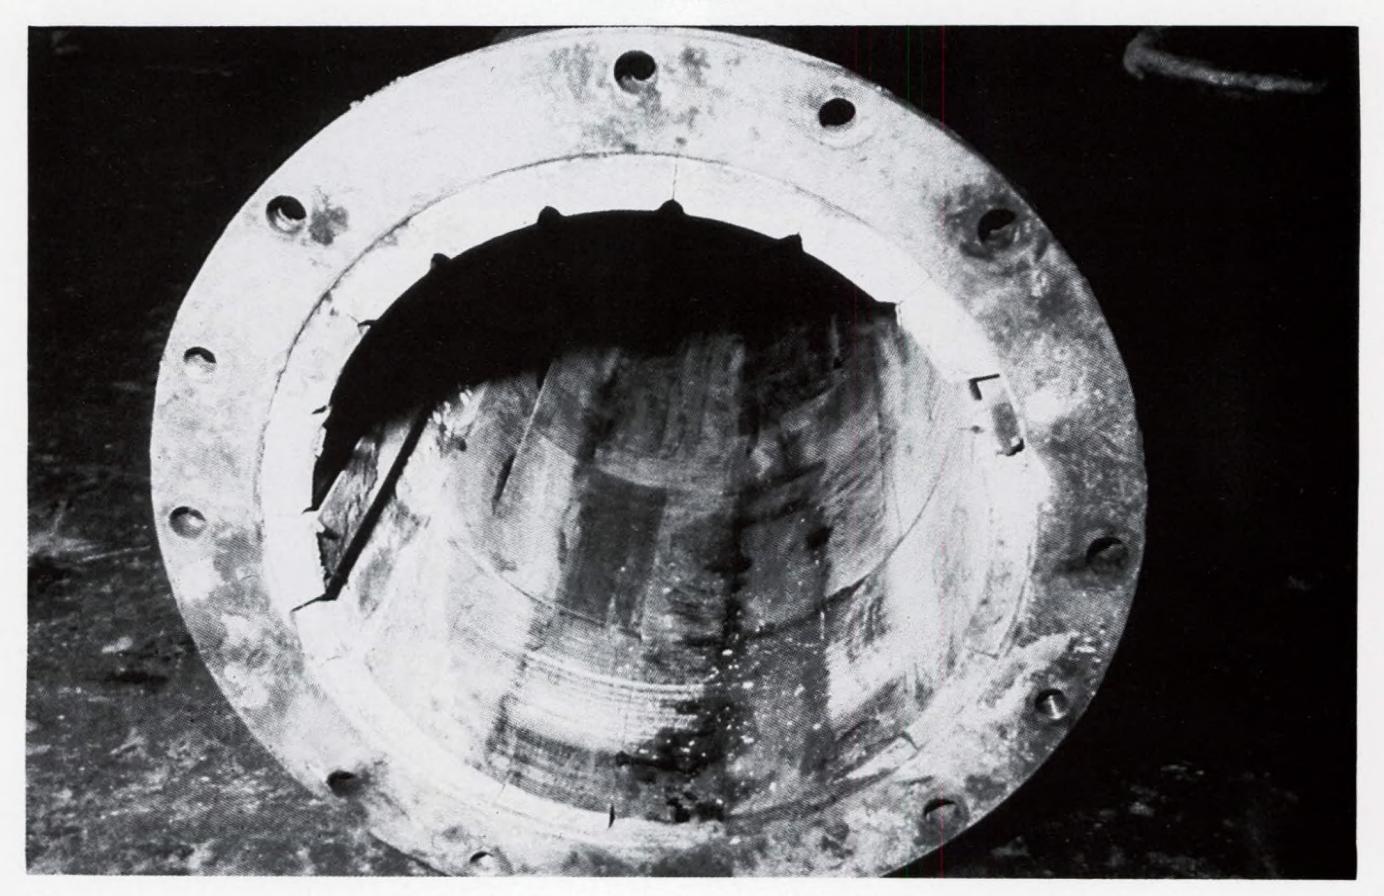
FIG. 33

When the screwshaft finally succumbed to the high bending stresses to which it had been subjected, the wear-down of the bush was found to be 19.5 mm! (See Fig. 33.)

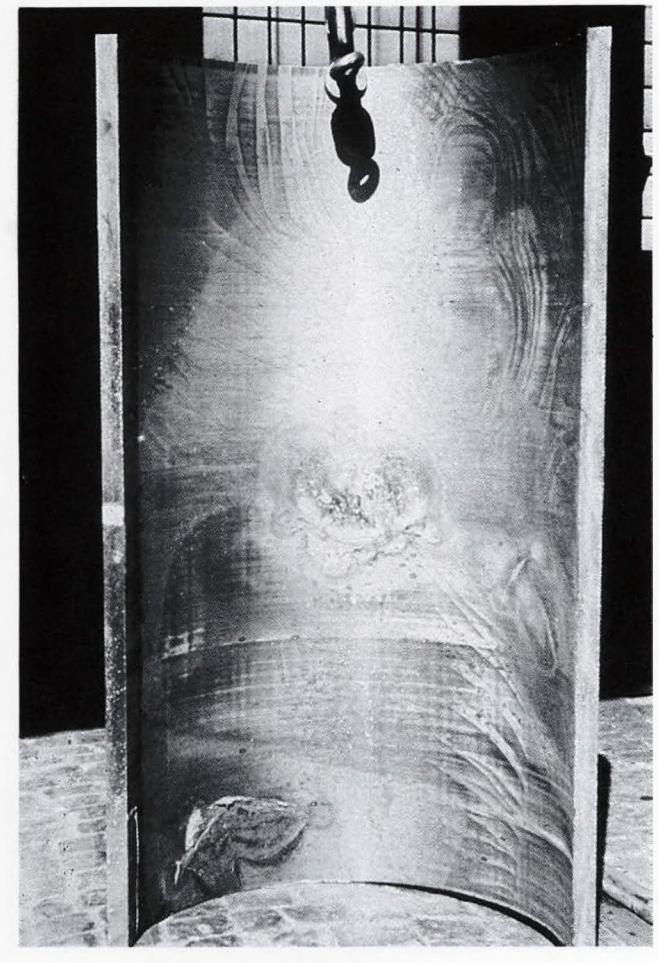
FIG. 36

Occasionally cracks are found in bronze screwshaft liners, as shown in Fig. 36, and suggestions will be made that the cracks should be chipped or ground out and the resulting groove filled up with a sealing compound.

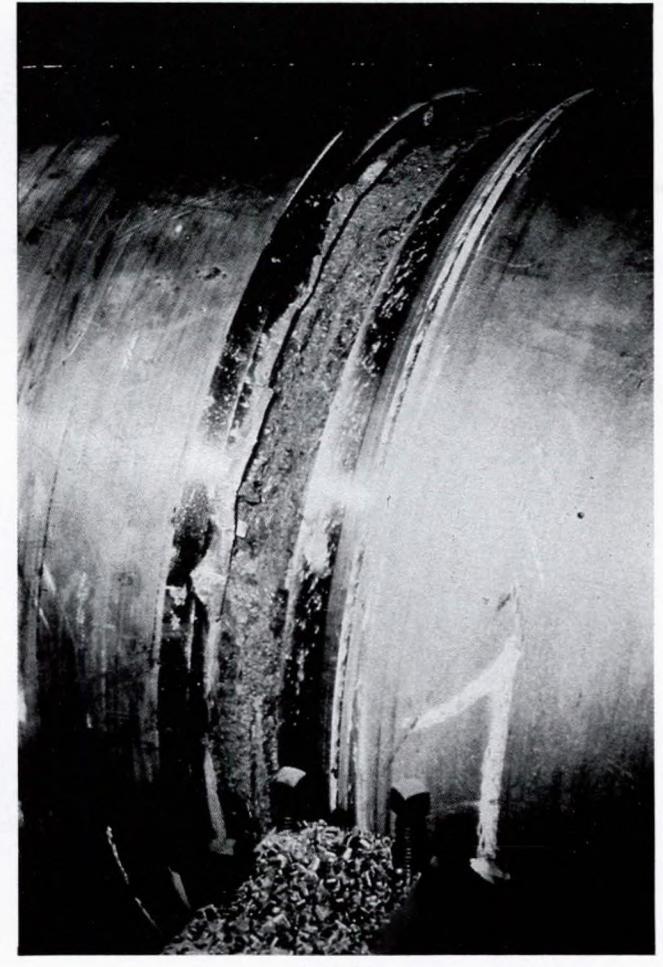
FIG. 39

This screwshaft was fitted with bronze liner in three sections having two circumferential welds. During the shaft survey, a crack was seen at the side of one of these welds (see Fig. 38). The shaft was placed in a lathe for investigation and, after machining the weld material away, a very deep crack was exposed in the body of the shaft, exactly in line with the crack which had been found in the liner (see Fig. 39).

mum permitted by the Rules to ensure weldability. Lead is frequently added in the foundry to improve machinability but it may also occur as an impurity in the foundry raw materials. Lead will not dissolve to any significant extent in iron-based alloys nor in many other engineering metals but will exist as grain boundary films and, at higher concentrations, as discrete globules which are soft and ductile.

Lead has a relatively low melting point (232°C). When present in materials which are to be welded, the lead melts at low temperatures and results in grain boundary cracking.

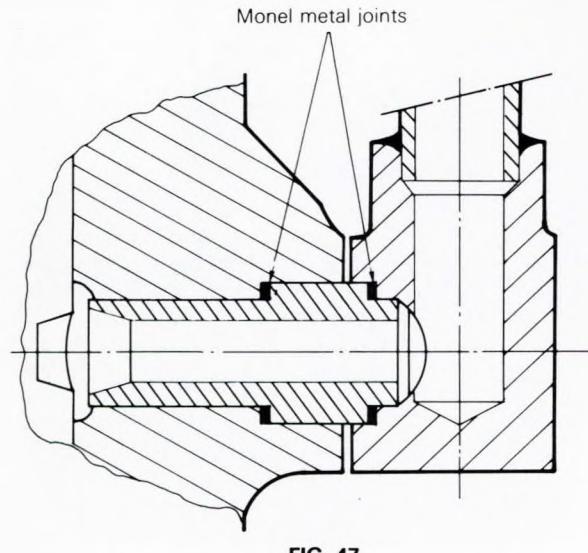
FIG. 47

Fire broke out in the engine room of a twin-screw ship fitted with medium speed engines. Investigation revealed that a joint had failed in the high pressure fuel system at the discharge from the fuel pump. Copper ring joints were found in those places where the designers specify that only monel metal is to be used (see Fig. 47).

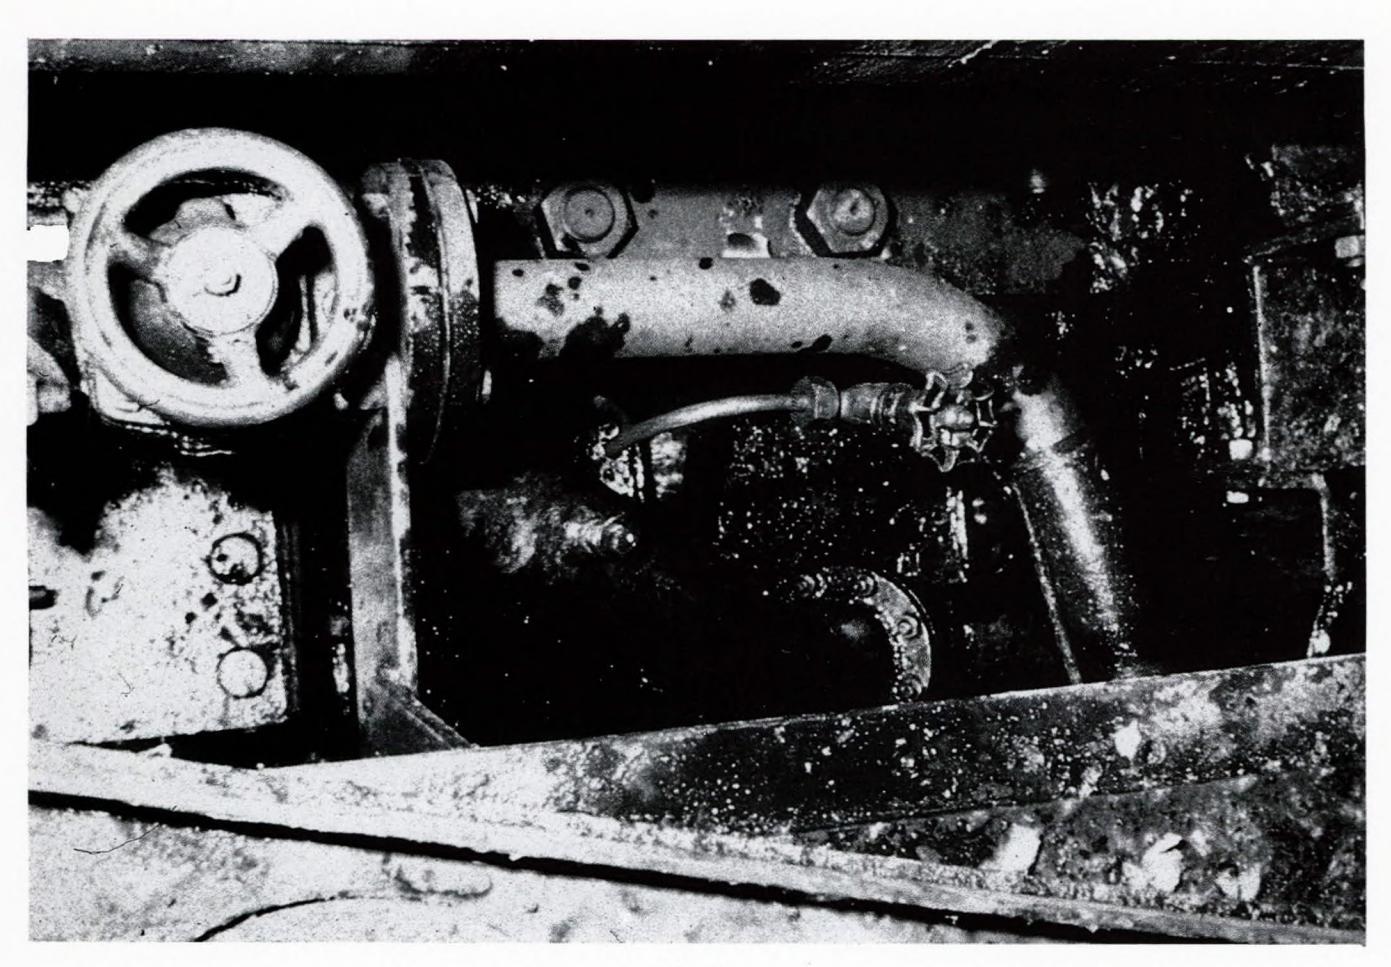
FIG. 52

An engineer noticed oil spreading over a floorplate in the auxiliary engine room of a large motor ship. When he lifted the plate to investigate, a jet of lubricating oil rose into the air and descended upon an adjacent auxiliary engine. A serious fire broke out. Figure 52 shows the copper pressure gauge pipe which had work-hardened and fractured.

This is another example of the danger of subjecting copperbased alloys to fluctuating shock loading. The case quoted in Section 8.2. and illustrated in Fig. 47 also refers to this danger.

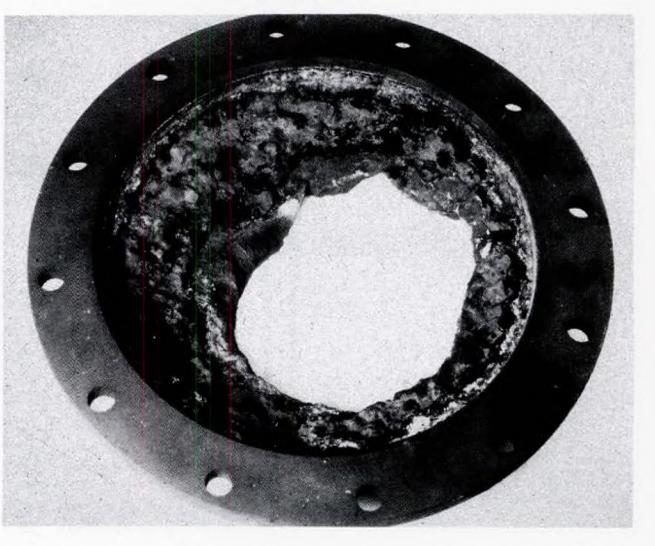
FIG. 57

The failure at sea of the cast iron cover of a lubricating oil cooler on an auxiliary oil engine caused serious flooding of the engine room and the Master was compelled to put into a port of refuge to seek assistance (see Fig. 57).

The failed parts, together with other similar covers from the ship, were examined at the Society's laboratory at Crawley and it was concluded that the severe deterioration of the cast iron had been due to the galvanic system set up through sea water in the presence of copper alloys, aggravated by pollution of the water and the presence of stray electric currents.

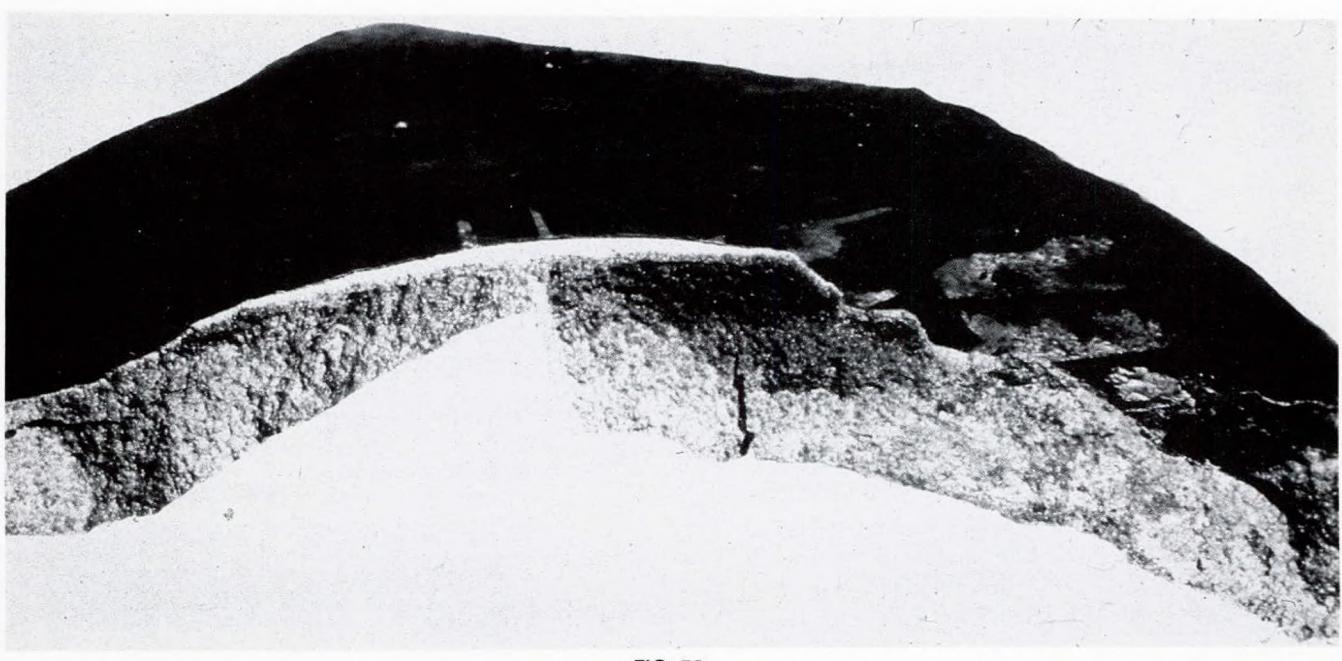
FIG. 58

A very important clue to the state of the castings emerged when an apparently undamaged cover was picked up and found to be unexpectedly light in weight. A tap with a hammer resulted in a large piece falling out (see Fig. 58).

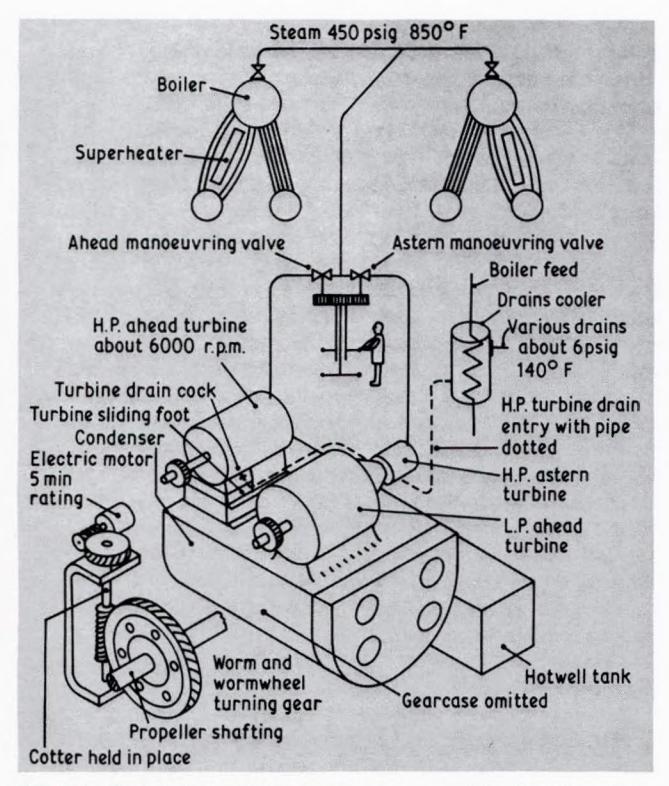
FIG. D4 General installation arrangement with offending drain pipe shown dashed

that the fuel consumption per shp measured by a shaft torsion meter was considerably more than it should have been. It was also noted that the HP astern turbine-casing temperature was much higher than anticipated. This caused some concern and one of the designers of the turbine plant stated that in his opinion there was high pressure/temperature steam leaking into the HP astern turbine casing via a hole of about 5/16 in diameter.

After a delay of about a day the adjustment and acceptance trials were again commenced. On the following day at about 0600 hours the manoeuvring platform began to vibrate violently, after some manoeuvring, and the complete plant was shut down, it being strongly suspected that the HP ahead turbine rotor had 'bent'. Subsequent examination proved this to be correct and the warming-up procedure was suspected, as were the turbine-casing's sliding feet, it being suspected that they were not sliding freely. The gland steam system also became suspect.

HP ahead turbine again commenced to vibrate, but not as badly as previously. The rotor was removed upon arrival in the UK and was straightened by heat treatment, rebalanced and refitted, all without loss of ship's service time.
