25 YEARS EXPERIENCE WITH SEA-WATER-COOLED HEAT-TRANSFER EQUIPMENT IN THE SHELL FLEETS

E. B. Shone and G. C. Grim

ISSN 0309-3948
Trans IMarE(TM)
Vol. 98, Paper 11 (1986)

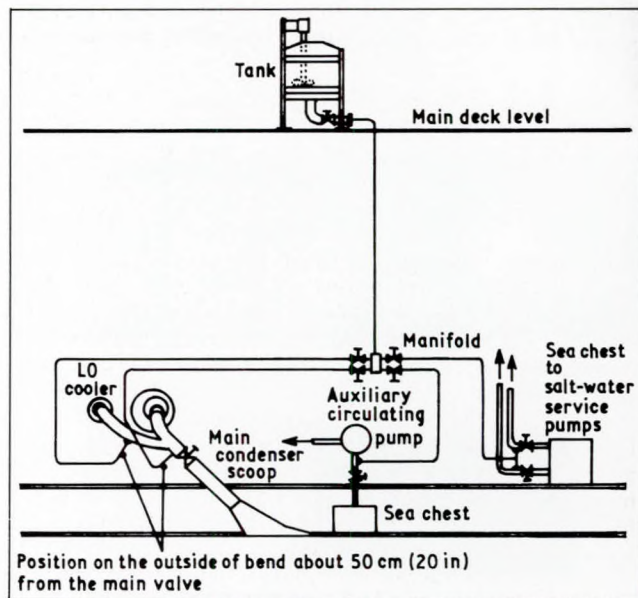
The ferrous sulphate system was fitted during the docking and the general layout shown in Fig. 2 was adhered to. A site for the tank mixer was found in the engineers' store-room situated at main deck level. The tank was firmly fixed in position by welding brackets from the main frame to the bulkhead. A water supply was coupled in from the fresh-water supply and a platform and steps constructed to allow easy filling of the tank.

FIG. 2: General layout of the ferrous sulphate injection system

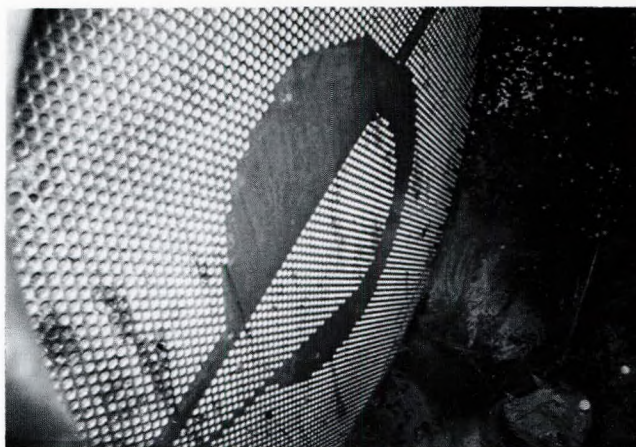
The success of the electrochlorination is illustrated in Fig. 10, which shows the main-condenser inlet on the *Limnea*. On this vessel the chlorination system had operated as it was designed to. Figure 11 shows the main condenser of the *Latia*, which was heavily fouled following a failure of the electrochlorination cells.

FIG. 10: Main-condenser inlet of the *Limnea* free of fouling

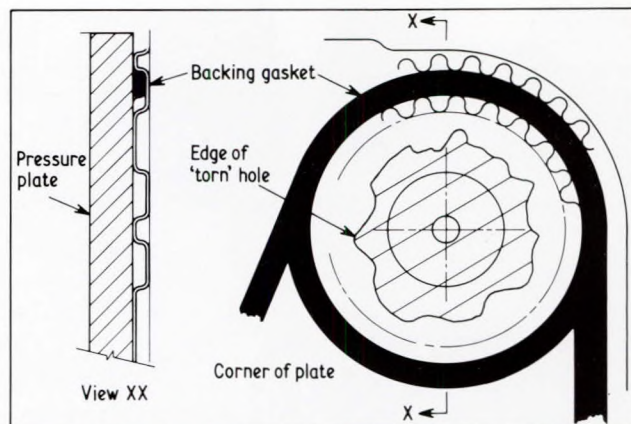
FIG. D2: Diagram of titanium plate, showing contouring
