# Solution of machinery problems by field investigation

F. KUNZ, B.A., C.Eng., F.I.Mar.E., M.I.Mech.E.  
Lloyd's Register of Shipping

## SYNOPSIS

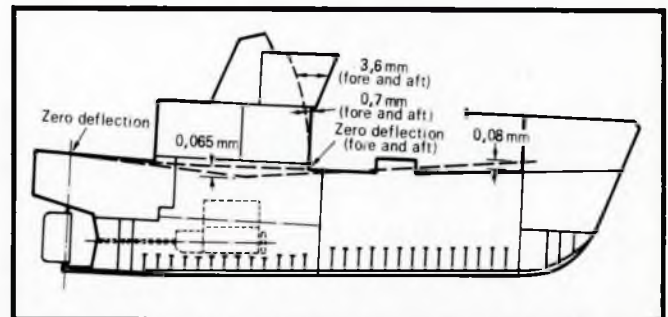
Fig. 8. Vertical vibration response of a trawler

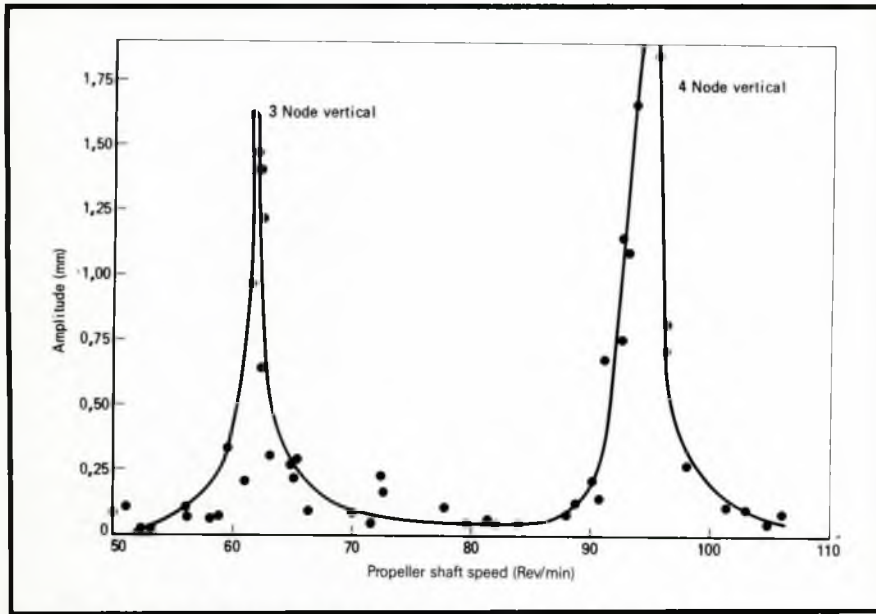
Fig. 9. Second-order excited hull vibrations in different vibration modes

Hull girder criticals, in common with most structural vibration, involve very little damping and thus they develop over a very narrow speed range to considerable amplitudes, with low vibration levels on either side of resonance. As the critical frequencies are affected by the draft of the ship the potential overall speed range in which they are of concern is far wider than the critical itself, sometimes giving rise to apparently contradictory reports. Some owners are able to operate vessels with potentially troublesome hull girder vibrations by judicious adjustments of speed and more rarely of ballast distribution without the complication of secondary balancers. Clearly, objective knowledge of a vessel's characteristics can be of help in these matters. Results of a typical vibration investigation on a 25,000 ton tanker are presented in Fig. 9.

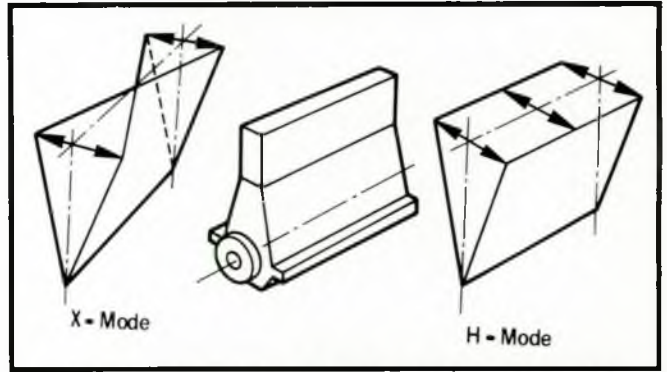
Fig. 15. Transverse vibrations of diesel engines

Engines can vibrate in a number of vibration modes, the most common transverse modes being the X- and H-mode respectively (Fig. 15). Excessive pitching or fore and aft vibration in a shear mode are less common but it has been noted that longitudinal engine vibration problems appear to have become more common with the latest generation of long-stroke engines with relatively low numbers of cylinders.

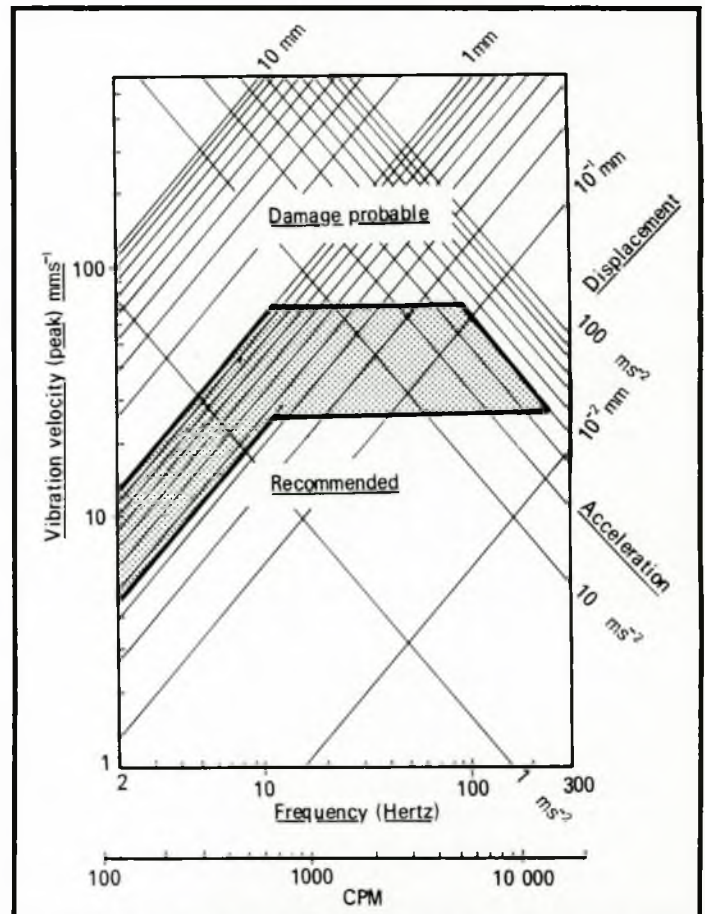
It is normal to use the amplitude of engine vibrations at the cylinder head level for assessments of vibration severity. No single acceptable level can be quoted but in the experience of TID the values shown in Fig. 16 are representative. The upper band of the shaded band represents VDI while the lower band is based on Japanese experience. The

Fig. 16. Reciprocating engine vibration severity
