Marine Machinery Failures

H. N. PEMBERTON (Member of Council)*

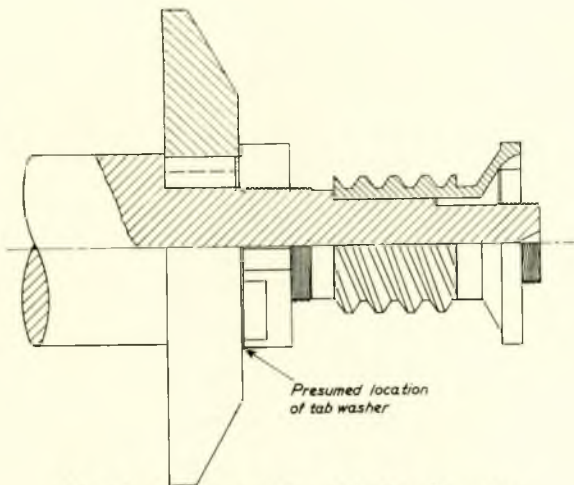
FIG. 6—Governor drive of turbo-alternator

There was no evidence that the set failed as a result of gross overspeeding. Most of the components of the thrust and governor drive were recovered from the debris. It was noted that the security of the thrust assembly had depended upon a tab washer which locked the retaining nut (Fig. 5). The conditions of the threads in this nut and on the shaft indicated that the nut had slackened back before the shaft was damaged (Fig. 6). It was considered that this was the primary cause of the breakdown. As the tab washer was not found, despite a careful search of the wreckage, it could not be

established whether this washer had failed during service. It is interesting to note that different locking arrangements for the thrust retaining nut were used on some similar sets. As a result of this accident steps were taken to check the security of the thrust assemblies on all sets of this type.

Irrespective of the type of machinery it is necessary to ensure that locking arrangements for threaded components are efficient. Tab washers, split pins and locking washers and wires should be replaced after the threaded connexions have been separated and before reassembly. There should be no

freedom for the nut to move and so damage the locking device. Undersized split pins and tab washers, slack locking wires or wires looped around a nut so that slackening is not prevented, can have disastrous consequences.

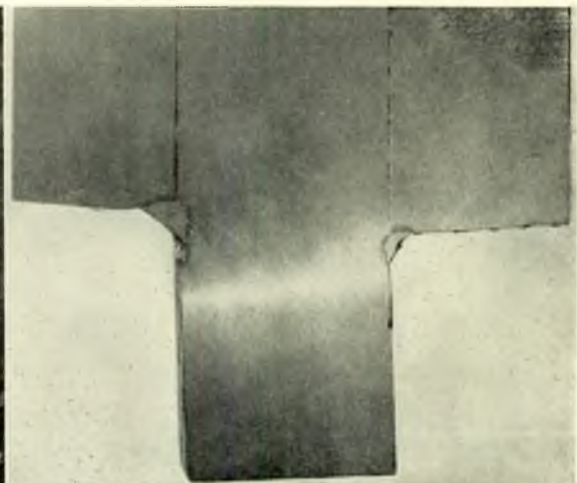
FIG. 14—Section across butt-strap, showing fillet welds

The position is by no means so satisfactory where welds that may be termed "incidental" or even "indiscriminate" are concerned. Indiscriminate welding of attachments to boiler shell plates is to be discouraged and the sealing of riveted joints by a light fillet weld could lead to serious trouble. In one case a seal weld between the double butt straps and shell plate of a Scotch boiler was used instead of caulking. When this boiler was put under hydraulic pressure the circumferential stretching that took place threw a considerable load on the small fillet weld, and this, combined with initial cracking in the fusion zone, caused the boiler to rupture catastrophically. The shell plate tore along the lower edge of one of the riveted longitudinal butt straps for the full length of the boiler. Part of the small sealing fillet weld laid along the edge of the strap is shown in Figs. 13 and 14. This failure clearly demonstrates that small fillet welds should be avoided in riveted joints where they impose undesirable restraint.

emphasis. This fault had been mentioned in relation to Fig. 13 where the boiler shell cracked in way of the sealing welding. Surely, Mr. Victory continued, it was also one of the major faults leading to the fracture of main boiler stays and possibly to some of the bedplate failures. Here he thought it should be stressed that heat treatment after welding could be of very little use if cracks were already present due to hardening and contraction stresses in the heat affected zone.

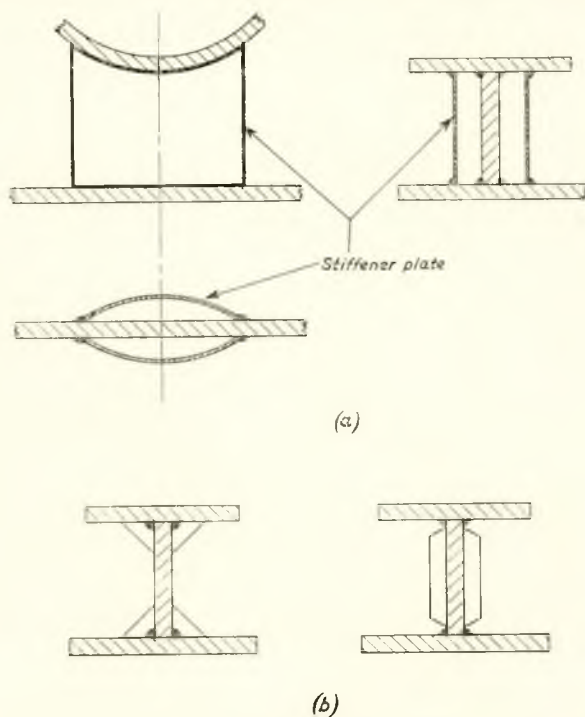
FIG. 15—Stiffener of fabricated girders: a) inadvisable; b) preferable

trate a principle concerning the attachment of stiffener plates to fabricated girders which have to carry bearing loads. In Fig. 15(a), curved stiffener plates are shown welded to the web plate of a transverse girder. These stiffeners are welded not only to the web plate but also to the top and bottom flanges of the girder, and therefore, besides acting as stiffeners, are called upon to take a share of the direct load. Where stiffeners are intended merely to reinforce the web of a girder, they should not be tight between the flanges, but as in Fig. 15(b). In all bedplate design and construction where it is intended to replace castings by welded fabrications in order to save weight, it is essential that the saving should not be made at the expense of rigidity and stiffness.

It was quite apparent that the failures reported under "Welding" were the result of poor fitting of the parts which were attached by fillet welds. In his opinion Lloyd's Register should never permit fillet welding for loaded parts such as were indicated by Figs. 15 and 16—only full depth welding could make a satisfactory connexion.

Double-weld butt type joints should be adopted wherever possible in view of their superior fatigue strength. In large bedplates, double-plated transverse girders have an advantage over single-plate girders, especially in way of the bearing housings, since a much stiffer girder is thus obtained and better support given to the bearing. Again, if long through bolts are used, passing through the cast steel bearing housing and securing the upper entablature to the bedplate, a more even distribution of static and gas loads will be achieved. Access holes should be as small as possible in order to avoid cutting out too much material that would otherwise help in carrying the loads. If access holes are flame cut their edges should be finished off by machining or grinding so as to have no rough spots where a crack might originate. Figs. 15(a) and (b) illus-

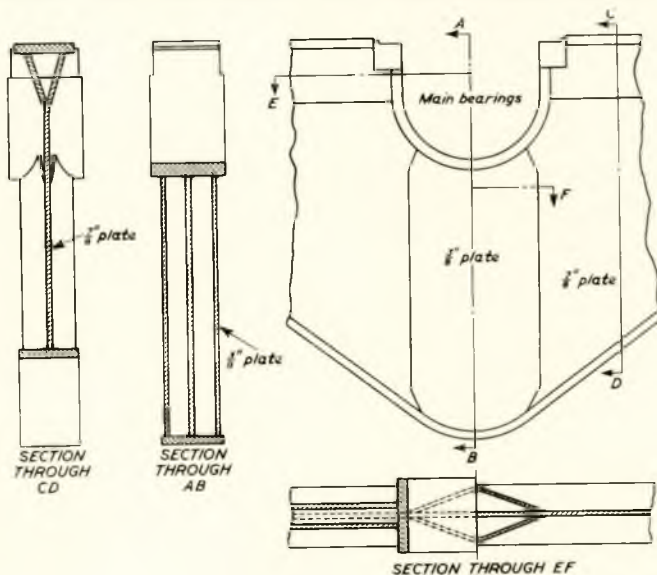
FIG. 32

Referring to Diesel engines: Mr. Pemberton advocated cast steel main bearing housings having web extensions which were butt welded to the vertical cross-girders of bedplates. Experience had confirmed the value of this construction in ensuring down-welding. For comparison with Fig. 15(a): Fig. 32 showed a design for main engine bedplates which, for a time, had a measure of popularity. It seemed simple and effective, but inherent welding problems were responsible for its discontinuance.

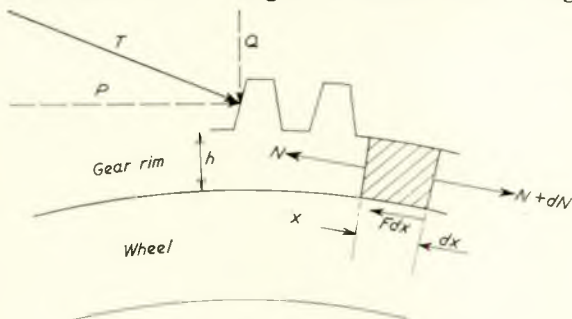
FIG. 36

Professor F. Odquist of the Royal Institute of Technology in Stockholm had given a theory for this kind of slip, based on a simple model (Fig. 36).

A force balance for the element dx in the tangential direction (Fig. 36) gave

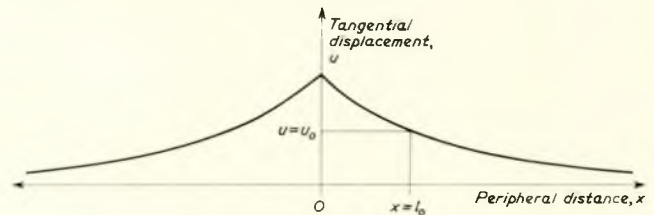
FIG. 37—Rim without dowel pins

Fig. 37 showed the result for partial slipping of a shrunk-on rim without dowel pins. Maximum slipping occurred where $x = l_0$, that was, where the force P was applied. The displacement then decreased to u_0 at $x = l_0$. For x greater

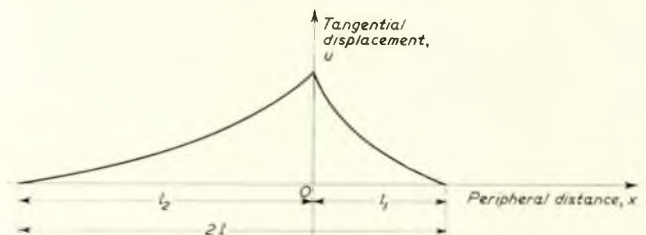
FIG. 38—Rim with dowel pins at distance $2e$

Fig. 38 showed the case of a shrunk-on ring with dowel pins at a distance $2 \cdot 1$. The force P was applied at $x = 0$ at a distance 1_1 from one pin and 1_2 from the other. In this case the dowel pins, which might be axial or radial, were assumed to be completely stiff, so that no displacement u could occur at the pins. When the pin was completely stiff, it had to resist the whole force P , when P was at the pin.
