MARINE MACHINERY FAILURES

B. K. Batten, M.Sc., C.Eng., M.I.Mar.E.*

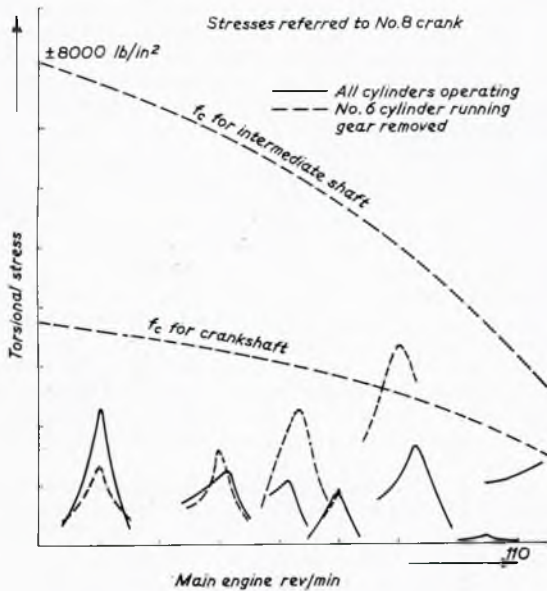
FIG. 11—Crankshaft torsional stresses with and without No 6 cylinder running gear removed

A 19 000 bhp 9-cylinder oil engine crankshaft failed in the forward web of No. 8 crankthrow after approximately 200 million power strokes. Immediately prior to fracture the engine had been running for 360 h at 90 rev/min with No. 6 cylinder unit entirely "hung-up" (2×10^6 cycles).

Subsequent torsional vibration records, with and without No. 6 cylinder "hung-up", showed the engine had, in fact, been running for 2 million cycles on a 1-node fourth order critical (Fig. 11) and this, coupled with the stress raising effects of the internal flaws, had initiated the fatigue failure of the crankshaft.

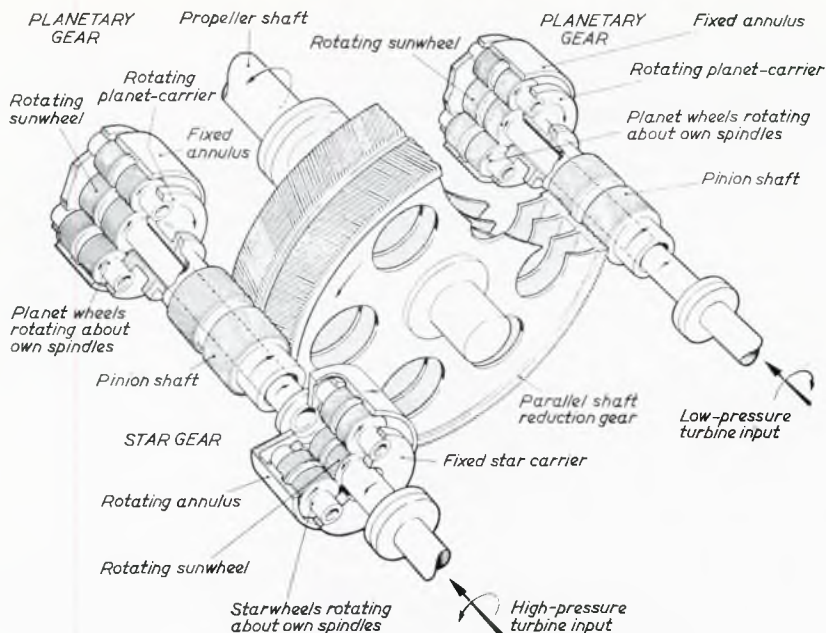
The author had mentioned that trouble had occurred in two of the H.P.1 gear designs fitted in the triple-reduction gear arrangement. Some members might not be familiar with this arrangement, which was shown diagrammatically in Fig. 19. It would be noted that the H.P.1 star gear was connected to the H.P. turbine through a comparatively short quill shaft with a gear type flexible coupling at each end.

FIG. 19—Triple-reduction gear arrangement

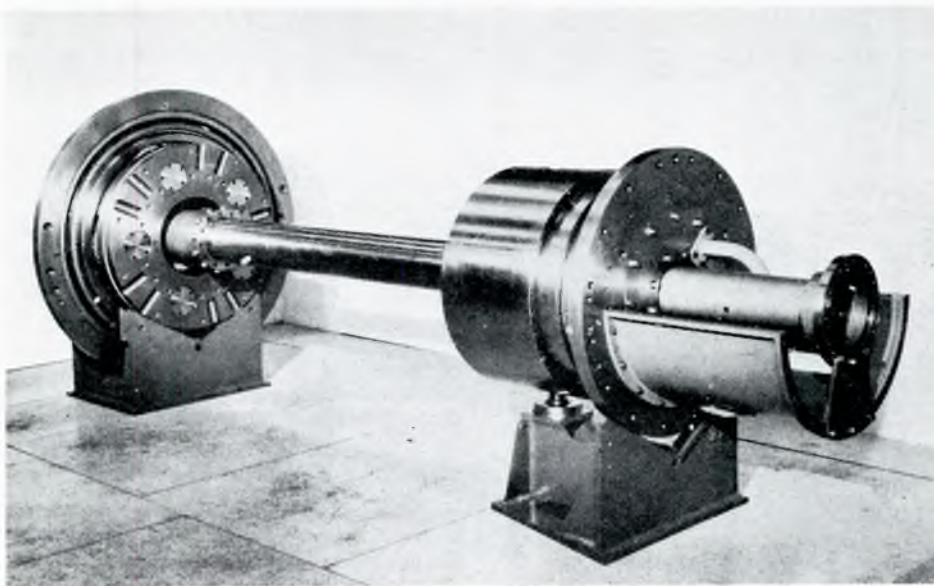
Fig. 20 showed an actual H.P.1 and H.P.2 gear of about 17 000 hp.

FIG. 20—H.P.1 and H.P.2 gear of about 17 000 hp

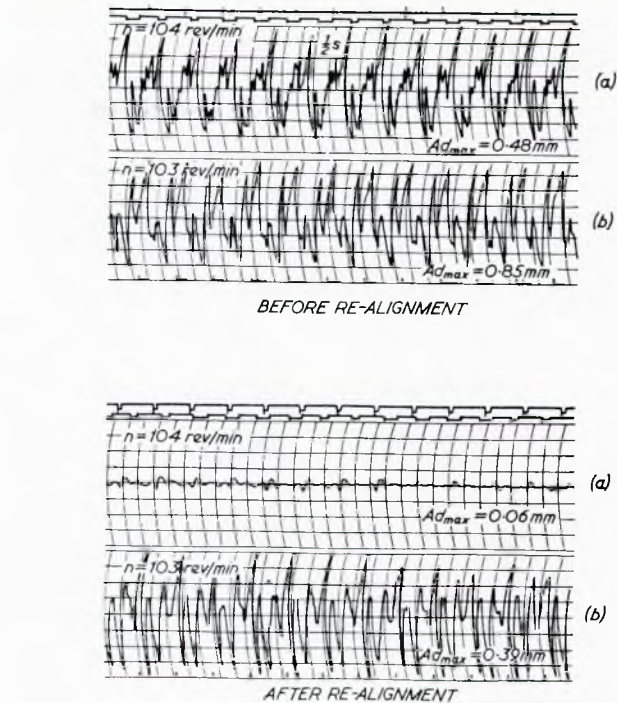
FIG. 33—Recordings of the vibrations affecting a crankshaft with two alignment variants (a) vertical vibrations of a journal, (b) longitudinal vibrations of a web— $P = 15000 \text{ hp}$
